Building Inspection Report

[REDACTED] Court, Nashville TN 37215

Inspection Date: January 18, 2008

Report Number: DD012508A

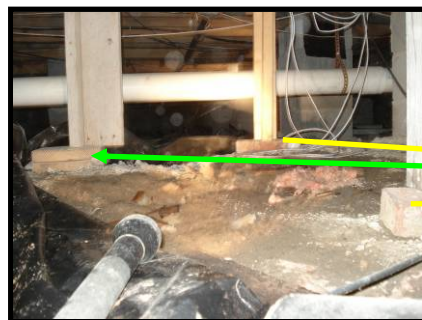
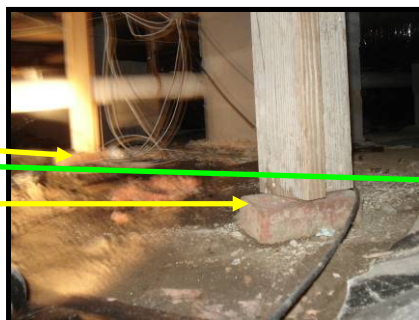
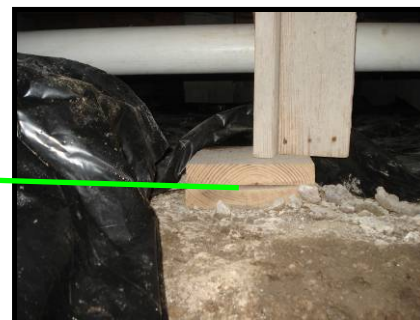
- Improve: Information:** Some additional supports have been added in the crawl space of the house. The supports do not appear to have been installed in a workman like manor and it is recommended that they be improved.

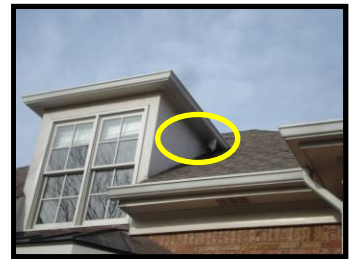
- **Monitor:** It is recommended that the downspouts, which are connected to tubes that run under ground, be checked periodically to insure the integrity of the tubes. If the tubes fail near the foundation storm water will be discharged against the foundation walls and can adversely affect the home.
- **Improve:** Downspout(s) that discharge onto the roof should be extended to discharge directly into the gutters below. Discharge directly on to the roofing materials can cause premature deterioration to the roof's surface often creates leaks around such points of discharge. **While this is not a requirement “BJK” makes this recommendation based upon observation of defects caused by gutters discharging onto the roofs.**

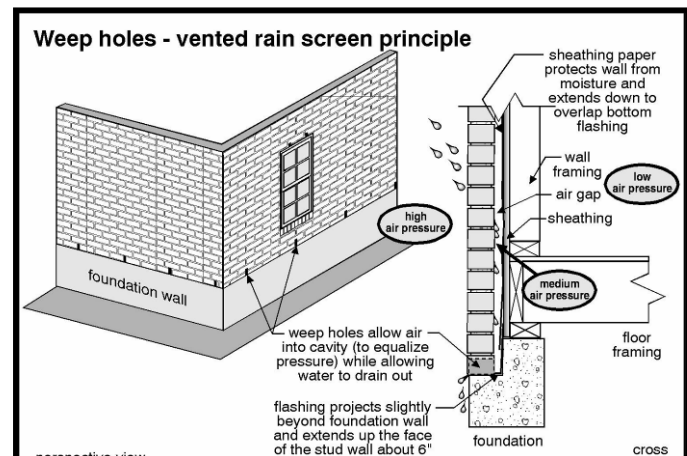
- **Improve:** Weep holes were not installed as required on the building. Weep holes are intended to allow water to exfiltrate and air to infiltrate the wall cavity. **Weep holes should be provided in masonry veneer and in the outside wythe of masonry walls at a maximum spacing of 4 ft (1219 mm) on center by omitting mortar in the head joints** Weep holes shall be located in the first course above the foundation wall or slab, and other points of support, including structural floors, shelf angles, and lintels. Shown at right and below are diagrams showing the proper placement for weep holes. **There is no evidence of any ill-effects from the lack of the required weep holes. Drilling weep holes in the mortar joints around the building to allow air infiltration to enter and dry the cavity is a simple and inexpensive.**

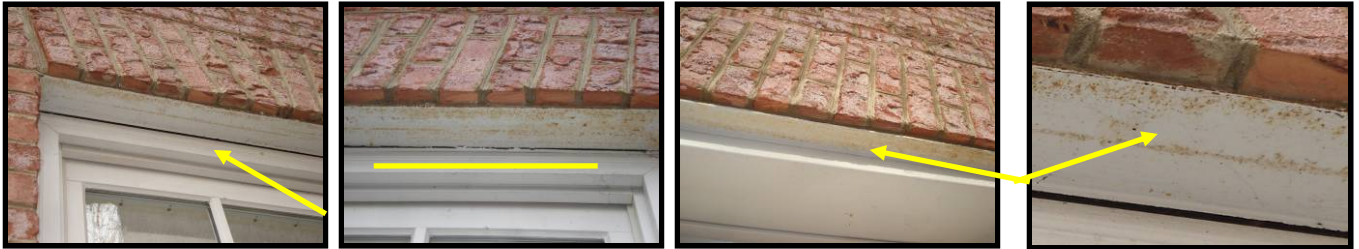
- **Improve:** There is rust starting to form on the lintels (the metal angel iron above doors and windows in brickwork) above the garage doors, the pedestrian door of the garage and several of the windows. Sand, prime and paint with a good quality rust inhibiting paint. Rusted lintels are known to damage brickwork. Also caulk between the lintel and the wood frame.

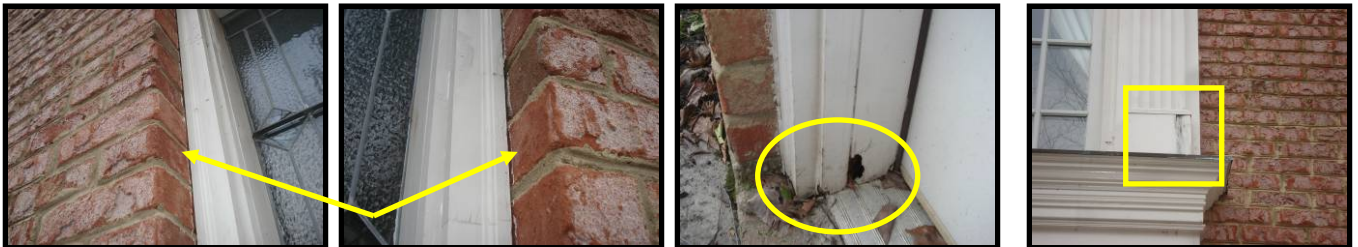
- **Repair:** There is some localized wood rot at the base of the frame around the pedestrian garage door. Gouging out the rotted wood and filling affected areas with “Bondo,” (an automotive body filler) sanding and painting with a quality paint is recommended for small areas while wood replacement is recommended only as a temporary fix while wood replacement is considered a permanent repair. It would be most advantageous to use a cementitious wood substitute rather than wood as it will not rot out.

- **Repair:** There is some localized wood rot to the trim above the rear entryway. As above this condition should be appropriately repaired.

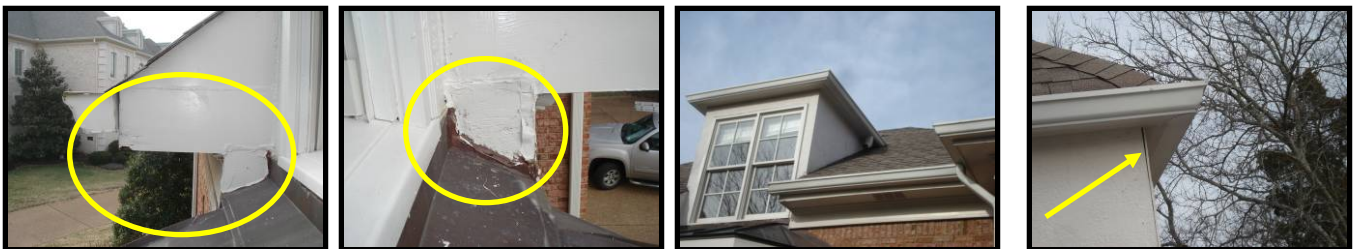
- **Repair:** There is localized wood rot to some of the fascia and trim boards around the dormers on the right side of the house. In conjunction with painting maintenance it is recommended that all fascia and soffit areas be carefully checked and repaired as needed. Again it is recommended that the damaged wood be replaced with a cementitious board rather than wood. It is also recommended that the point where the trim meets the siding be caulked. (Right picture below)

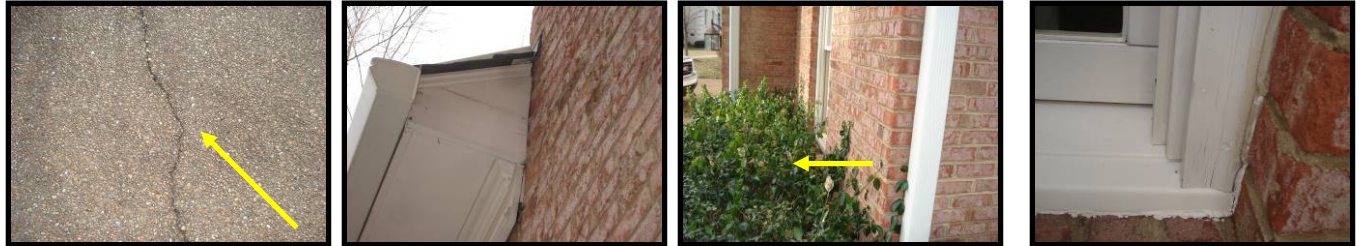
- **Repair:** There are some settlement cracks in the cement driveway. It is recommended that they be filled to prevent moisture from entering and eroding the surface beneath the cement which will lead to additional cracking. Sonneborn and Trimco make some excellent long lasting products to help seal such cracks. Exterior Materials, 665 Wedgewood Ave. Nashville, TN (near the State Fair Grounds) carries Sonneborn and Trimco products.
- **Improve:** It is a good idea to caulk points where dissimilar materials meet, especially where the joint runs vertically, to help prevent moisture and insect intrusion. Application of caulking around the trim as it meets the brickwork is recommended.

- **Improve:** All shrubs and vegetation should be cut back away from the building at least 12 -24" to promote proper air circulation around the walls. Vines and other climbing plants can cause damage to exterior surfaces and should not be allowed to grow on the building. Such vegetation also prevents proper drying of the siding and provides a pathway for insect life which can cause damage to your home
- **Repair:** The wood trim around most of the home has reached the point where painting maintenance is required. Exterior wood trim on windows, dormers, chimneys, porch railings and columns, etc., must be kept well painted to prevent decay. Proper preparation including scraping, sanding and painting with a good quality paint will protect the wood and your investment

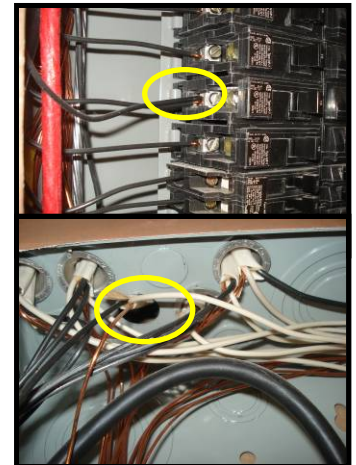
- **Repair:** Cable clamps (sometimes referred to as bushings or grommets or connectors) are required where wiring passes into the any distribution panel, box or fixture. Such devices serve to protect the wiring from the metal edges of the panel openings. There is a connector missing on a wire that enters the panel from the top of the box.

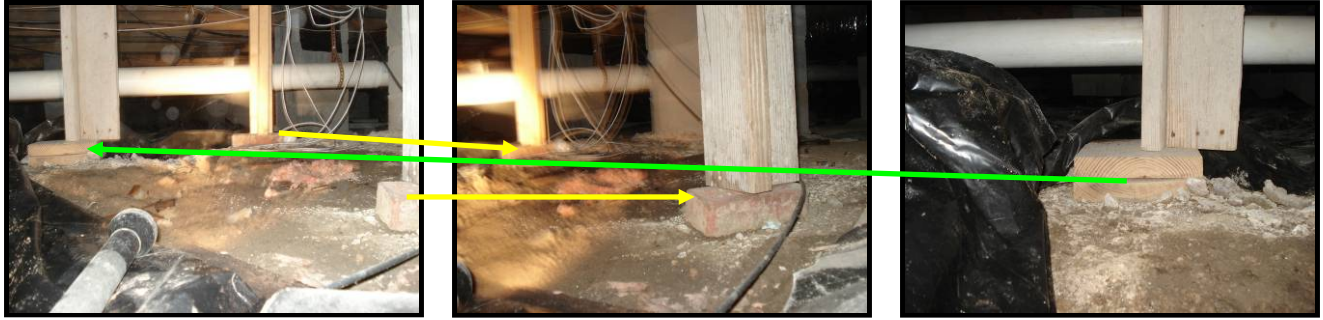
- **Improve: Information:** Some additional supports have been added in the crawl space of the house. The supports do not appear to have been installed in a workman like manor and it is recommended that they be improved.

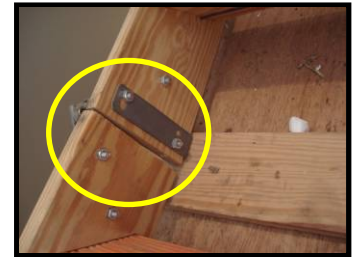
- **Repair:** The ladder on the pull down stairs to the attic needs to be trimmed to sit on the floor in a fully open position. Often if theses are not correctly trimmed the stairs will not support the weight of the climber leading to malfunctioning of the unit over time.

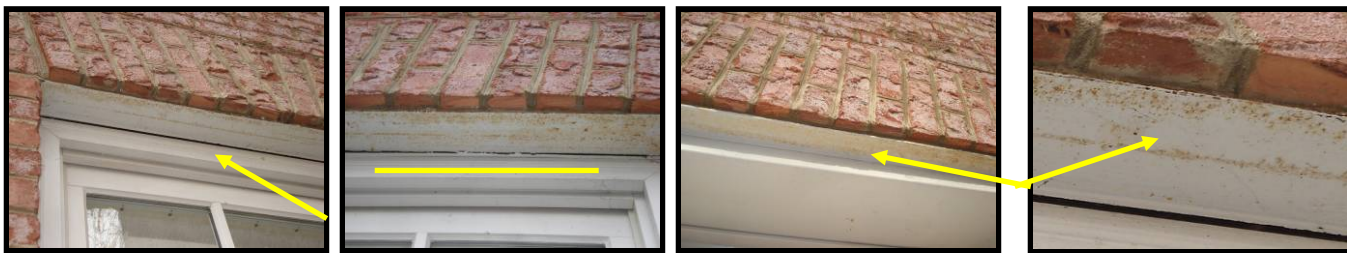
- **Improve:** There is rust starting to form on the lintels (the metal angel iron above doors and windows in brickwork) above the garage doors, the pedestrian door of the garage and several of the windows. Sand, prime and paint with a good quality rust inhibiting paint. Rusted lintels are known to damage brickwork. Also caulk between the lintel and the wood frame.

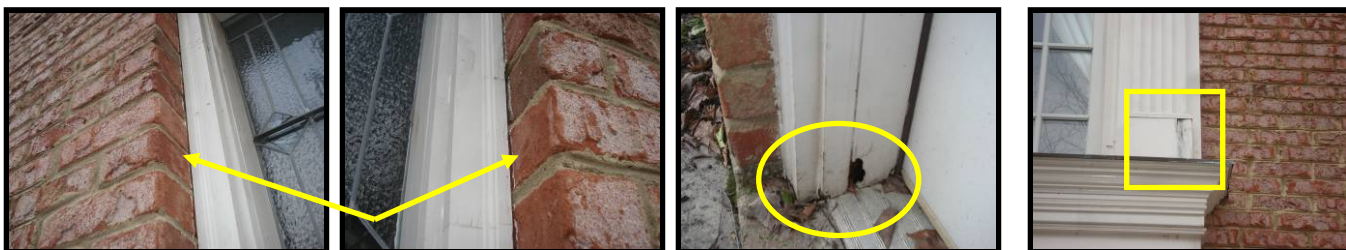
- **Repair:** There is some localized wood rot at the base of the frame around the pedestrian garage door. Gouging out the rotted wood and filling affected areas with "Bondo," (an automotive body filler) sanding and painting with a quality paint is recommended for small areas while wood replacement is recommended only as a temporary fix while wood replacement is considered a permanent repair. It would be most advantageous to use a cementitious wood substitute rather than wood as it will not rot out.

- **Repair:** There is some localized wood rot to the trim above the rear entryway. As above this condition should be appropriately repaired.

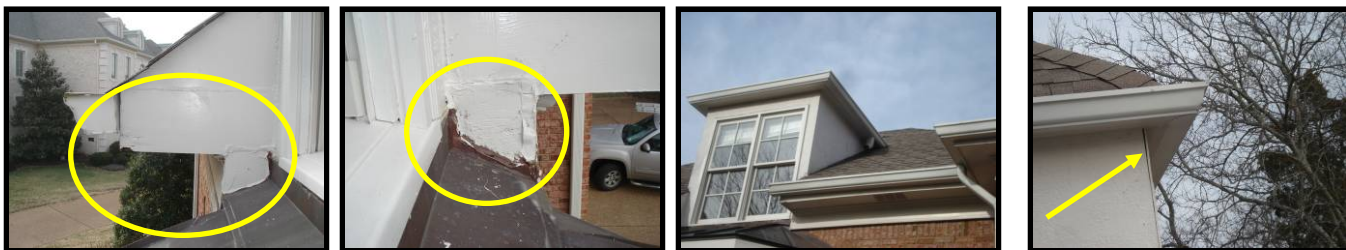
- **Repair:** There is localized wood rot to some of the fascia and trim boards around the dormers on the right side of the house. In conjunction with painting maintenance it is recommended that all fascia and soffit areas be carefully checked and repaired as needed. Again it is recommended that the damaged wood be replaced with a cementitious board rather than wood. It is also recommended that the point where the trim meets the siding be caulked. (Right picture below)

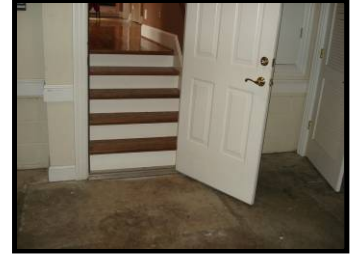
- **Safety Issue: Information:** The steps from the kitchen area to the garage terminate at the door with the door closed and at the garage floor when the door is open. It is generally required that a 36" deep landing be present rather than a door.
