Building Inspection Report

4th Avenue N. Nashville TN 37219

Inspection Date: July 12, 2007

Report Number: JA071207AC

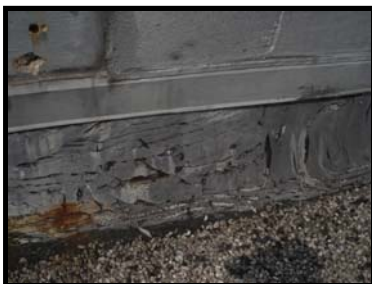
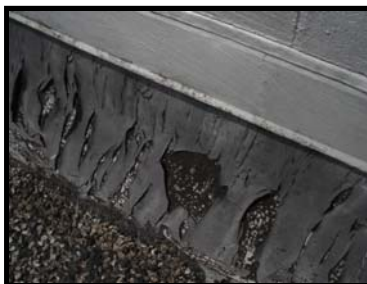
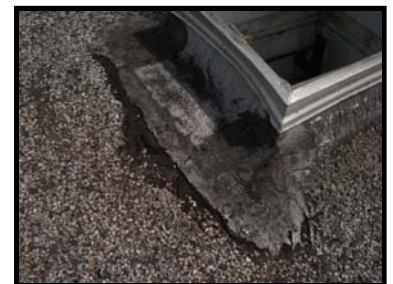
THE ROOF ABOVE THE MECHANICAL FLOOR

The flashing on the parapet walls have failed and are allowing water to enter.

There is damage to flashings around penetrations give rise to moisture collecting under roof topping.

There is bubbling and air pockets in the roofing material indicating delamination and that moisture is under some of the areas.

There is noted deterioration of the surface beneath the stone casting commensurate with aged worn out material in need of replacement.

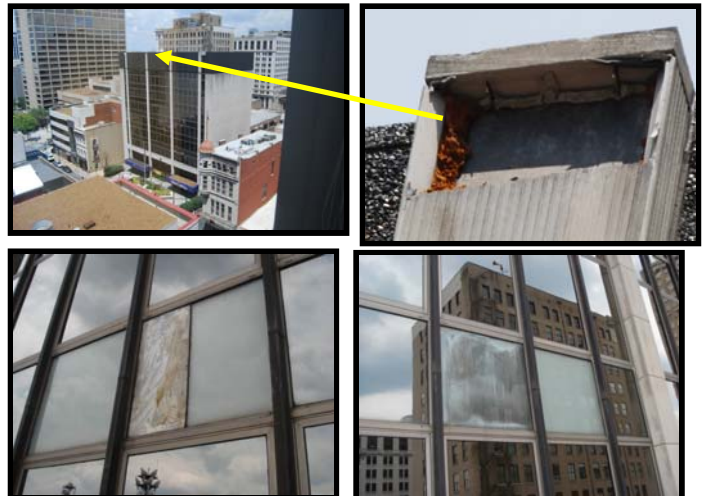
- **Safety Issue: Improve:** On the front of the building there is a piece of cement casting that has broken off. It is recommended that the piece be appropriately repaired or replaced. It is possible that in time moisture could cause the adhesive to fail and that a strong wind could cause the remaining piece to fall causing damage to property or injury to someone below.
- **Improve:** There are a few places where the glass of the windows has had seal failure or has been broken. Damaged windows should be replaced.

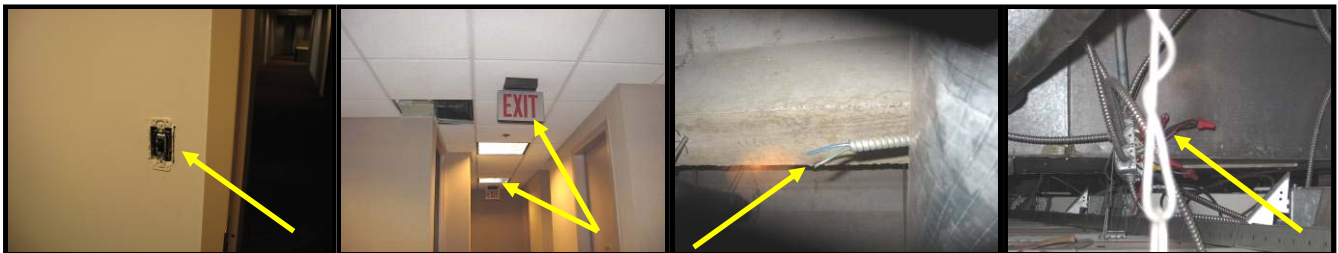
- **Repair:** One of the switch plates is missing in room 7-Z. Missing outlet cover plates should be replaced to avoid a shock hazard.
- **Repair: Safety Issue:** The Exit lights were out in several locations on the 7th floor. All safety exit lights should be brought into proper working order.
- **Repair:** There is an improperly terminated wire in the ceiling cavity of the front hall of the 7th floor. All wires are required to be terminated within an approved box or fixture and boxes are required to be fitted with covers.
- **Repair:** There are uncovered junction boxes in the ceiling cavity of the front hall of the 7th floor. All junction boxes should be fitted with cover plates, in order to protect the wire connections.

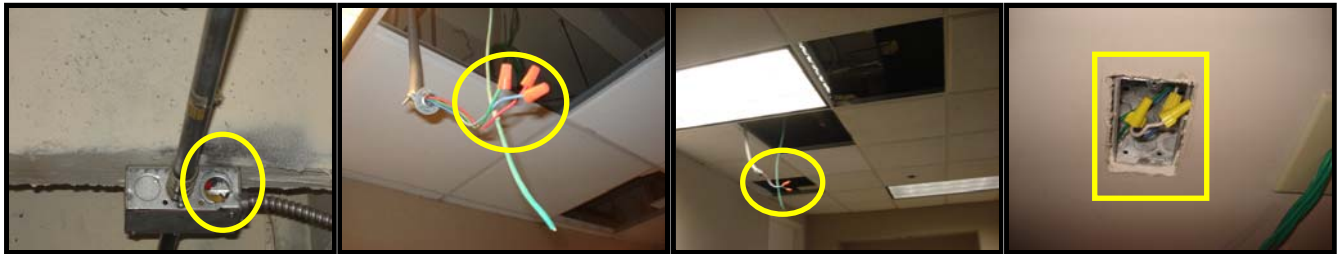
- **Repair:** There are missing junction box cover plates at several locations on the 6th floor. All junction boxes should be fitted with cover plates, in order to protect the wire connections.

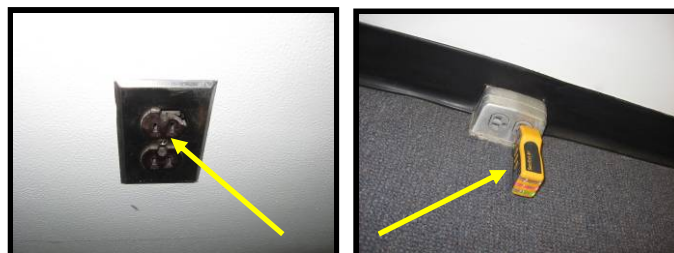
- **Repair:** An outlet in the middle of the main hall is damaged. It should be replaced.
- **Repair:** One of the floor outlets in room 5-I has reversed polarity. An outlet has reversed polarity (i.e. it is wired backwards). This outlet and the circuit should be investigated and repaired as necessary.

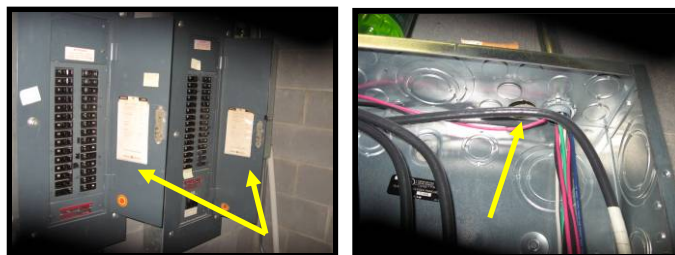
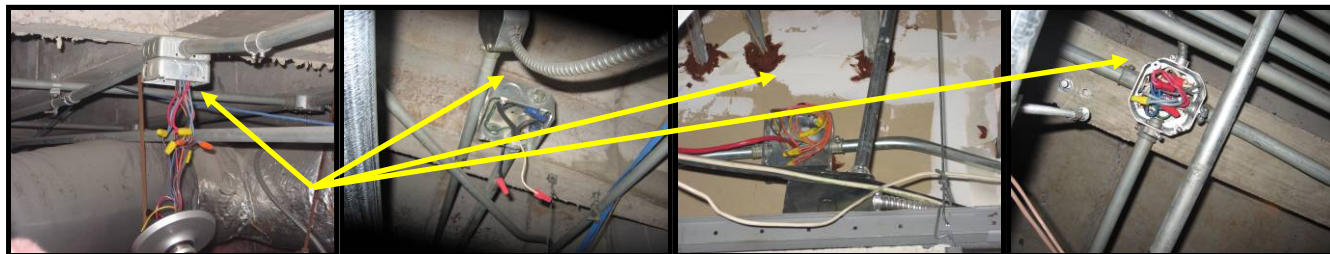
- **Repair:** Open boxes were observed on the front wall and back hall wall of room number 4-X. It is recommended that all wall boxes be fitted with receptacles and covers or appropriate cover plates.

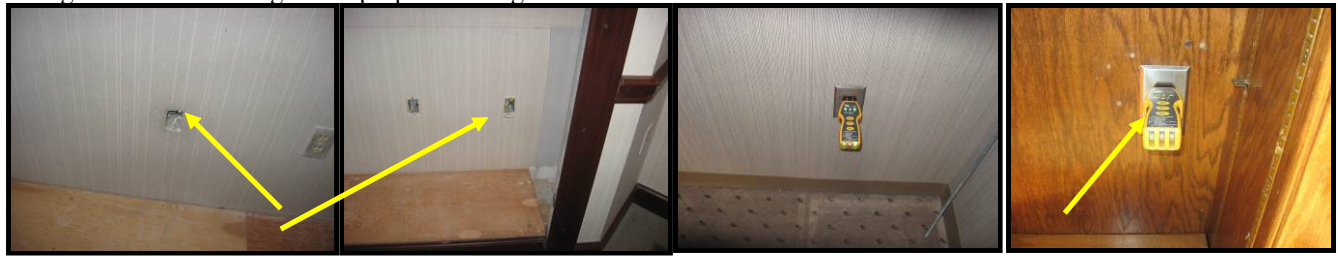
- **Repair:** Several of the outlets and lights in the hall of room number 4-X did not function when tested. All outlets and lights should be brought into proper working order.

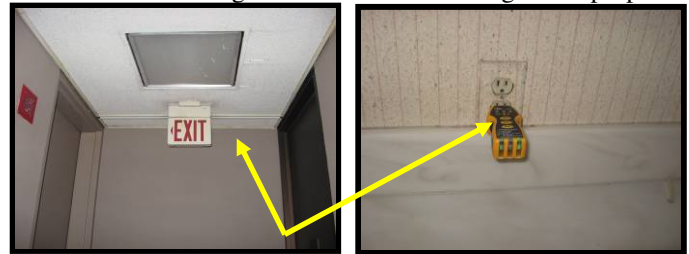
- **Safety Issue: Repair:** Many of the safety exit signs of the 4th floor are not lighted and should be brought into proper working order.
- **Repair:** The lights in room 4-AA did not operate when tested and should be repaired.
- **Safety Issue: Improve:** Since 1984 it has been a standard building practice for countertop outlets within six feet of the sink to be GFCI protected. The counter top outlets in room number 4-PP are not protected as required.
- **Repair: Safety Issue:** There are several pipe chases in the walls and ceiling cavity of the 4th floor that need to be sealed to prevent penetration in case of a fire.

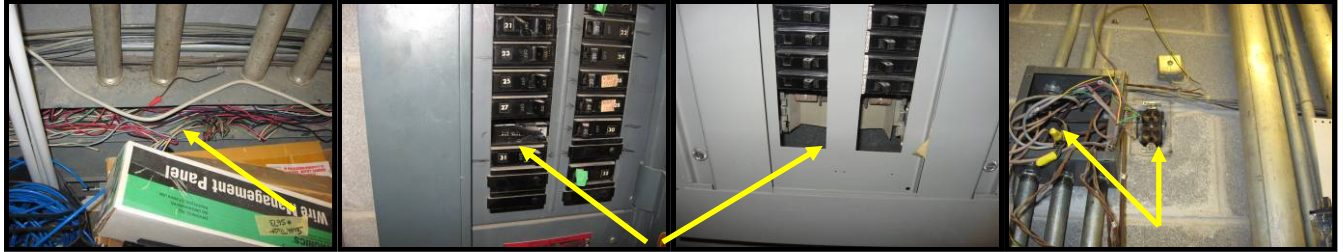
- **Repair:** There are openings in the face of the electrical sub panels ("dead fronts") in the mechanical room on the first floor. Specifically panel number 1 LA and the sub panel to the left of the main panel. There should be no openings in the face which would allow the insertion of any object. Insertion of an object could cause damage to the equipment and could injure a person should they come in contact with the inserted object. Openings should be filled with blank spacers.
- **Repair:** There are uncovered junction boxes and outlets in the mechanical room on the first floor. All junction boxes and outlets should be fitted with cover plates, in order to protect the wire connections.

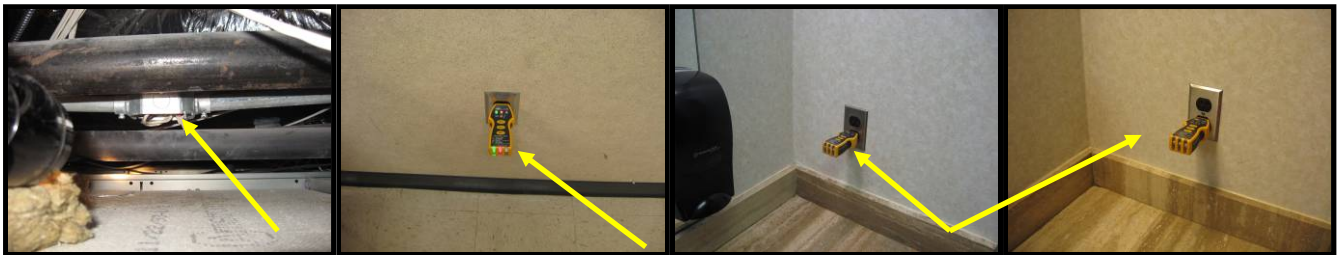
- **Repair:** There is an uncovered junction box in the ceiling cavity over room number 1-F. All junction boxes should be fitted with cover plates, in order to protect the wire connections. Ceiling cavity spot checked only.
- **Repair:** There are 2 outlets with reversed polarity in room number 1-C. An outlet has reversed polarity (i.e. it is wired backwards). This outlet and the circuit should be investigated and repaired as necessary.
- **Safety Issue: Improve:** Since 1971 it has been a standard building practice for bathroom outlets to be GFCI protected. The 1st floor restroom outlets were not functioning as required and not GFCI protected. It is recommended that they be appropriately repaired.

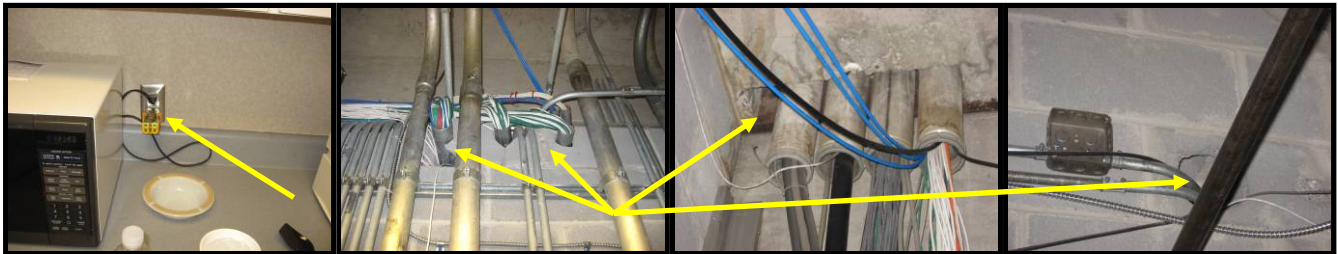
- **Repair: Safety Issue:** Not all of the counter top outlets in room number 1-CC are GFCI protected. It is recommended that the outlets be improved.
- **Repair: Safety Issue:** There are several holes in the ceiling cavity and walls that should be sealed for fire protection.

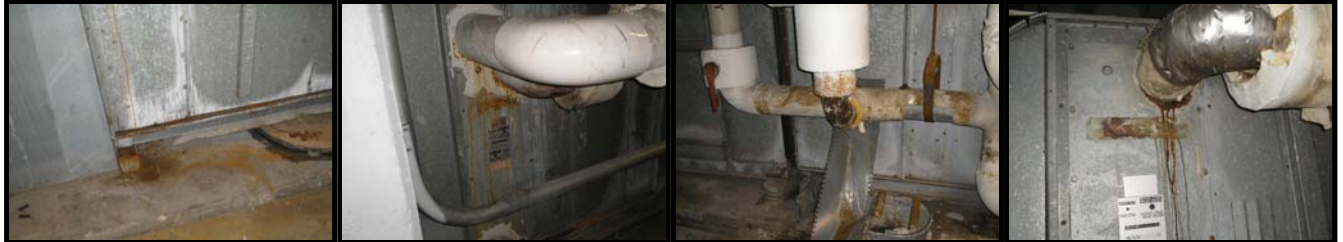
The coil units in the penthouse air handlers leak and frames are rusted out

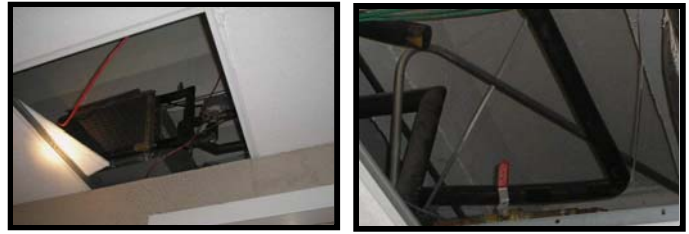
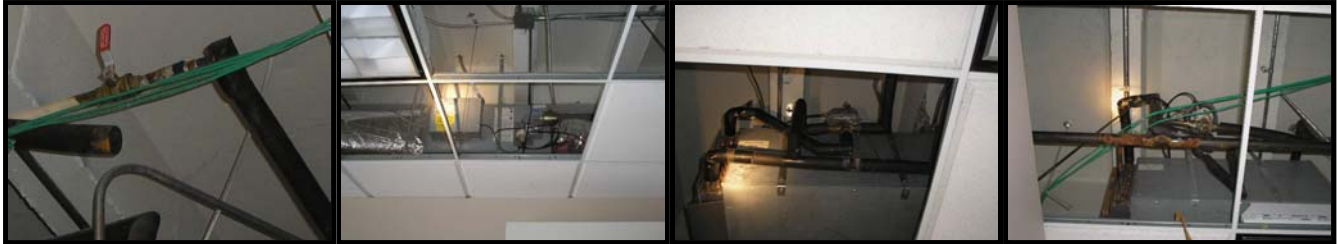
There is extensive repair work to be done on the fan coil unit piping. Control valves are leaking. Fittings are leaking. And insulation missing is causing condensation leaks.

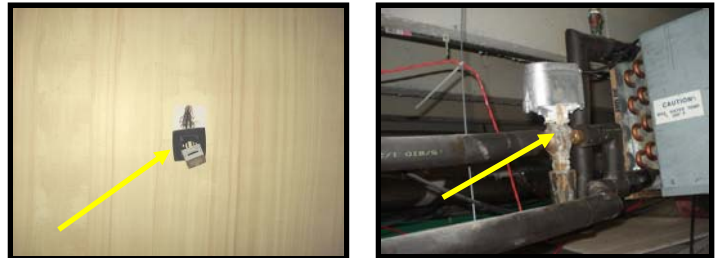
- **Improve:** There was no thermostat in room number 7-A. No air flow was detected.
- **Improve:** There are several missing thermostats at various locations on the 6th floor. It is recommended that all missing thermostats be properly installed
- **Monitor:** There is a valve next to the HVAC unit in the ceiling of the 6th floor that appears to have leaked at one point in time. The valve did not appear have been leaking at the time of the inspection, but should be monitored.

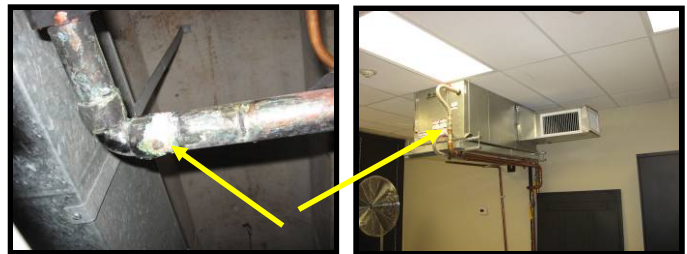
- **Repair:** The thermostat in 5th floor Suite 1 hall has been pulled from the wall and should be repaired.
- **Repair:** A leak in the copper condensate line was observed in the ceiling cavity over room number 5-A. It is recommended that the line be properly repaired.
- **Information:** A separate AC unit was installed by the tenants in room number 5-O to service the computer servers located in that room.

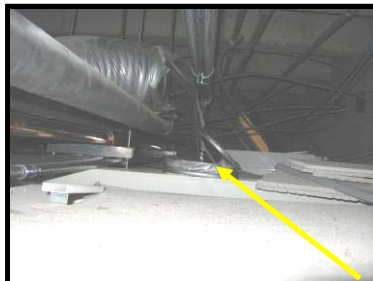
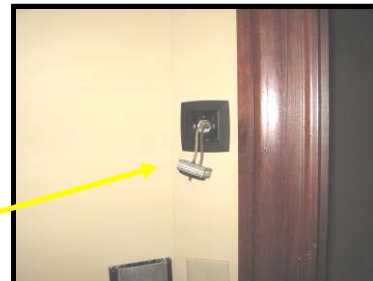
- **Repair:** One of the ducts in the ceiling cavity over room number 4-I has been unhooked and should be repaired during renovations.
- **Repair:** The thermostat in back hall did not operate as intended and the thermostat in room number 4-DD is damaged and should be repaired.

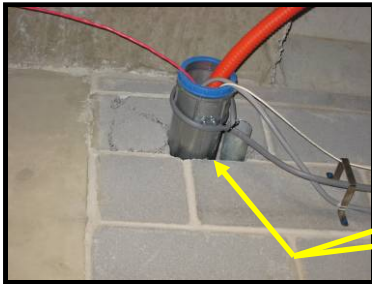
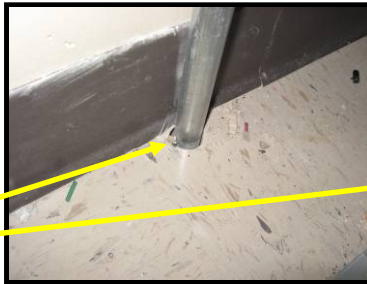
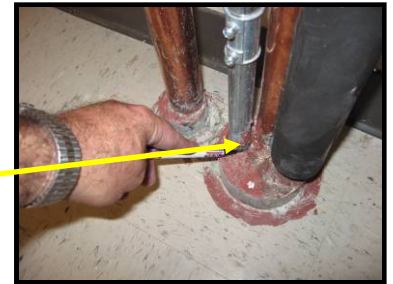
- **Repair: Safety Issue:** Fire caulking is necessary at the conduit and pipe chases in the mechanical room and room number 5-O.

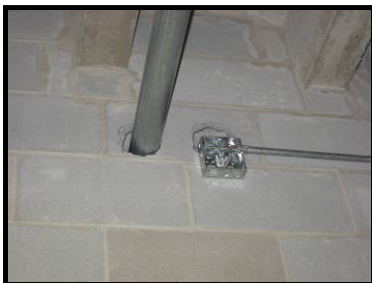
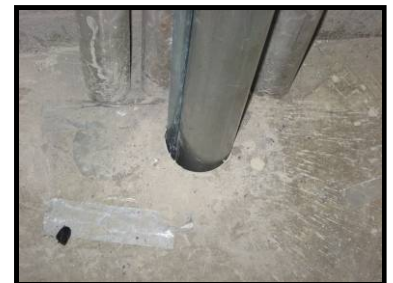
- **Repair: Safety Issue:** There are several pipe chases in the walls and ceiling cavity of the 4th floor that need to be sealed to prevent penetration in case of a fire.

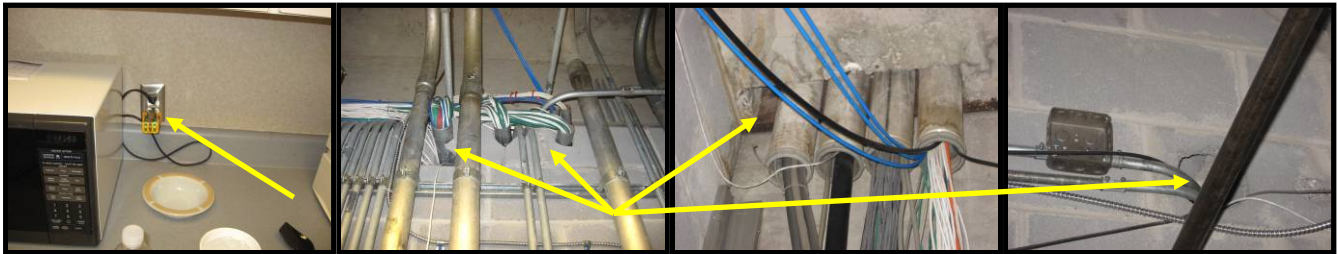
- **Repair: Safety Issue:** There are several holes in the ceiling cavity and walls that should be sealed for fire protection.

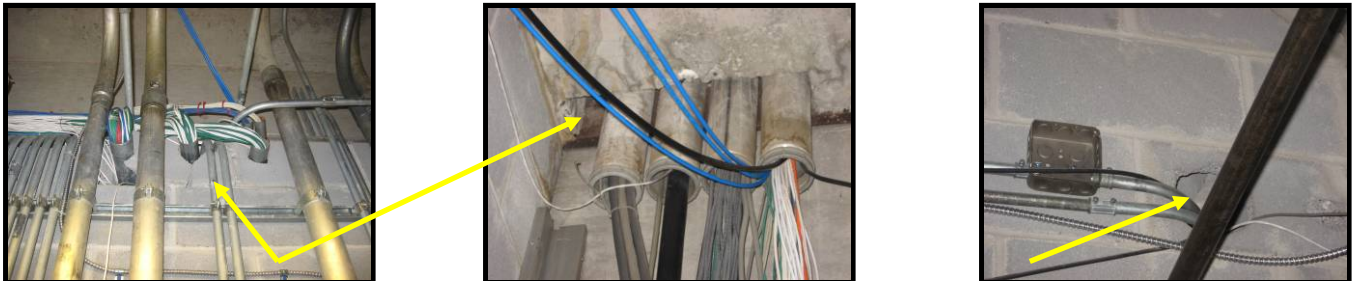
- **Repair: Safety Issue:** Fire caulking is necessary in several places in the mechanical room of the 1st Floor.

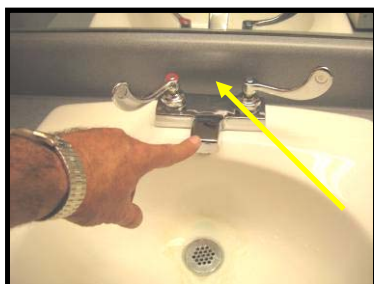
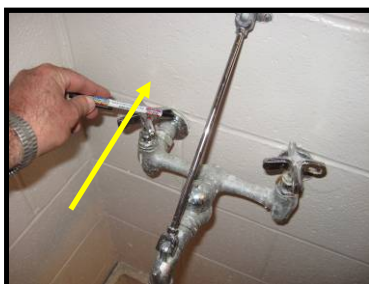
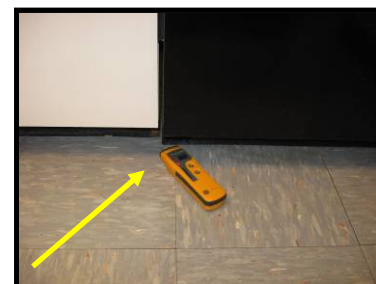
- **Repair:** The right sink in the women's bathroom on the 7th floor is leaking and should be repaired or replaced.
- **Repair:** The hot water valve on the faucet on the mop sink in the kitchen is turned off or defective and should be repaired or replaced.
- **Repair:** Moisture was detected on the floor in front of the dishwasher in the kitchen on the 7th floor indicating that the dishwasher is leaking. It is recommended that the dishwasher be replaced.

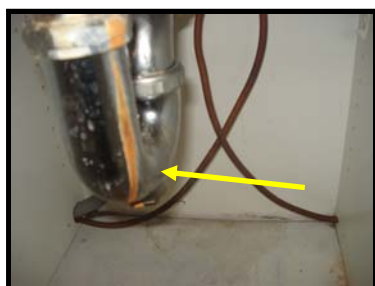
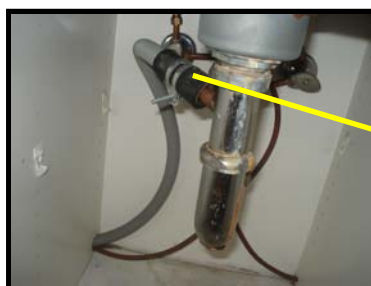
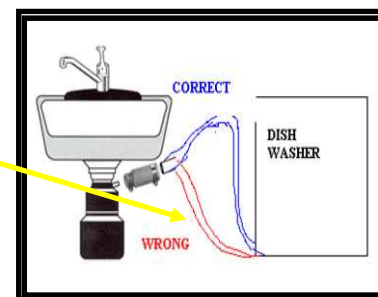
- **Monitor:** There are metal traps under some of the sinks. These traps are beginning to show evidence of minor rusting. It is recommended that they be replaced with plastic traps which do not rust. Such traps are inexpensive and easy to install and could save many dollars of repair should the metal traps fail and begin to leak.
- **Improve:** The drain, from the dishwasher which connects to the drain under the kitchen sink, needs to be modified. Presently the drain rises up from the dishwasher to the drain. It needs to be re-routed to first run up above the drain and then downward to the drain. This rise is necessary to prevent water draining from the sink from backing up into the dishwasher.

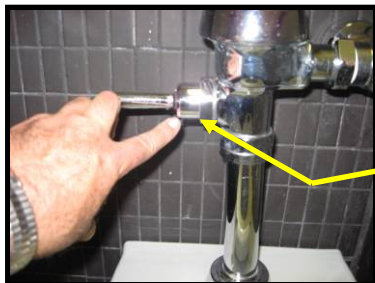
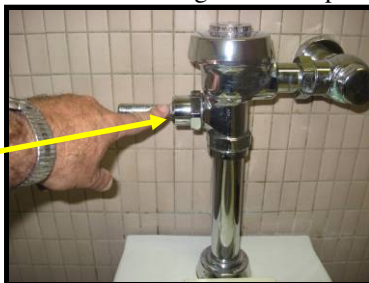
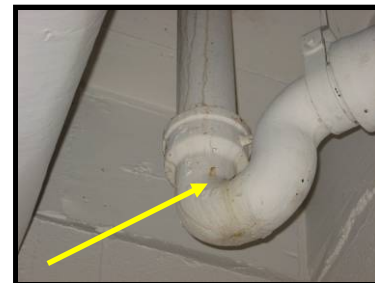
- **Repair:** The valve on the commode in the men's bathroom on the 5th floor is leaky and should be repaired or replaced. Additionally the commode did not flush as intended.
- **Repair:** The valve on the last commode in the women's bathroom is leaky and should be repaired or replaced.
- **Monitor:** Water staining was observed on the waste line in the mop room of the 5th floor indicating leaking in the fixture on the floor above. It is recommended that this be investigated and repaired.

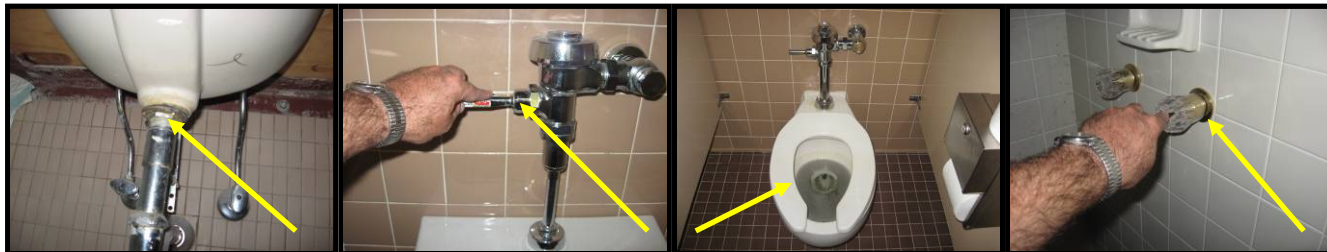
- **Repair:** The drain on the left sink in the women's bathroom in suite #2 is leaky and should be repaired.
- **Repair:** The valve on the urinal in the men's bathroom in suite #1 is leaky and should be repaired or replaced.
- **Repair:** The commode in the women's bathroom in suite #1 is out of service and should be repaired or replaced.
- **Repair:** The faucet on the shower in the personal bathroom at the back of suite #1 is defective and should be replaced.

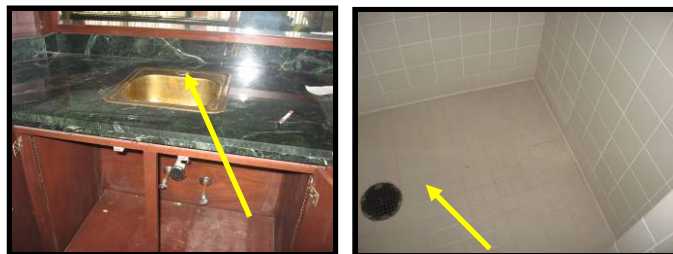
- **Repair:** The faucet on the sink in room number 4-PP has been removed and should be replaced during renovations.
- **Repair:** The grout in the personal shower at the back of suite #1 is cracked and deteriorated and should be repaired. Cracked, deteriorated and/or missing shower stall grout and caulk should be replaced. It is important to maintain the caulking in tiled showers along wall corners and floor and wall seams to prevent moisture from getting into the mud base below the tile. Damage can be caused if these areas are not well sealed and maintained. Periodic inspection and maintenance is certainly more preferable than costly repairs.

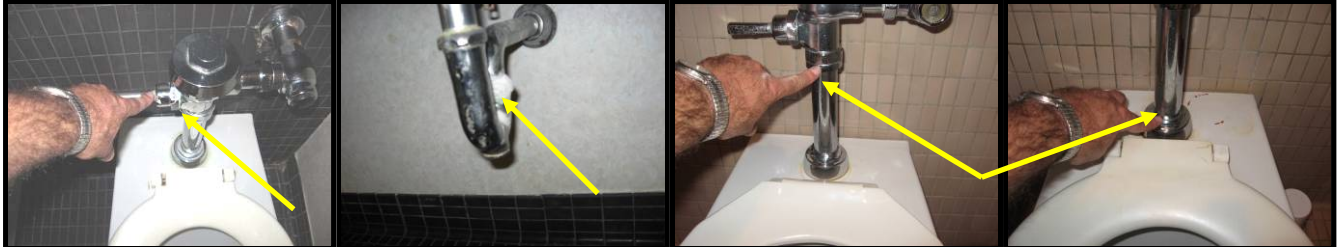
- **Repair:** The valve on the left commode in the men's bathroom on the 1st floor is leaky and should be repaired or replaced.
- **Improve:** The waste line on the right sink in the men's bathroom on the 1st floor was observed to be deteriorated and should be replaced.
- **Repair:** The first commode in the women's bathroom on the 1st floor is out of service and the valves on the 2nd and 4th commodes are leaky. It is recommended that the commodes be brought into proper working order.

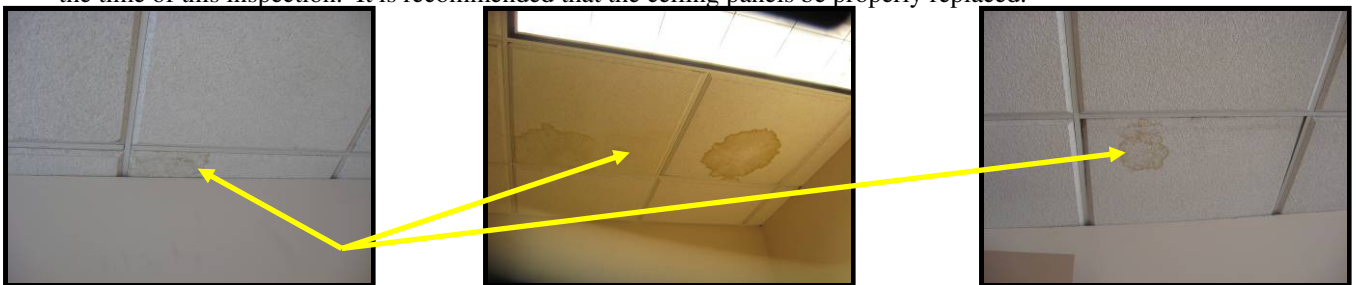
- **Repair:** Moisture staining was observed in the ceilings of room numbers 7-D, 7-Z, and 7-N. No moisture was detected at the time of this inspection. It is recommended that the ceiling panels be properly replaced.

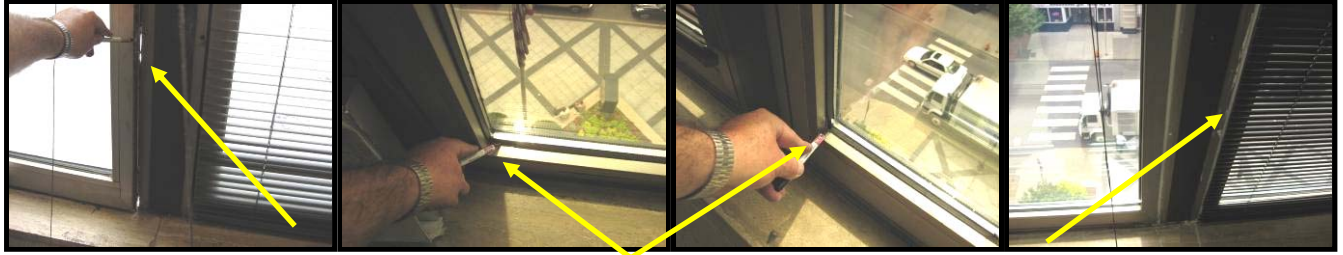
- **Information:** One of the windows in room number G opens to the exterior. (4th floor roof) It is recommended that this be monitored and repaired as necessary.
- **Improve:** Several of the windows of the 5th floor had deteriorated seals; there was tape over holes in the window frames indicating attempts at stopping cold air flow and places where the seals were caulked to prevent leaking. It is recommended that the windows on the 5th floor be brought into proper condition.

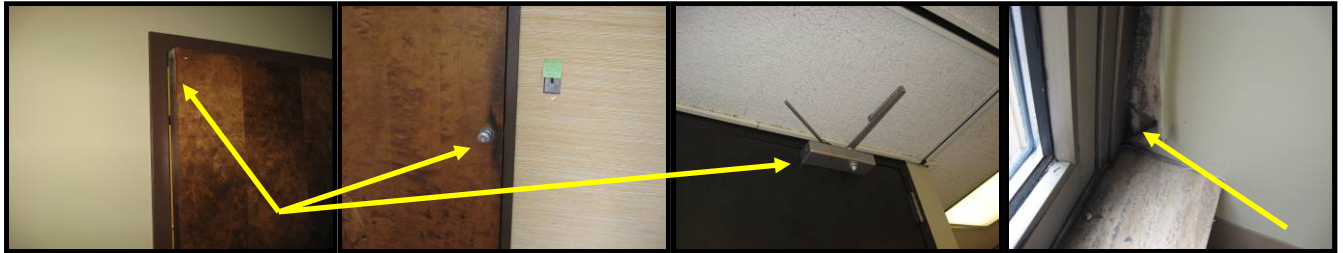
- **Repair:** The door at room number 5-R did not latch or had difficulty closing properly. Usually adjusting the strike plates on the door jamb will restore correct function. It is recommended that the door be properly adjusted.
- **Repair:** The handle on the door in room number 5-T is damaged and should be repaired.
- **Repair:** The door closer on the door in room number 5-W is damaged and should be repaired.
- **Repair:** Drywall damage was observed at the edge of one of the windows in room number 5-X. All drywall damage or deterioration should be repaired.

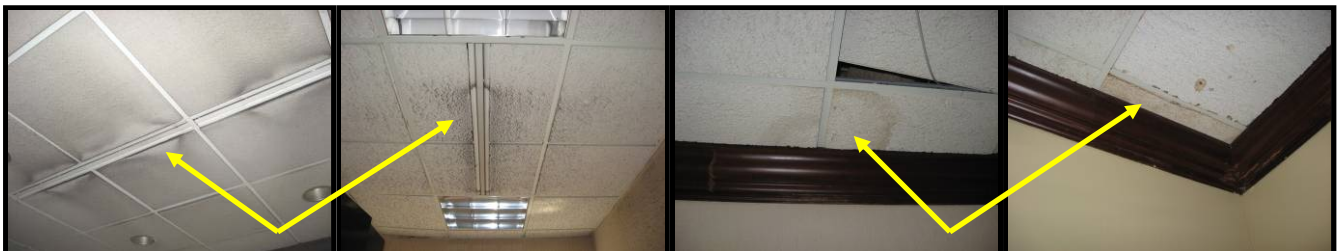
- **Repair:** The ceiling is bad in several rooms and moisture stains were observed in room numbers 4-FF, 4-PP, 4-GG and 4-JJ. All ceilings should be brought into proper condition.

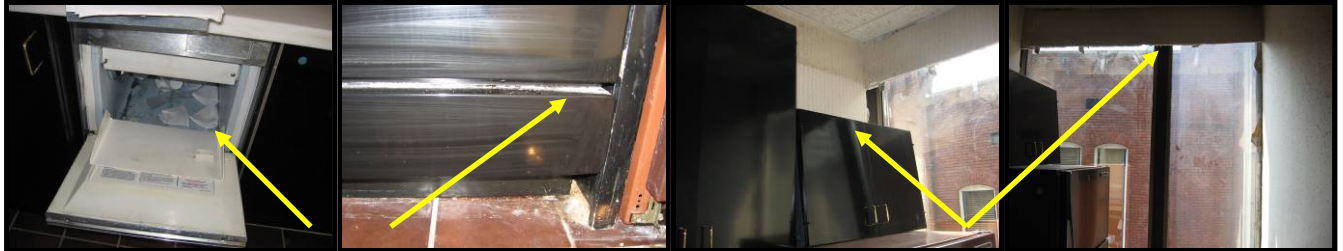
- **Repair:** The ice machine and dishwasher in room number 4-PP are defective and should be replaced.
- **Repair:** The back exterior wall in room number 4-PP has been removed to make repairs. Additionally cabinets in the same room have been removed. It is recommended that the walls be properly repaired after the work behind the walls is done.

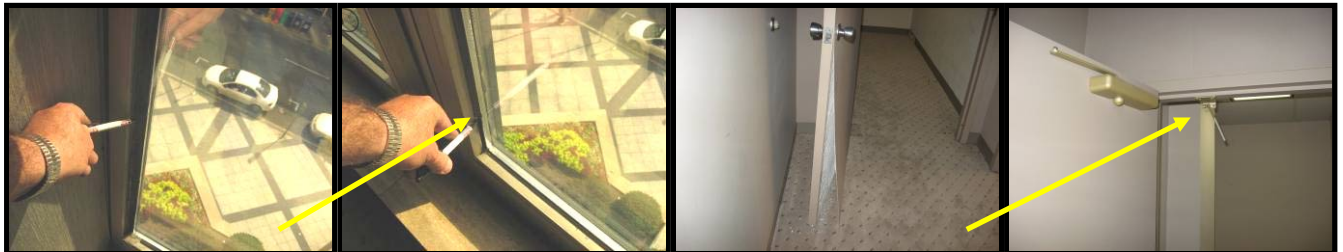
- **Improve:** Several window seals were cut short and defective indicating that there may be air infiltration in several areas. It is recommended that the windows on the 4th floor be properly repaired.
- **Repair:** The door in room number 4-HH (closet) is damaged and should be replaced.

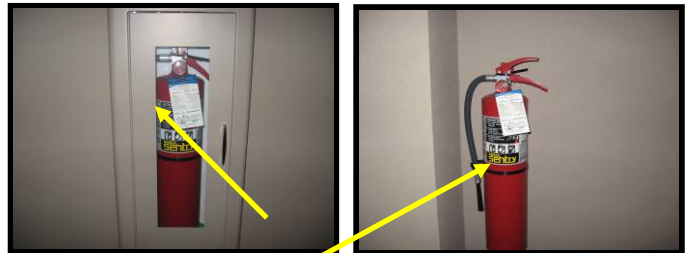
- **Improve: Safety Issue:** The inspection date on the fire extinguishers is out of date. It is recommended that the fire extinguishers be brought up to date.

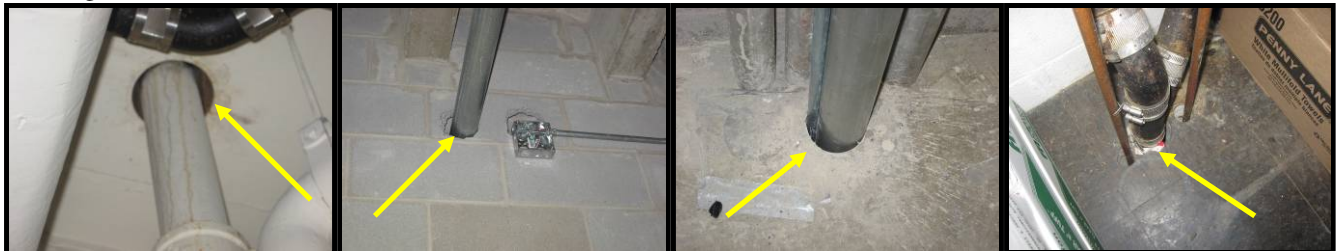
- **Improve: Safety Issue:** Several areas on the 4th floor should be sealed for fire safety where conduit or plumbing passes through the floors.

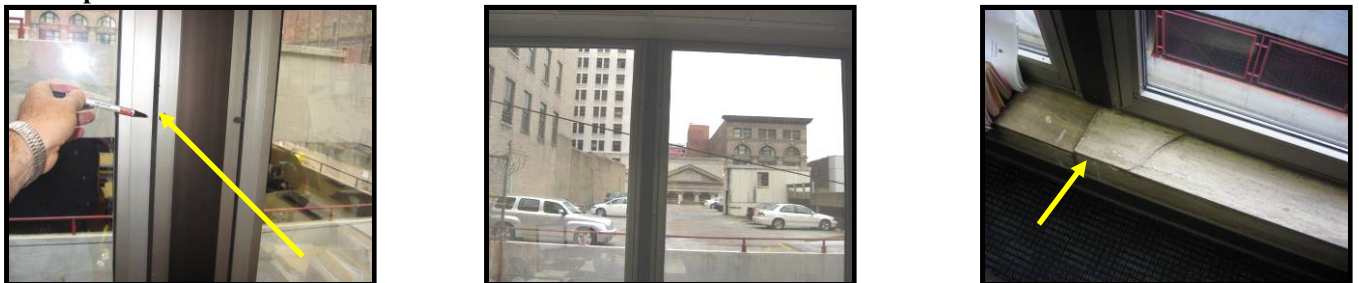
- **Repair:** The window seals were bad in the windows in room numbers 2-I and 2-P. It is recommended that all windows be brought into proper condition.
- **Repair:** There is a crack in the marble window sill in room number 2-I.
