Building Inspection Report

[REDACTED] k Lane, Nashville TN 37214
Inspection Date: January 10, 2008

Report Number: ML011008AD

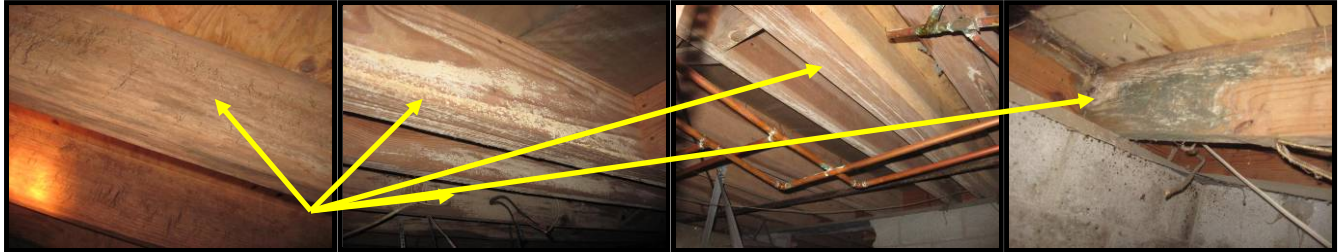
- Information: Safety Issue: Improve:** A mold type growth is visible on most of the floor joists in the crawl space. The level of mold growth is moderate to high. *The presence of certain mold and mold spores in housing can result in mild to severe health effects in humans and pets and can deteriorate the structure of the dwelling resulting in structural damage. Health effects include, but are not limited to: sinus congestion, blurry vision, sore throat, dry cough, aches and pains, skin irritation, bleeding of the lungs, headaches, memory loss and fever. As humans vary greatly in their chemical make-up, so does the individual's reaction to mold exposure. For some people, a small number of mold spores can cause ill effects. In others it may take more.* Because mold can adversely affect your health and the amount of mold type growth present is significant, it is BJK's Company policy to recommend that a sample be taken and sent to the laboratory to determine the type(s) of mold that are present to help determine the proper course of action to be taken. Because of the amount of mold type growth present it is recommended that a professional be engaged to mitigate the mold.

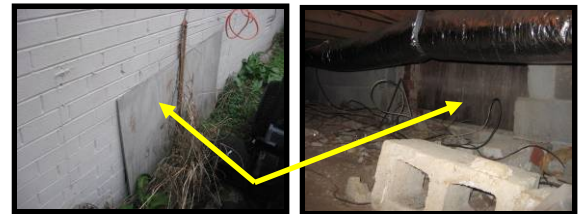
- Repair:** A portion of the foundation and exterior brick wall has been removed to accommodate the ducts of a Package HVAC unit at the left side of the back addition. Since an HVAC unit is no longer in use in that location the foundation and brick wall should be restored.

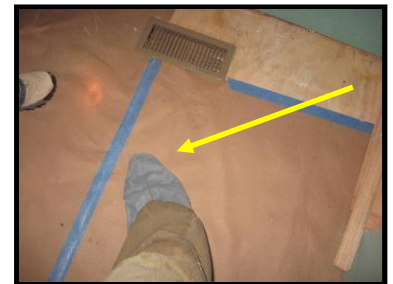
- Repair:** Soft places were observed in the sub floor of the unfinished master bathroom. This condition should be addressed when preparations are made to complete the bathroom.

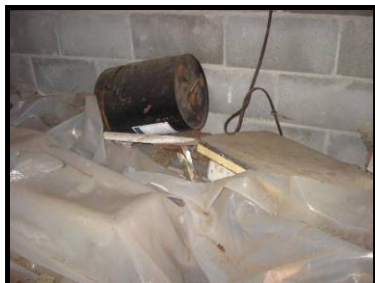
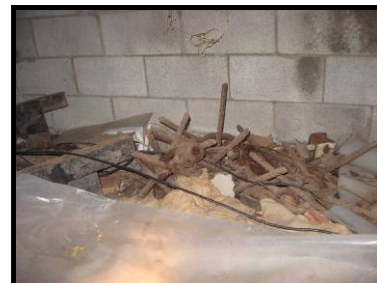
- **Improve:** All wood debris and/or trash should be removed from the crawl space. Such debris tends to attract termites and organic debris around a property increases risk of insect or rot damage to your home.

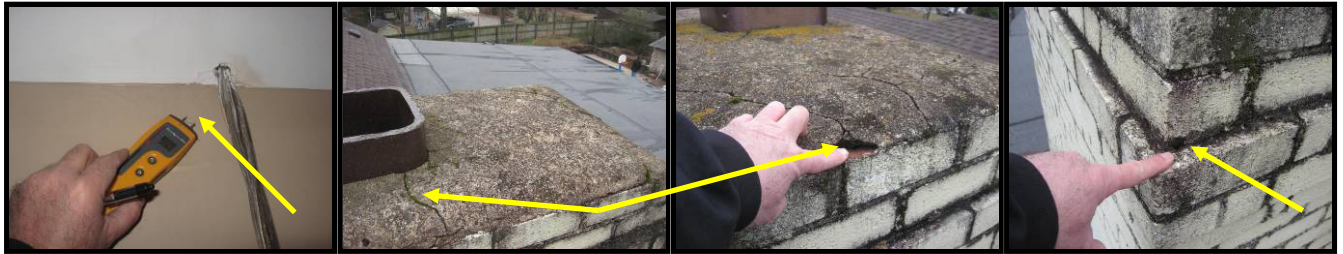
- **Monitor: Repair:** Moisture and moisture damage was observed at the right ceiling and wall by the fireplace (from facing the fireplace). It is recommended that the chimney and flashing be examined to attempt to determine the source of the moisture. It is recommended that repairs be made by a licensed roofing contractor.
- **Repair:** The masonry chimney cap has some cracks in the concrete which needs to be sealed with roofing cement or other appropriate sealant to prevent moisture penetration. Moisture penetration will eventually cause damage to the brickwork and structure if not kept sealed.
- **Repair:** The masonry chimney needs re-pointing in places (replacing the mortar between the bricks) to avoid water damage.

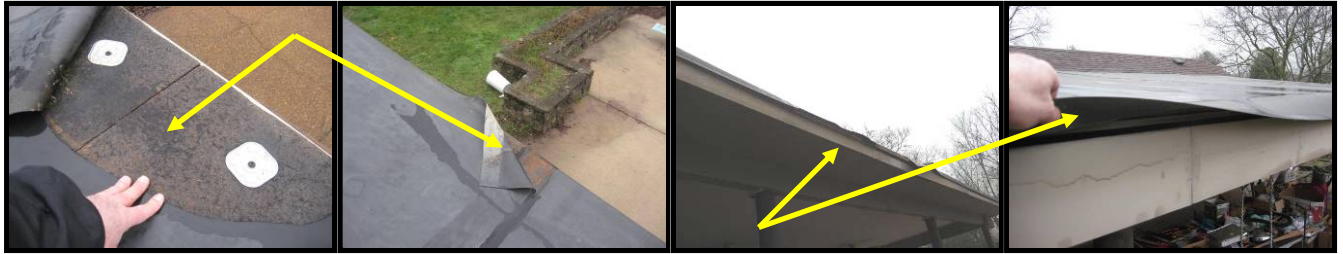
- **Repair:** The rubber roofing material over the back patio is improperly terminated at the edge of the roof allowing some of the material to tear. It is recommended that this condition be repaired by a licensed roofing contractor.

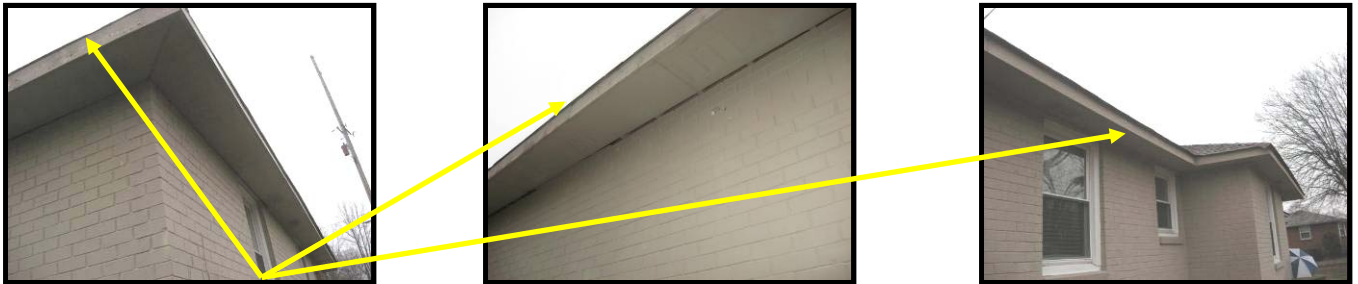
- **Repair:** No gutters have been installed on the home. Properly installed gutters and downspouts will direct water away from the house and foundation which will help to maintain a dry crawl space or basement.

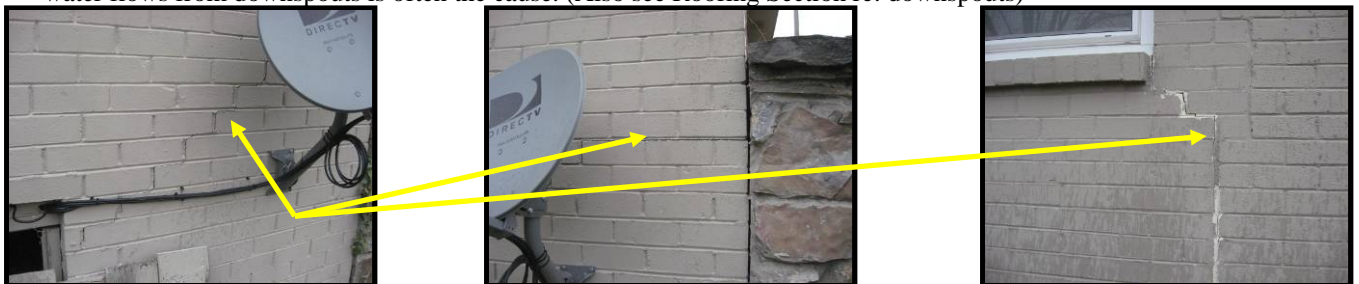
- **Repair:** There were a few minor cracks or deteriorated mortar joints in the brick veneer of the home at the back left corner addition wall and where the garage doors have been bricked in. This is fairly common and not considered to be structurally significant. Obviously, these cracks should be sealed with caulk or mortar to keep out moisture and monitored for changes in character such as widening or displacement. Minor settlement in areas of the foundation walls where too much rain water flows from downspouts is often the cause. (Also see Roofing Section re: downspouts)

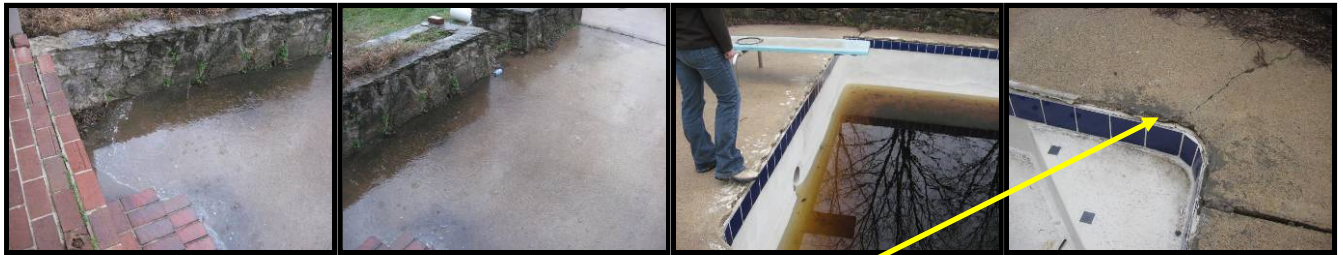
- **Repair:** The back pool patio is low at the back right corner of the back addition of the house and water is ponding in that area. It is recommended that steps be taken to allow water to run from the patio.
- **Improve:** Some of the stone walls of the raised flower beds are cracked and should be sealed with mortar or caulked to prevent moisture intrusion.
- **Monitor: Improve:** It should be noted that the swimming pool itself was not inspected but the concrete walk around the pool is cracked and deteriorated and the edging has been removed. It is recommended that the swimming pool and surrounding concrete be examined by a swimming pool contractor to determine the appropriate course of action to be taken and the costs associated with proper repairs.

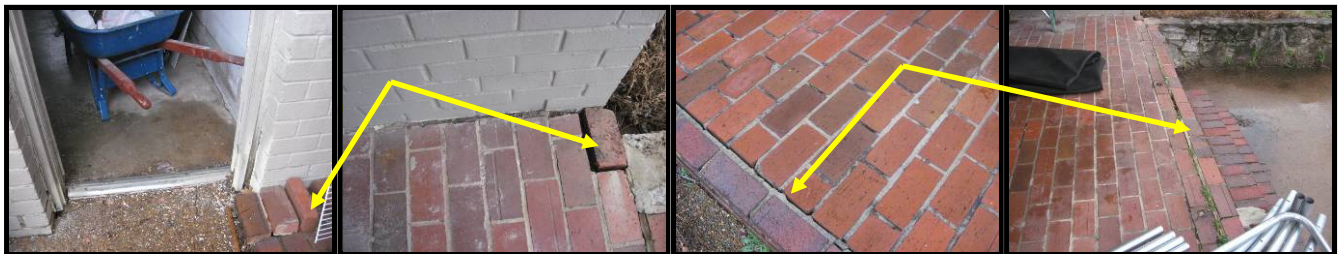
- **Repair:** Deteriorated mortar joints and displacement was observed in the brick banding of the back patio. It is recommended that the damaged or missing bricks be repaired and all deteriorated mortar joints filled to prevent moisture intrusion. Some of the brick banding may have to be replaced to repair the displacement.

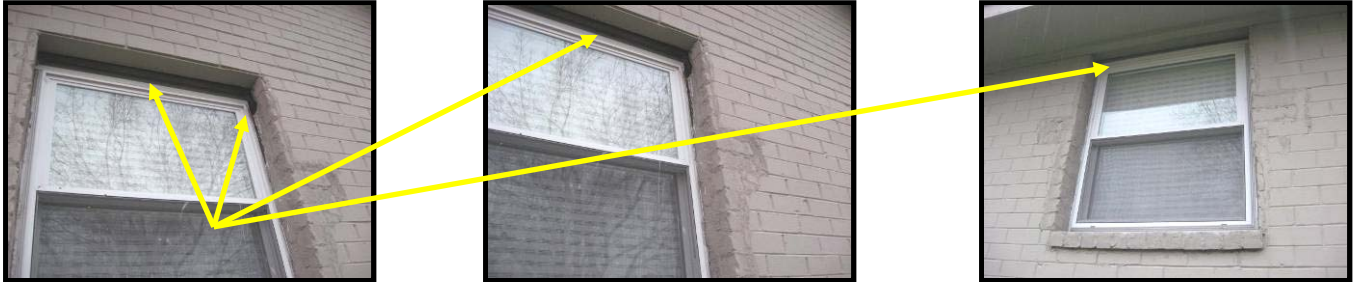
- **Repair:** The exterior of the windows of the back addition are unfinished and improperly sealed to the brick. It is recommended that the windows be repaired and properly sealed. **Repair:** The front door opening has been widened in renovations. The lintel above the door is in 2 pieces and appears to be resting on the top of the door frame. It is recommended that this condition be examined by a licensed contractor and repaired.

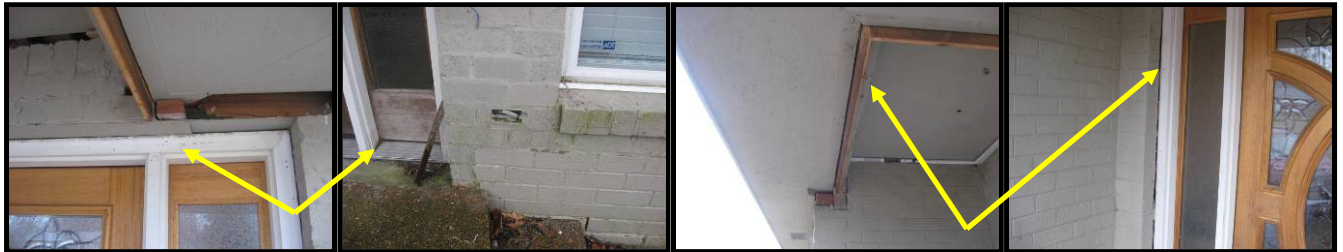
- **Improve:** All window and door frames should be sealed to the brickwork or framing with a good quality adhesive caulk to prevent water and insect intrusion. Water penetration in these areas can lead to wood rot and decay. This is a maintenance item which should be checked periodically and is best performed in conjunction with painting maintenance.
- **Repair:** The front porch ceiling is not complete and gaps are open to the attic. Additionally there appears to be brick missing over the front door. It is recommended that the front porch ceiling and brick around the door be properly repaired.

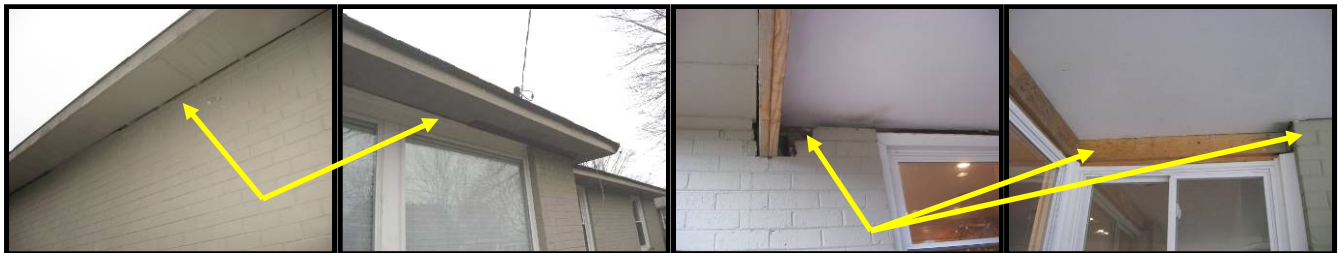
- **Repair:** The wood trim at the bottom of the soffit at the back of the house, and over the front window is missing and should be replaced.
- **Improve:** Wood trim is missing from over the windows and at the corner of the wall and ceiling at the back patio. It is recommended that the back patio be properly completed.

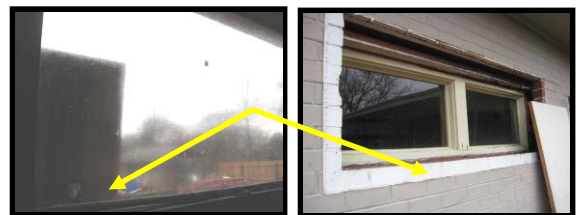
- **Repair:** The back windows of the garage room are single pane, in poor condition and all of the exterior trim has been removed. It is recommended that the windows be repaired or replaced.
- **Repair:** The wood trim around exterior of the home has reached the point where painting maintenance is required. Exterior wood trim on windows, dormers, chimneys, porch railings and columns, etc., must be kept well painted to prevent decay. Proper preparation including scraping, sanding and painting with a good quality paint will protect the wood and your investment.

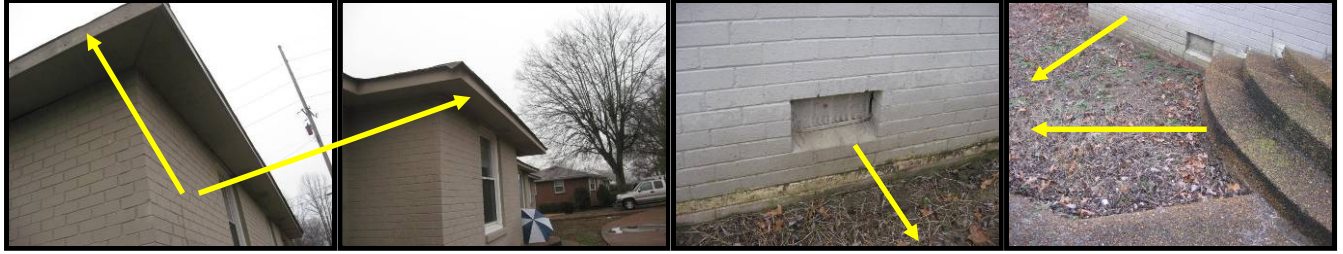
- **Improve:** The final grading at the front of the house should be improved to proper run water away from the foundation.

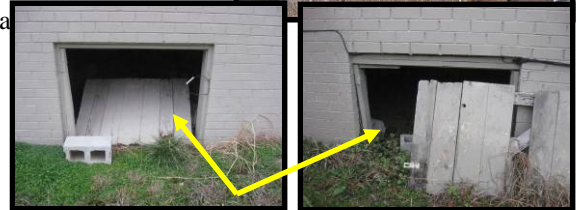
- **Repair:** Both of the crawl space doors at the exterior of the house should be replaced.

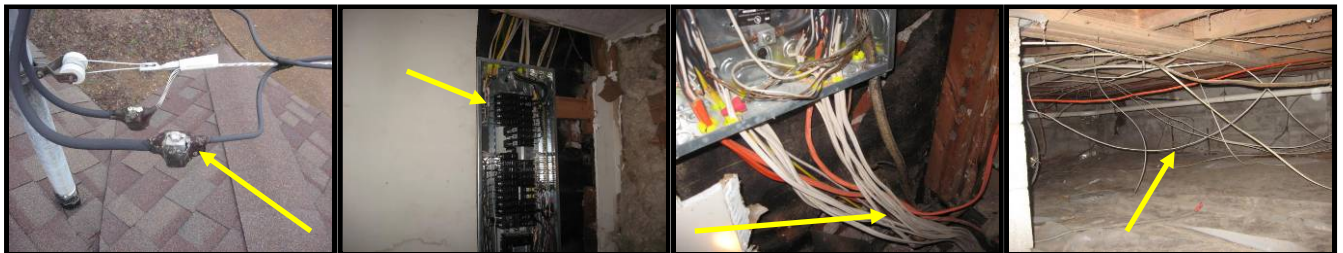
- **Repair:** The wires running into the base of the main panel in the garage room are running outside of the wall cavity and are exposed on the interior walls. It is recommended be properly protected by running them into the wall cavity or building a chase to cover them.

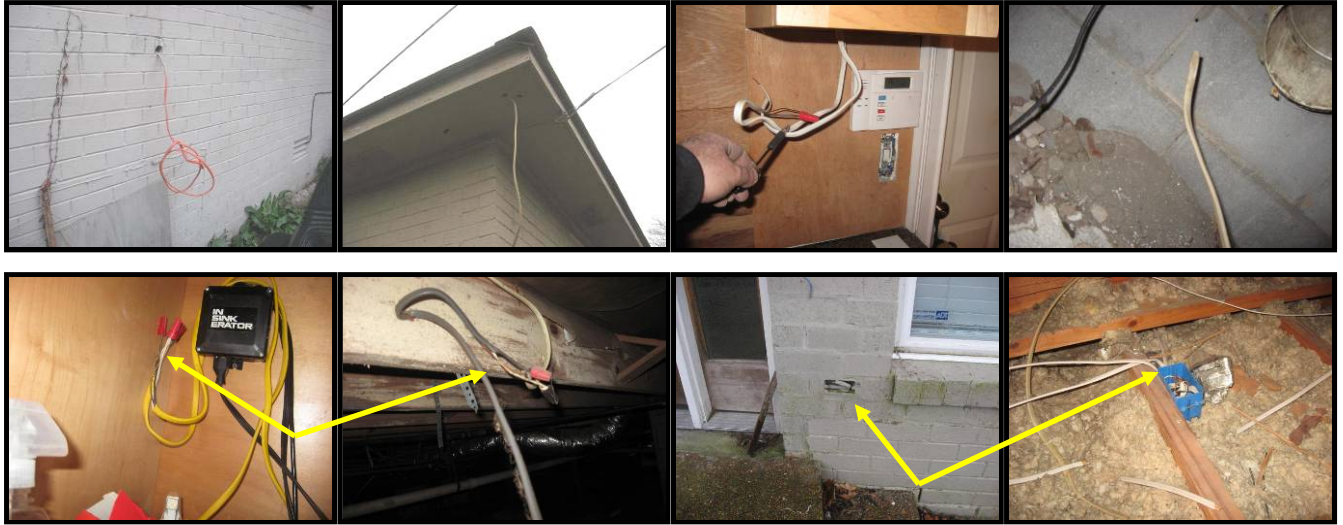
- **Repair:** All junction boxes should be fitted with cover plates, in order to protect the wire connections.
- **Repair:** Damaged wiring should be replaced or appropriately repaired.

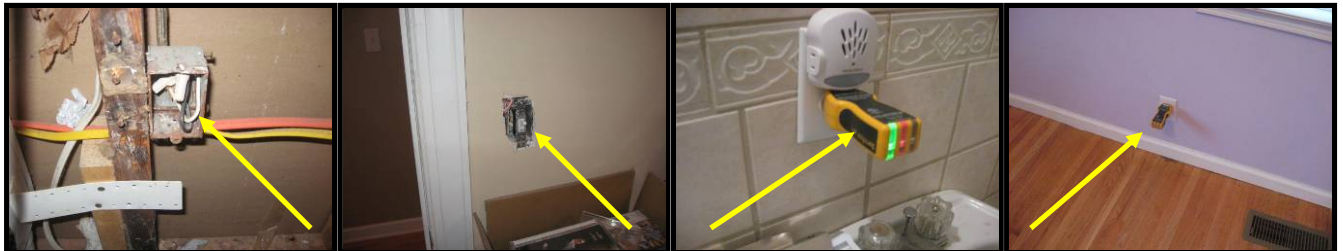
- **Repair:** There are several outlets and switches throughout the house missing proper covers. Missing outlet cover plates should be replaced to avoid a shock hazard.
- **Repair:** The outlet in the hall bathroom has reversed polarity. An outlet has reversed polarity (i.e. it is wired backwards). This outlet and the circuit should be investigated and repaired as necessary. It is recommended that a GFCI (Ground Fault Circuit Interrupter) be installed in the hall bathroom.
- **Repair:** The outlets in the front left bedroom are inoperative. These outlets and the circuit should be investigated and repaired.

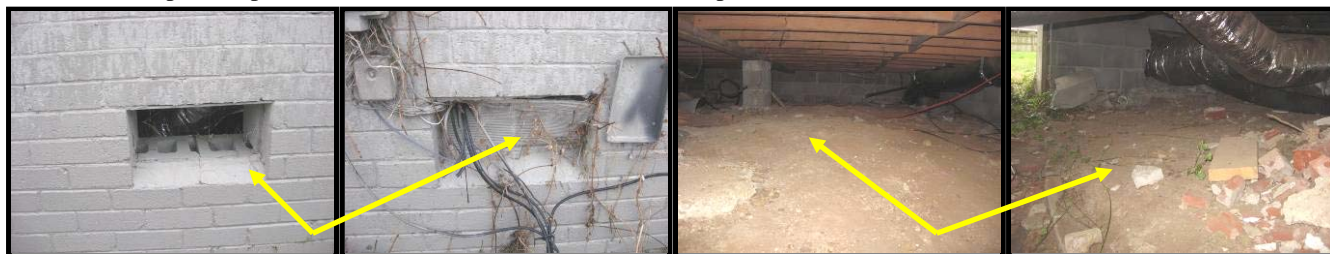
- **Improve:** A moisture (vapor) barrier should be installed on the crawl space floors in the additions of the house. Such barriers help to keep down the levels of moisture in the crawl space areas.

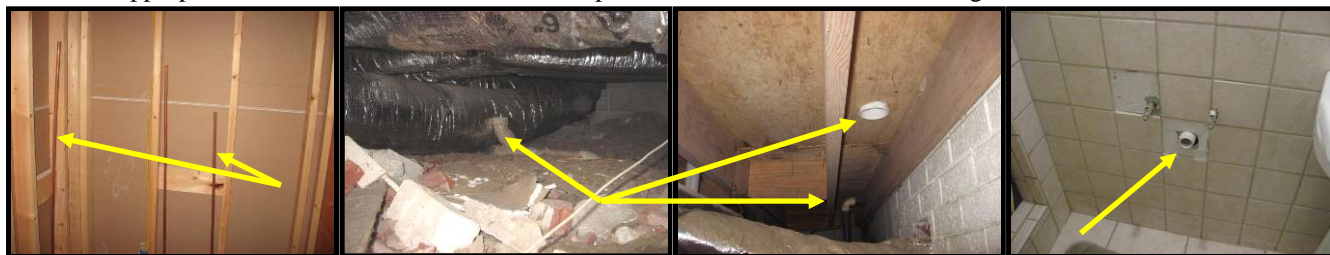
- **Repair:** The hose bibs (exterior faucets) are not properly secured to the building. The collar should be securely fastened into the brick or substrate by a mechanical means.
- **Repair:** The hose bib at the front of the house is leaky and should be repaired or replaced
- **Information: Improve:** The plumbing in the unfinished master bathroom is incomplete. This includes the drain and waste lines and the water supply lines. A considerable amount of work will be required to rough the plumbing in so the renovation process can be completed.
- **Repair:** The sink in the hall bathroom has been moved with the intention of moving the plumbing. (The sink does not work at this time) It is recommended that a licensed plumber be engaged to give estimates on the appropriate course of action to be taken to repair the hall bathroom sink and rough in the master bathroom.

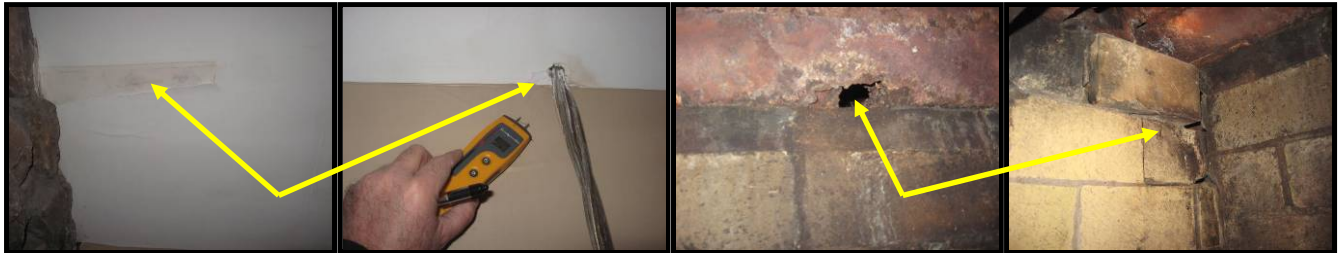
- **Repair:** Moisture damage was observed at the ceiling over the chimney and the wall at the right side of the chimney. Moisture was detected when tested. When the source of moisture is repaired the damage should be able to be repaired with drywall tape and compound.
- **Repair:** The metal damper in the fireplace in the family room is rusted and damaged and should be repaired.
- **Repair:** There are loose firebricks and cracks in the firebox of the fireplace in the family room. It is recommended that the fireplace and chimney be cleaned and examined by a certified chimney sweep and repaired to ensure safe operation.

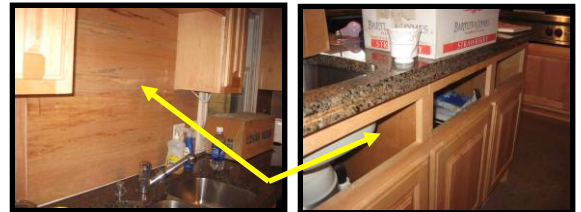
- **Repair: Safety Issue:** There is a gap between the stone front of the fireplace and the hearth. It is recommended that the gap be filled.
- **Improve:** The kitchen is unfinished particularly the wall behind the counter and some of the cabinet fronts of the island. It is recommended that the kitchen be properly completed.

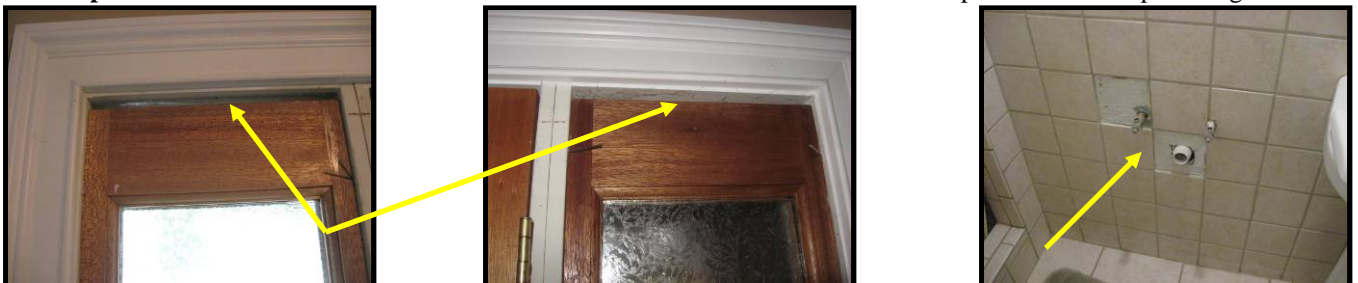
- **Repair:** The side glass panels of the front door are loose in the frame and there is a considerable gap at the top of the door jam. It is recommended that the front door be properly repaired.
- **Repair:** The tiles on the wall behind the sink in the hall bathroom will have to be replaced when the plumbing is moved.

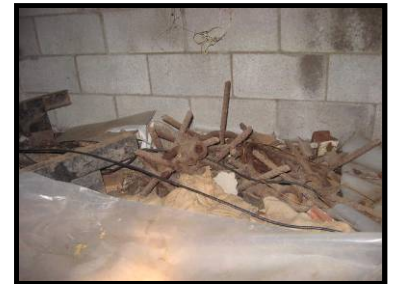
- **Improve:** All wood debris and/or trash should be removed from the crawl space. Such debris tends to attract termites and organic debris around a property increases risk of insect or rot damage to your home.

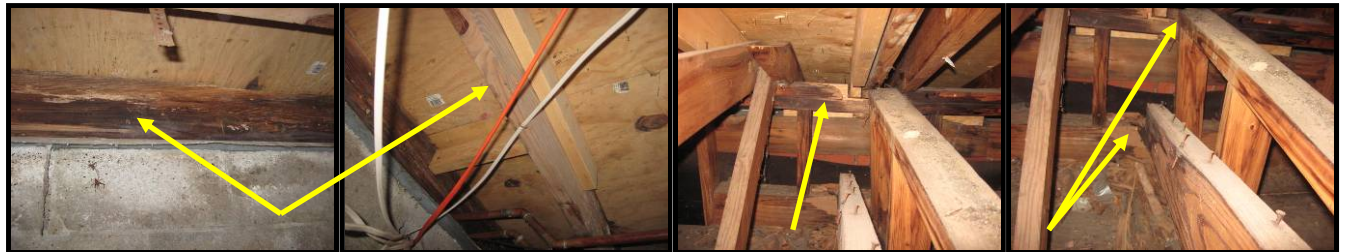
- **Monitor:** Past moisture staining was observed in the wood rim joist at the right side of the crawl space. Additionally some of the sub floor appears to have been replaced in this area. The repairs appear to be functioning as intended.
- **Repair:** The top plate at the top of the wood frame wall over the garage pedestrian door has moisture damaged and should be repaired.

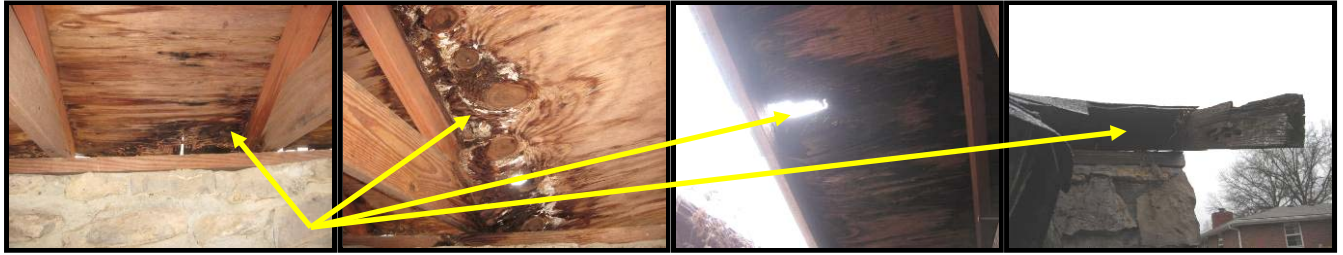
- **Repair:** Localized wood rot was observed in much of the decking and some of the rafters of the pool pump house roof. It is recommended that the roof structure of the pool pump house be properly repaired.

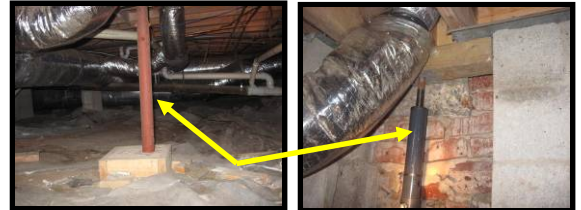
- **Monitor:** Several additional supports have been added to the floor structure of the house particularly under the dining room and kitchen area. The additional supports appear to be functioning as intended.

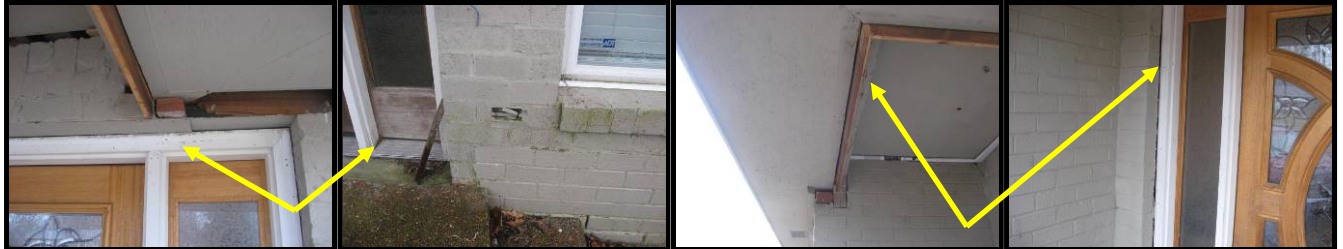
- **Repair:** The wood trim at the bottom of the soffit at the back of the house, and over the front window is missing and should be replaced.
- **Improve:** Wood trim is missing from over the windows and at the corner of the wall and ceiling at the back patio. It is recommended that the back patio be properly completed.

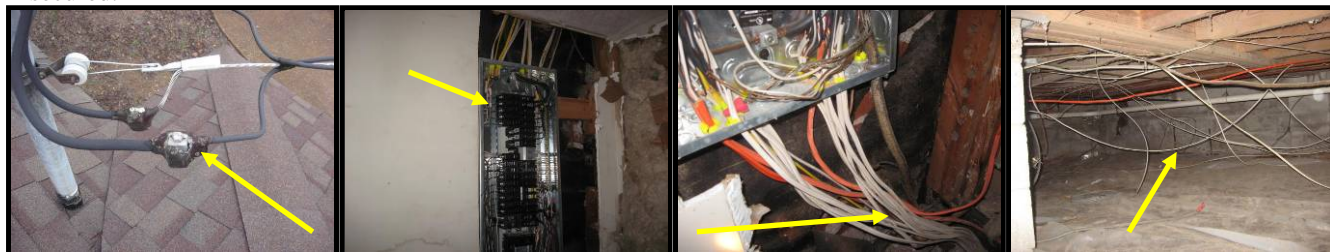
- **Repair: Safety Issue:** There are improperly terminated wires in the in the kitchen, attic and crawl space and at the exterior of the house. All wires are required to be terminated within an approved box fitted with a cover or and approved fixture.
- **Safety Issue: Improve:** All wire splices are required to be contained within appropriate boxes and fitted with covers. There are several inline splice in the attic, crawl space and under the kitchen sink which should be corrected.
- **Repair:** All junction boxes should be fitted with cover plates, in order to protect the wire connections.
- **Repair:** Damaged wiring should be replaced or appropriately repaired.

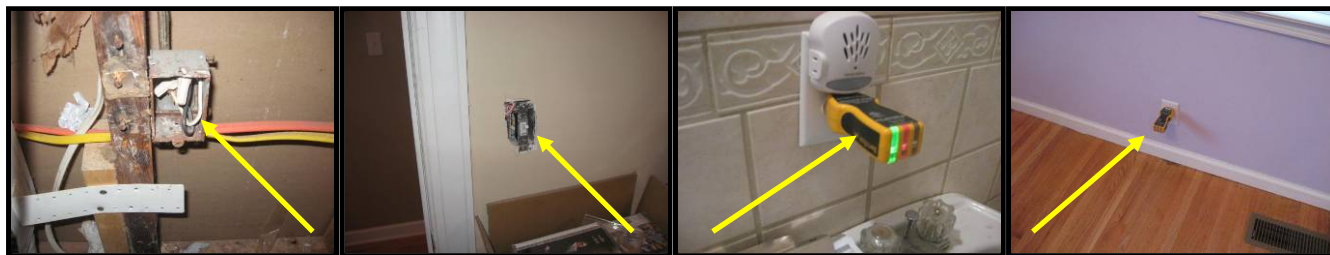
- **Information: Improve:** Arc Fault Circuit Interrupter protection is now required and is installed on circuits serving bedrooms. The AFCI (Arc Fault Circuit Interrupter) breaker will shut off a circuit in a fraction of a second if arcing develops. The current inside of an arc is not always high enough to trip a regular breaker. In the past you may have noticed a cut or worn piece of a cord or a loose connection in a junction box or receptacle arcing and burnt without having tripped a regular breaker. As you can guess that resulted in and is a major cause of fires in dwellings. Arc Fault Circuit Interrupters serve to prevent such fires. There is a difference between AFCIs and GFCIs. AFCIs are intended to reduce the likelihood of fire caused by electrical arcing faults; whereas, GFCIs are personnel protection intended to reduce the likelihood of electric shock hazard. *It is required that all outlets (points where electricity is utilized including lights, wall plugs, etc) go dead when an arc fault is applied to the circuit.* The breakers did not trip when a fault was placed on the circuit and should be examined by a licensed electrician and brought into proper operation.

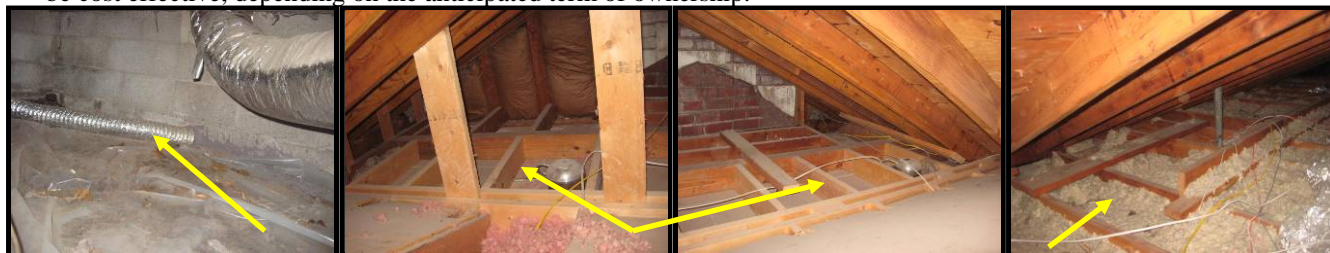
- **Repair:** Some of the crawl space vents are missing and others are in poor condition. It is recommended that all of the crawl space vents be replaced.
- **Improve:** A moisture (vapor) barrier should be installed on the crawl space floors in the additions of the house. Such barriers help to keep down the levels of moisture in the crawl space areas.
