# Building Inspection Report

[REDACTED] Rd., Brentwood TN 37027

Inspection Date: February 19, 2007

Report Number: RN021907PD

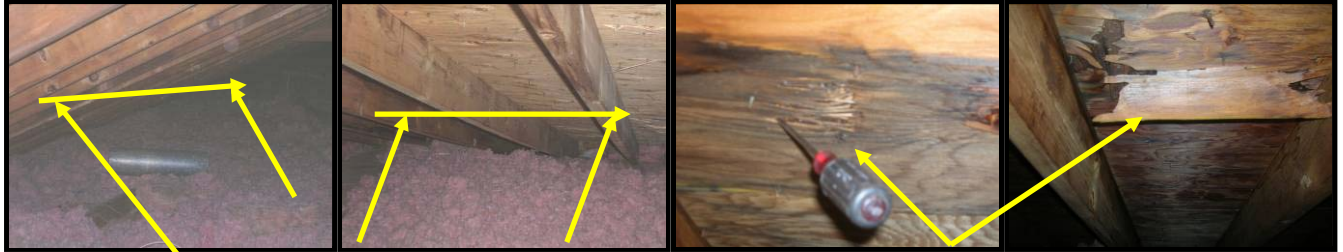
- **Major Concern: Repair:** Rafter bounce was experienced in several locations while walking of the roof during the inspection. The condition was particularly bad in the locations of the old roof vents. Upon further inspection it is noted that there are no purlins or purlin braces installed under the rafters in the attic. It is recommended that this condition be examined by a qualified contractor to make recommendations for proper repairs.
- **Repair:** Some of the roof decking of the home is deteriorated and should be properly replaced. It is recommended that the roof decking be examined and any damaged decking replaced when the roof is replaced. (See roofing section)

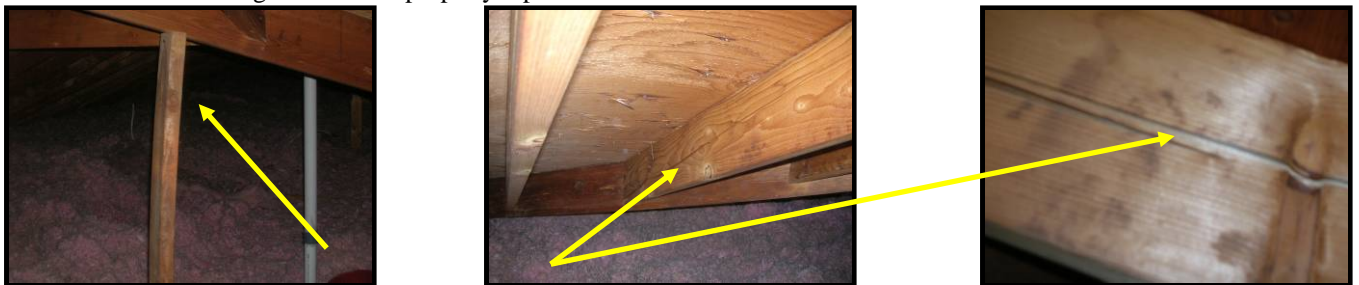
- **Repair:** There is a main valley rafter support that is bowing from the weight. It is recommended that the valley rafter at the back slope of the house be properly supported.
- **Repair:** There are a couple of jack rafters in the same location as the valley rafter that are cracked. It is recommended that all cracked or damaged rafters be properly repaired.

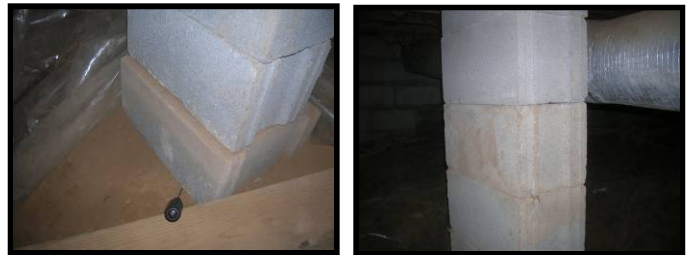
- **Repair:** Additional block columns were added in various locations in the crawl space to fix what is suspected to be floor bounce. Generally to eliminate “bounce” in floors it is best to install a support in the center of the span of the joists, thus effectively cutting the span of such joists in half. I usually prefer a beam (2 length of 2” x 8” lumber with a piece of plywood between them nailed together) installed along the middle of the span with a jack-post at each end about 18” in from the end of the beam. The jack-posts should be well founded on a cementacious base. (a solid concrete block will do) A structural engineer or licensed general contractor should be consulted for details of such repairs. It is recommended that the floor bounce be properly repaired.

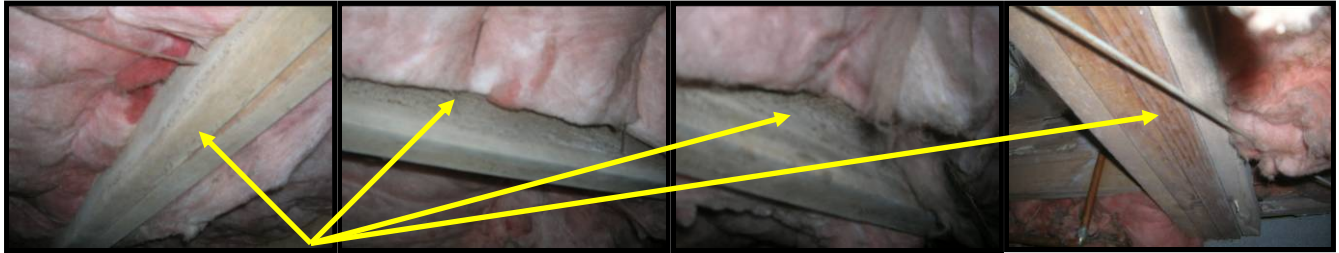
- Safety Issue:** A mold type growth is visible on some of the floor joists in the crawl space. The level of mold growth is moderate. The presence of certain mold and mold spores in housing can result in mild to severe health effects in humans and pets and can deteriorate the structure of the dwelling resulting in structural damage. Health effects include, but are not limited to: sinus congestion, blurry vision, sore throat, dry cough, aches and pains, skin irritation, bleeding of the lungs, headaches, memory loss and fever. As humans vary greatly in their chemical make-up, so does the individual's reaction to mold exposure. For some people, a small number of mold spores can cause ill effects. In others it may take more. Because mold can adversely affect your health, it is BJK's Company policy to recommend that a sample be taken and sent to the laboratory to determine the type(s) of mold that are present to help determine the proper course of action to be taken. **Because of the amount of mold type growth present it is recommended that a professional be engaged to mitigate the mold.**

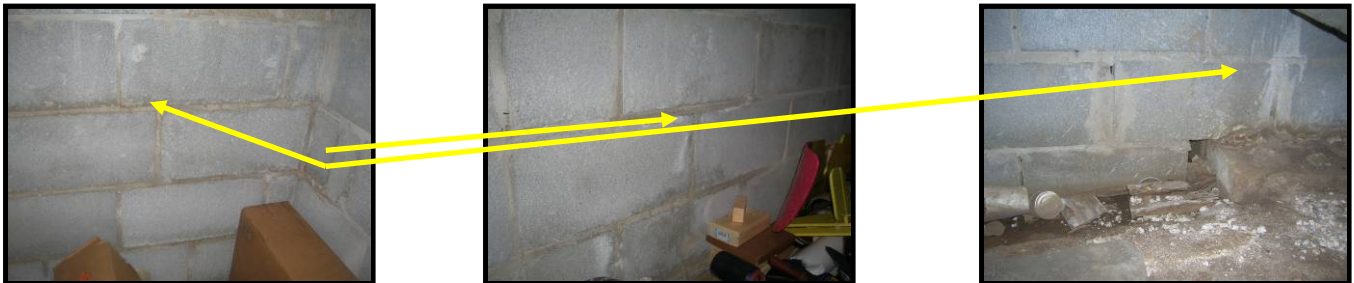
- Monitor:** There is evidence of minor moisture damage under the end hall bathroom. No moisture was present at the time of this inspection but this area should be monitored for additional damage.
- Improve: Information:** Along the back corner wall behind the garage and in places on the block crawl space wall there is evidence of water penetrating the block work and there is some efflorescence on the block work. **Efflorescence is a white crystalline or powdery, often fluffy/fuzzy deposit on the surface of masonry materials like concrete, brick, clay tile, etc. It's caused by water seeping through the wall/floor/object. The water dissolves salts inside the object while moving through it, and then evaporates leaving the salt on the surface.** This indicates that the grading just above this area should be checked and re-graded or downspouts redirected from this area as necessary.

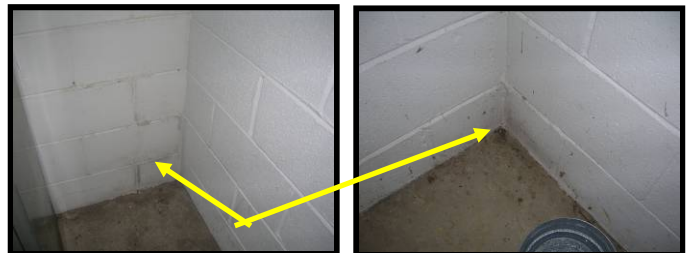
- Repair:** Possible moisture intrusion was observed at the base of the inside corners of the garage. It is suspected that surface water is infiltrating these areas. Addressing the lot and gutter drainage should help to correct the condition. (See roofing section)

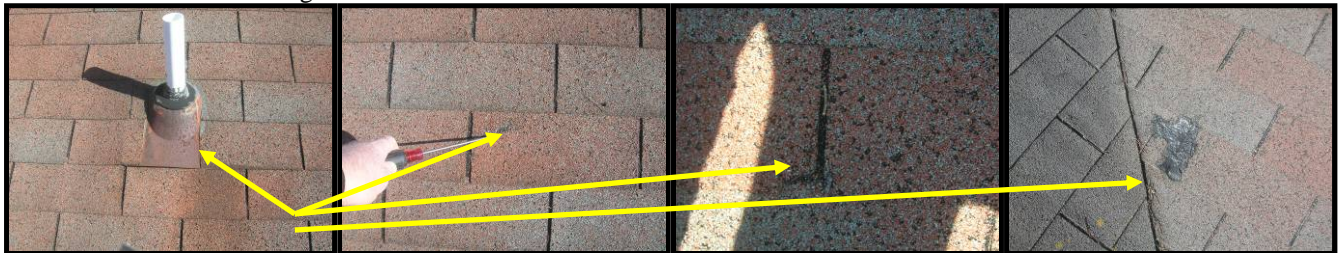
- **Repair:** The roof shingles are 15 years old and have reached the end of their useful life. There are a number of damaged or broken shingle tabs and the plumbing vent boots appear to be deteriorating. It is recommended that it be replaced. It is also recommended that the roof be stripped before installing a new roof surface which will help locate any damaged or deteriorated roof decking.

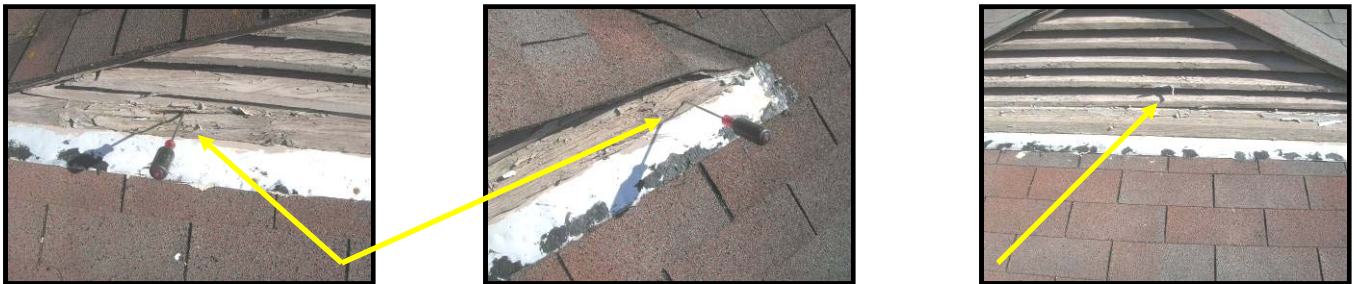
- **Repair:** The wood roof vents are deteriorated. It is recommended that they be replaced during the roofing process. (See insulation and ventilation section of this report.

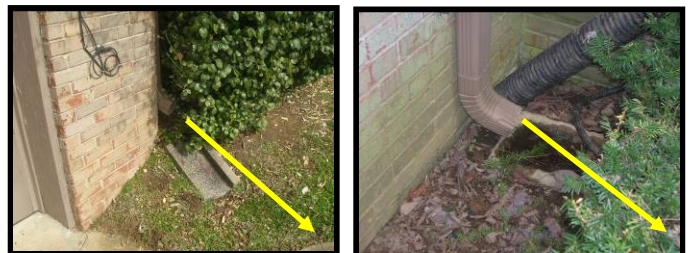
- **Improve:** It is important to divert water away from the foundation of the home with a gutter and downspout system that is kept clean and in good repair. It is recommended that all downspouts be extended with plastic diverter tubes to channel water at least 4 to 5 feet away from the building. This is important for helping to maintain a dry crawl space. Downspouts which discharge onto cement should have splash blocks beneath them.

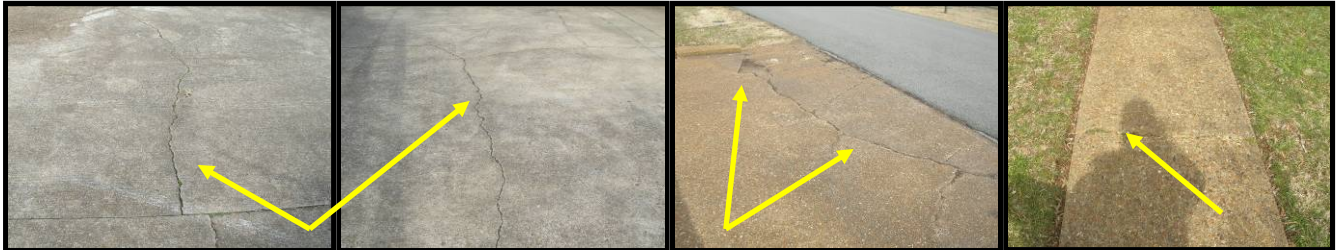
- **Repair:** There are several settlement cracks in the cement driveway and sidewalks. It is recommended that they be filled to prevent moisture from entering and eroding the surface beneath the cement which will lead to additional cracking. Sonneborn and Trimco make some excellent long lasting products to help seal such cracks. Exterior Materials, 665 Wedgewood Ave. Nashville, TN (near the State Fair Grounds) carries Sonneborn and Trimco products. The drive entrance is severely deteriorated and cracked and may have to be replaced.

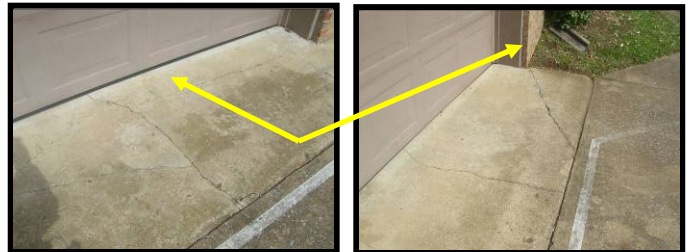
- **Repair:** There are some settlement cracks in the cement of the garage floor apron. It is recommended that they be filled to prevent moisture from entering and eroding the surface beneath the cement which will lead to additional cracking. Sonneborn and Trimco make some excellent long lasting products to help seal such cracks. Exterior Materials, 665 Wedgewood Ave. Nashville, TN (near the State Fair Grounds) carries Sonneborn and Trimco products.

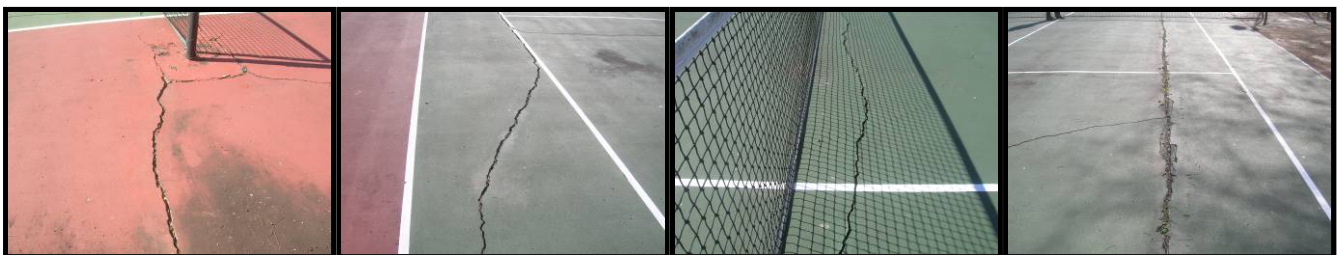
- **Major Concern: Repair:** The asphalt surface of the tennis court is severely cracked and obviously moving. It is recommended that the tennis court be examined by a resurfacing professional to determine the appropriate corrective steps to be taken for proper repairs.

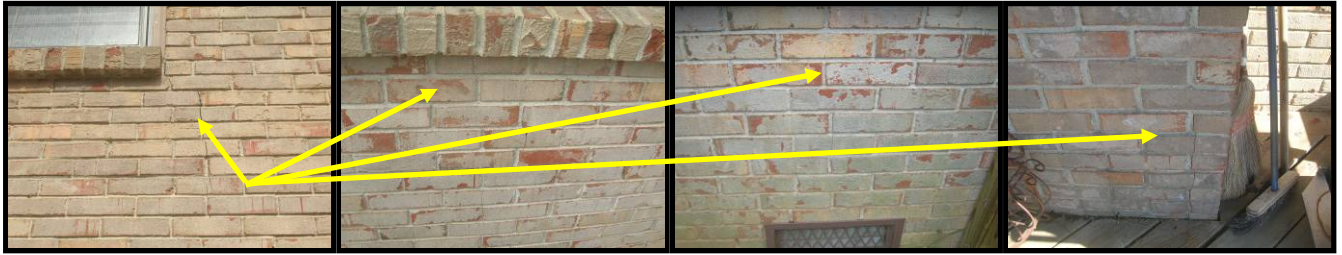
- **Repair:** There were a few minor cracks or deteriorated mortar joints in the brick veneer of the home. This is fairly common and not considered to be structurally significant. Obviously, these cracks should be sealed with caulk or mortar to keep out moisture and monitored for changes in character such as widening or displacement.

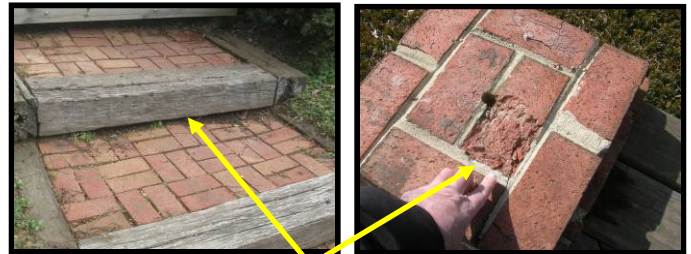
- **Repair:** The brick and railroad tie steps at the back of the house have settled and the ties are deteriorating. It is recommended that the brick steps at the back of the house be properly repaired.
- **Repair:** The brick at the top of the back left column of the back deck is deteriorated and should be repaired and properly sealed to prevent moisture intrusion for further deterioration.

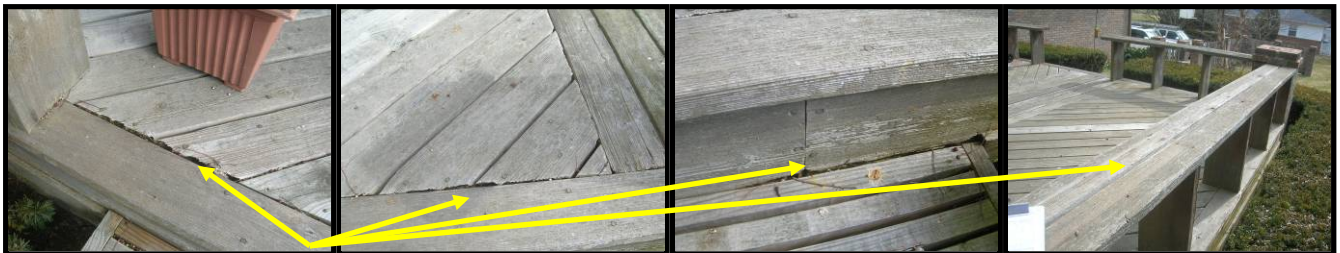
- **Repair:** The decking boards of the back deck are deteriorated in several places. It is recommended that all deteriorated decking boards be properly replaced.
- **Repair:** The ledger board at the back of the deck is deteriorated (by the back steps) and should be properly repaired.
- **Improve:** The back deck is at the point of needing to be stained to prevent moisture intrusion and further deterioration.
- **Information:** It should be noted that the bottom structural components of the back deck were inaccessible due to the brick foundation wall at its exterior. There may be additional damage that was not observable at the time of this inspection.

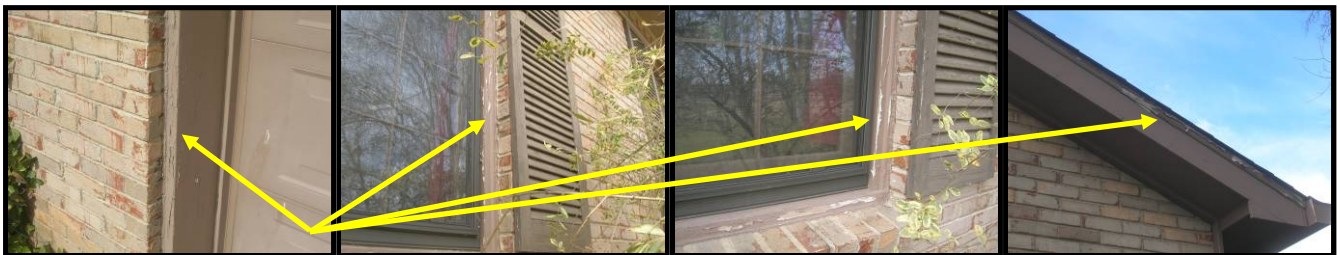
- **Repair:** The wood trim around the exterior of the home has reached the point where painting maintenance is required. Exterior wood trim on windows, dormers, chimneys, porch railings and columns, etc., must be kept well painted to prevent decay. Proper preparation including scraping, sanding and painting with a good quality paint will protect the wood and your investment.
- **Repair:** The fascia boards (the wooden board to which the gutter is typically fastened) and soffits (the horizontal wooden board between the building and the fascia) are at the point of needing paint and maintenance. Proper preparation including scraping, sanding and painting with a good quality paint will protect the wood and your investment.

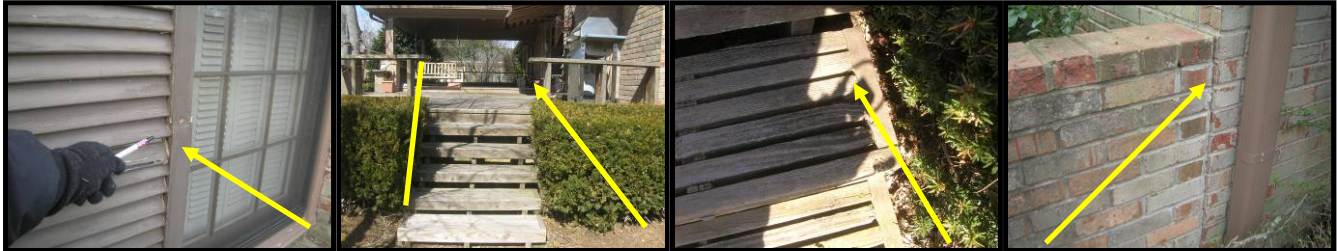
- **Repair:** The left shutter of the far right window is damaged and should be properly repaired.
- **Repair:** Standard building practices require a grippable handrail where there is a rise of 30 inches or more, or 2 or more risers on stairs. Such handrail should be 34"- 38" high with a grippable rail that is between 1 ¼ and 2 5/8 wide. A proper handrail should be installed on the wood steps from the back deck to the driveway.
- **Repair:** The wood steps from the back deck to the lower driveway are deteriorated and should be properly repaired or replaced.
- **Monitor:** The brick wall at the back right side of the house is cracked at the joint to the house and is displaced. It is recommended that this crack be sealed and monitored for changes in character such as widening or further displacement.

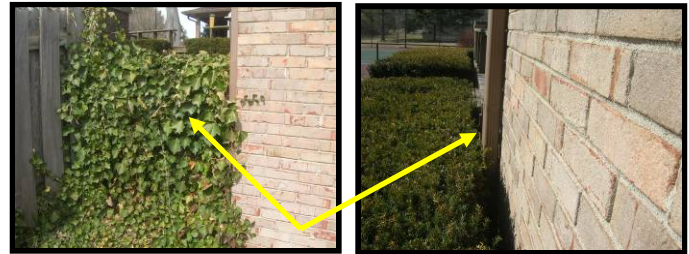
- **Improve:** All shrubs and vegetation should be cut back away from the building at least 12 -24" to promote proper air circulation around the walls. Vines and other climbing plants can cause damage to exterior surfaces and should not be allowed to grow on the building. Such vegetation also prevents proper drying of the siding and provides a pathway for insect life which can cause damage to your home.

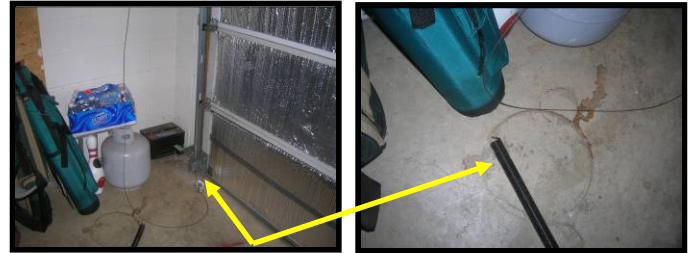
- **Repair:** The right garage door spring is damaged and the cables are loose and lying on the floor. It is recommended that the garage door be properly repaired and tested with the garage door opener. The left garage door was not operated due to personal belongings stacked against it. It is recommended that proper operation of this door be confirmed before closing.

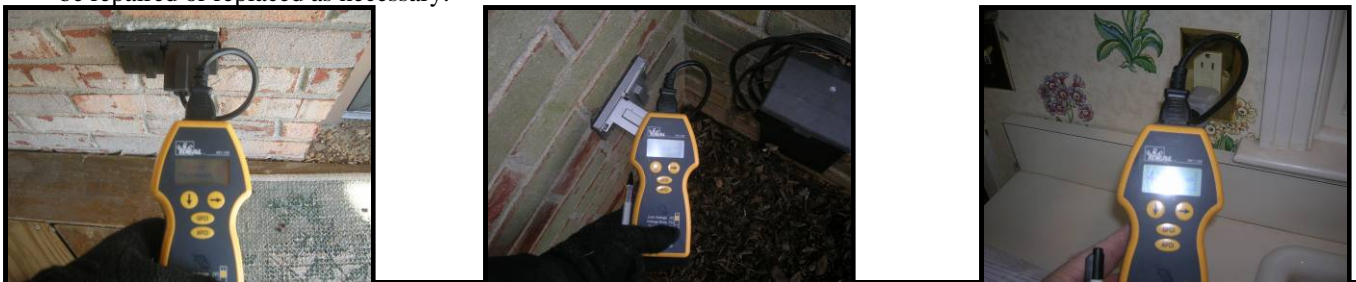
- **Safety Issue: Improve:** Since 1971 it has been a standard building practice for bathroom and exterior outlets to be GFCI protected. The exterior outlets are not protected as required.
- **Safety Issue: Improve:** Since 1975 it has been a standard building practice to have garage outlets be GFCI protected. The garage outlets are not so protected as required.
- **Repair: Safety Issue:** The ground fault circuit interrupter (GFCI) outlet in the kitchen did not trip when the test button was depressed or when a fault was placed on the line. The outlet is either defective or improperly wired. The outlet should be repaired or replaced as necessary.

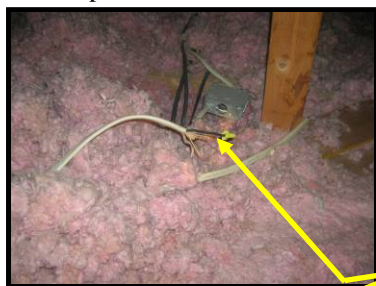
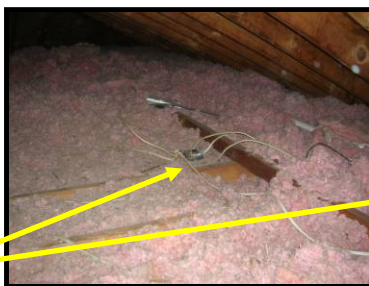
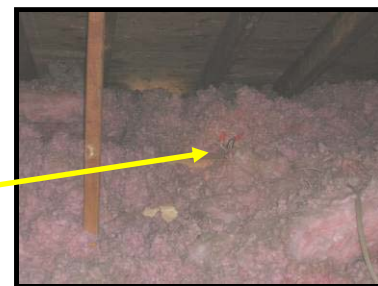
- **Improve:** The main electrical panel does not have an appropriate legend (A list which identifies what each fuse or breaker protects.) Such legends help when repairs are necessary or emergencies arise. The legend should be completed as soon as you occupy the home.
- **Repair: Safety Issue:** There are improperly terminated wires in the attic that should be repaired. All wires are required to be terminated within an approved box fitted with a cover and approved fixture.
- **Repair:** There are open junction boxes in the crawl space. All junction boxes should be fitted with cover plates, in order to protect the wire connections.

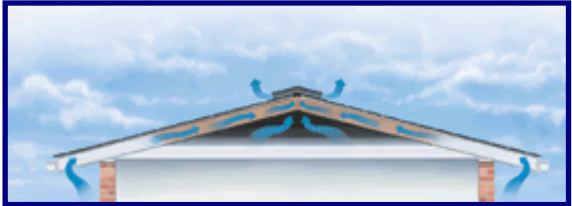
- Repair:** The level of ventilation should be improved. It is generally recommended that one (1) square foot of free vent area be provided for every one hundred and fifty (150) square feet of ceiling area. Proper ventilation will help to keep the house cooler during warm weather and extend the life of roofing materials. Proper ventilation of the attic occurs as follows: Replacement air enters through the undereave or soffit vents, bathes the underside of the roof and exits at ridge, roof or gable end vents. Even with no wind, the natural convection action of rising warm air maintains a continuous airflow along the underside of the roof. It's a system that works year 'round with no moving parts or energy consumption. In the main attic there was no ridge, roof or gable end vent for the hot air to escape from the attic.

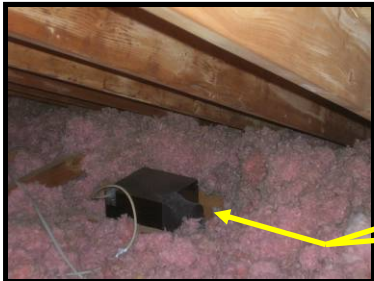
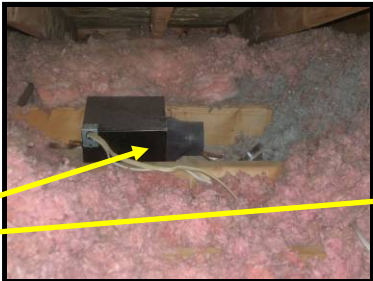
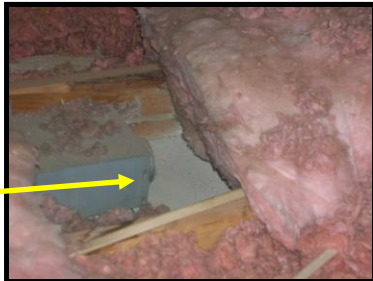
- Improve:** The moisture (vapor) barrier on the crawl space floor should be adjusted or improved to cover all areas of exposed soil. It currently covers only 85% of the ground.

- Repair:** The gas range down draft pipe is extended through the front exterior wall vent of the crawl space effectively reducing the crawl space ventilation. It is recommended that the range top down draft be rerouted and the exterior wall vent repaired.

- Repair:** All 3 of the bathroom ceiling vent fans vent into the attic. It is recommended that the vent fans be properly vented to the exterior of the house.

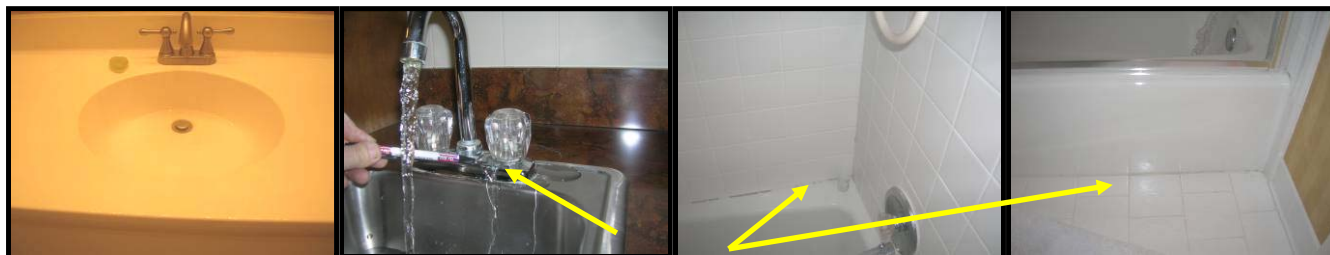
- **Repair:** There is no drip leg on the gas water heater in the back closet. A "drip leg" is normally required for gas appliance connections. This should be investigated.
- **Improve:** The sink in the end hall bath was observed to drain slowly, suggesting that an obstruction may exist. It is recommended that the sink be improved to drain properly.
- **Repair:** The faucet in the sink in the end family room is leaking. It is recommended that the faucet be repaired or replaced.
- **Improve:** It is important to maintain the caulking in and around the tub, along wall corners, floor and wall seams and around faucets and spouts to prevent moisture from getting into the subwall and floor. Damage can be caused if these areas are not well sealed and maintained. Presently some caulking improvements are necessary in the tub in the end hall bathroom.

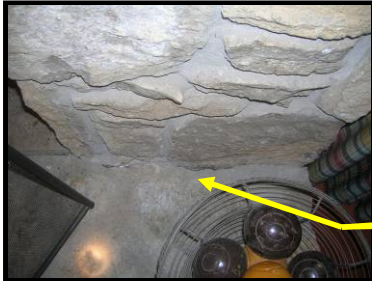
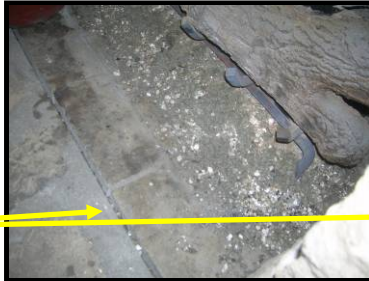
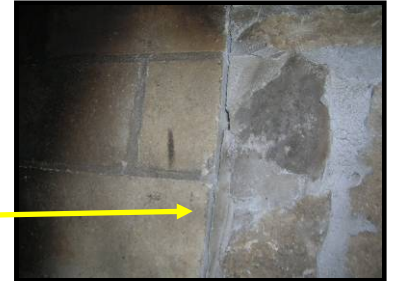
- **Repair: Safety Issue:** The fireplace in the back family room has cracks between the firebox and the stone face. There is also a crack between the hearth and the stone face and firebox. It is recommended that the chimney and fireplace be cleaned and inspected by a certified chimney sweep. It is additionally recommended that the fireplace be properly repaired to ensure safe operation. It is recommended that the fireplace not be used until the proper repairs are made.

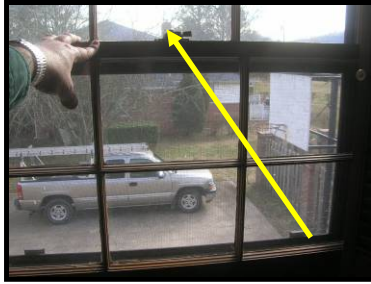
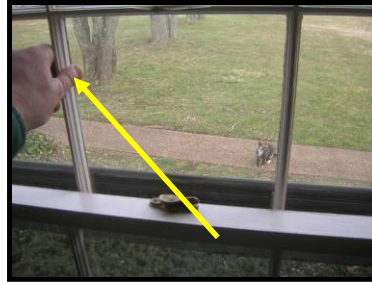
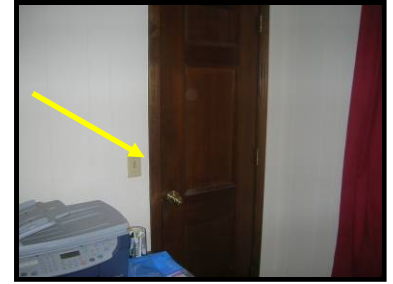
- **Safety Issue: Improve:** The back bedroom closet window did not open because they may be painted shut or do not fit properly in their frames. All windows should be brought to proper working order. In cases of emergency windows are often called upon to serve as a means of egress and should function as required.
- **Safety Issue: Improve:** The end window in the end family room and the kitchen windows did not stay open when raised. Some will drop swiftly toward the window sill. This can create a hazard for children and can impede the use of such windows as a means of egress in case of a fire. It is recommended that the tensioning springs be adjusted or replaced to bring the windows into proper working order.

- **Information:** It should be noted that the closet in the end family room is locked and should be opened and the condition of the closet inspected before closing.

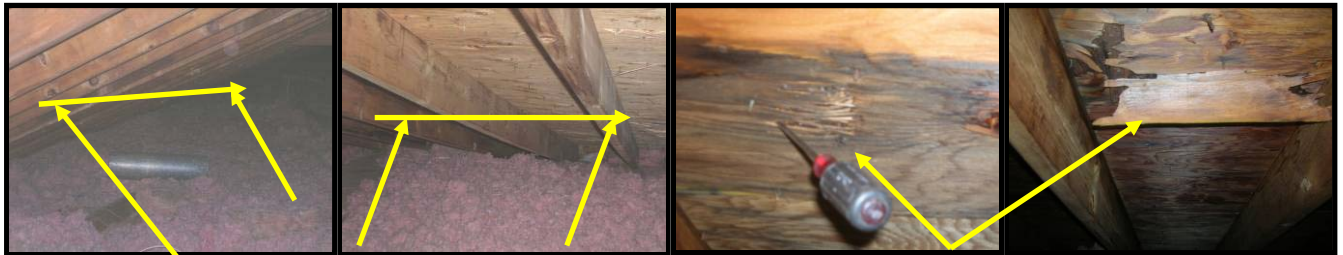
- **Major Concern: Repair:** Rafter bounce was experienced in several locations while walking of the roof during the inspection. The condition was particularly bad in the locations of the old roof vents. Upon further inspection it is noted that there are no purlins or purlin braces installed under the rafters in the attic. It is recommended that this condition be examined by a qualified contractor to make recommendations for proper repairs.
- **Repair:** Some of the roof decking of the home is deteriorated and should be properly replaced. It is recommended that the roof decking be examined and any damaged decking replaced when the roof is replaced. (See roofing section)

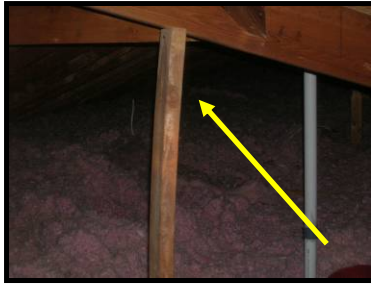
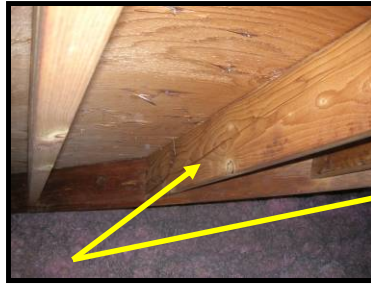
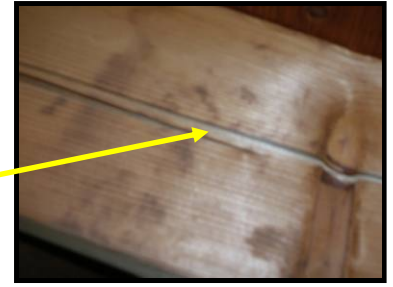
- **Repair:** There is a main valley rafter support that is bowing from the weight. It is recommended that the valley rafter at the back slope of the house be properly supported.

- **Repair:** There are a couple of jack rafters in the same location as the valley rafter that are cracked. It is recommended that all cracked or damaged rafters be properly repaired.

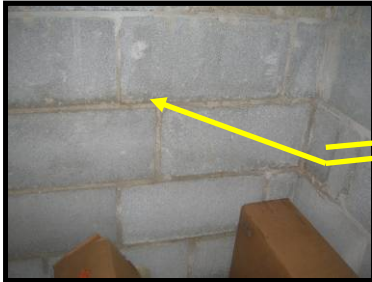
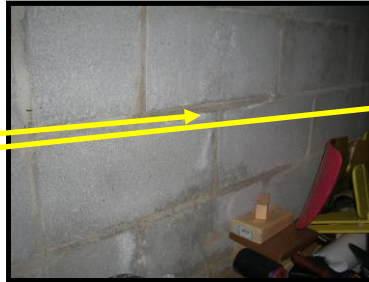
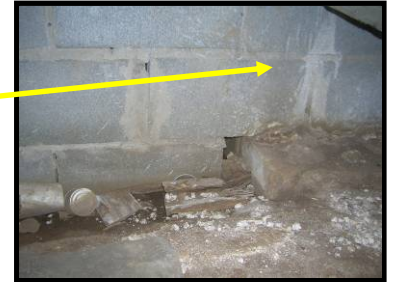
- **Improve: Information:** Along the back corner wall behind the garage and in places on the block crawl space wall there is evidence of water penetrating the blockwork and there is some efflorescence on the blockwork. **Efflorescence is a white crystalline or powdery, often fluffy/fuzzy deposit on the surface of masonry materials like concrete, brick, clay tile, etc. It's caused by water seeping through the wall/floor/object. The water dissolves salts inside the object while moving through it, and then evaporates leaving the salt on the surface.** This indicates that the grading just above this area should be checked and re-graded or downspouts redirected from this area as necessary.

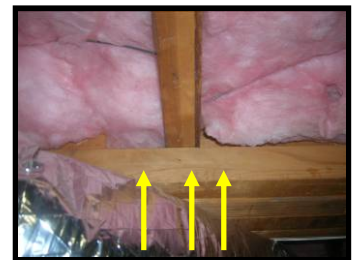
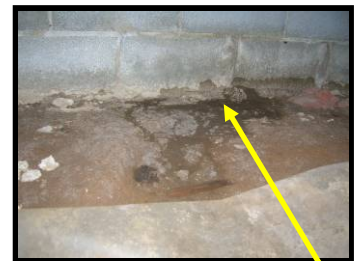
- **Information: Repair:** Floors are generally framed with solid-sawn lumber, floor trusses, or wood I-joists. Joist end-bearing should not be less than 1-1/2" on wood or metal, or 3" on masonry. Joists should be attached to the girders or beams by means of joist hangers, or toe-nailed into girders with a ledger. Face nailing alone is not sufficient to carry the load of the floor joist and it is required that 3- 16D penny nails be installed under each floor joist through the ledger. The ledger boards installed under the floor joists in the crawl space were not properly nailed with 3 - 16D penny nails under each joist as required. This condition should be corrected.
- **Improve:** Moisture was observed on the crawl space floor. It is recommended that lot and gutter drainage issues be addressed to help maintain a dry crawl space. (See roofing section)

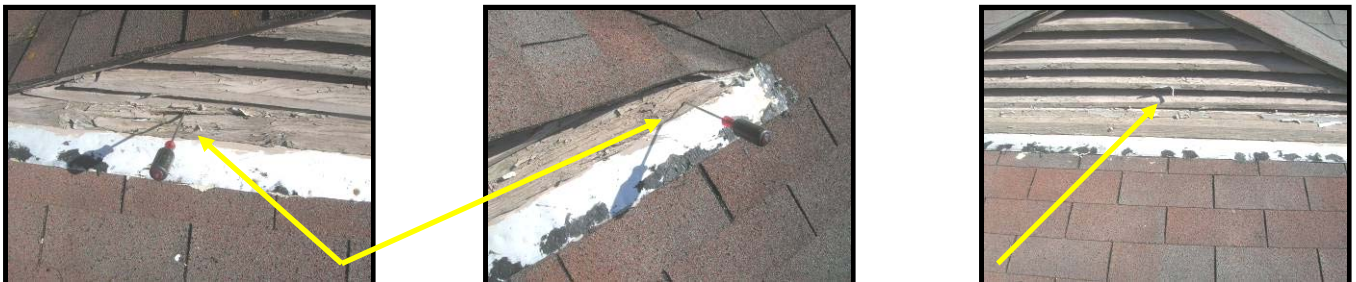
- **Repair:** The wood roof vents are deteriorated. It is recommended that they be replaced during the roofing process. (See insulation and ventilation section of this report.

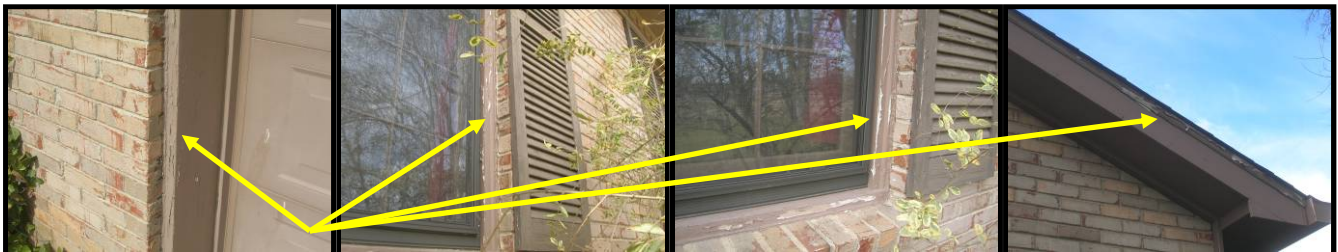
- **Repair:** The wood trim around the exterior of the home has reached the point where painting maintenance is required. Exterior wood trim on windows, dormers, chimneys, porch railings and columns, etc., must be kept well painted to prevent decay. Proper preparation including scraping, sanding and painting with a good quality paint will protect the wood and your investment.
- **Repair:** The fascia boards (the wooden board to which the gutter is typically fastened) and soffits (the horizontal wooden board between the building and the fascia.) are at the point of needing paint and maintenance. Proper preparation including scraping, sanding and painting with a good quality paint will protect the wood and your investment.

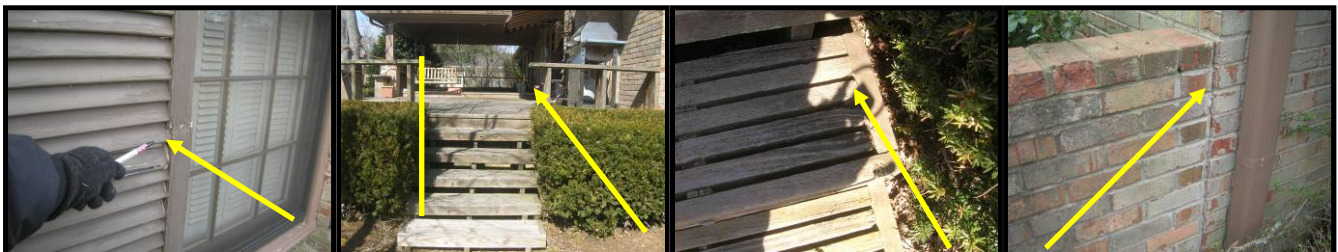
- **Repair:** The left shutter of the far right window is damaged and should be properly repaired.
- **Repair:** Standard building practices require a grippable handrail where there is a rise of 30 inches or more, or 2 or more risers on stairs. Such handrail should be 34"- 38" high with a grippable rail that is between 1 1/4 and 2 5/8 wide. A proper handrail should be installed on the wood steps from the back deck to the driveway.
- **Repair:** The wood steps from the back deck to the lower driveway are deteriorated and should be properly repaired or replaced.
- **Monitor:** The brick wall at the back right side of the house is cracked at the joint to the house and is displaced. It is recommended that this crack be sealed and monitored for changes in character such as widening or further displacement.

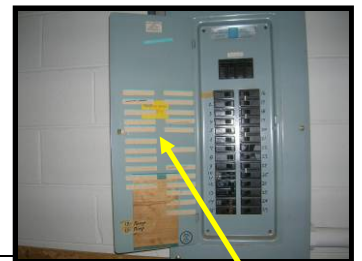
- **Improve:** The main electrical panel does not have an appropriate legend (A list which identifies what each fuse or breaker protects.) Such legends help when repairs are necessary or emergencies arise. The legend should be completed as soon as you occupy the home.

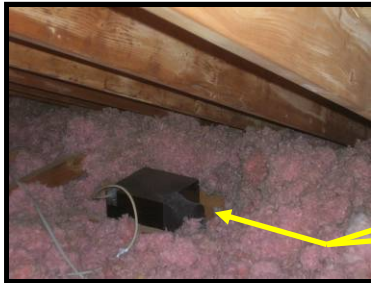
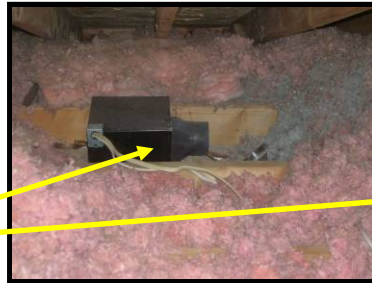
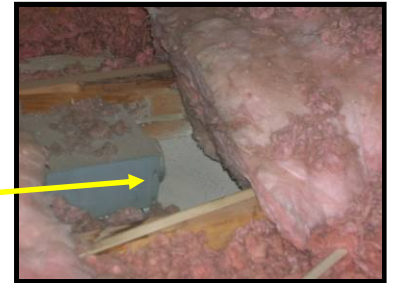
- **Improve:** The moisture (vapor) barrier on the crawl space floor should be adjusted or improved to cover all areas of exposed soil. It currently covers only 85% of the ground.
- **Repair:** The gas range down draft pipe is extended through the front exterior wall vent of the crawl space effectively reducing the crawl space ventilation. It is recommended that the range top down draft be re-routed and the exterior wall vent repaired.
- **Repair:** All 3 of the bathroom ceiling vent fans, vent into the attic. It is recommended that the vent fans be properly vented to the exterior of the house.

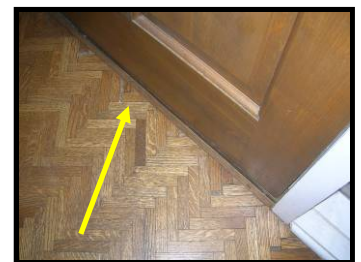
- **Repair:** The wood floor in the entry way is damaged and should be properly repaired.

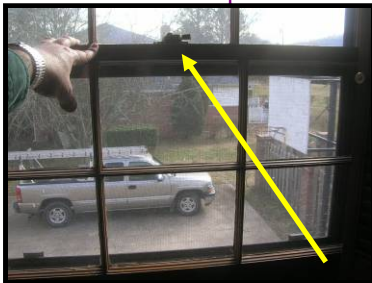
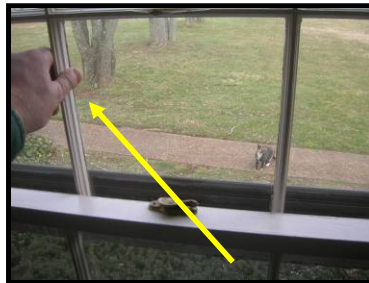
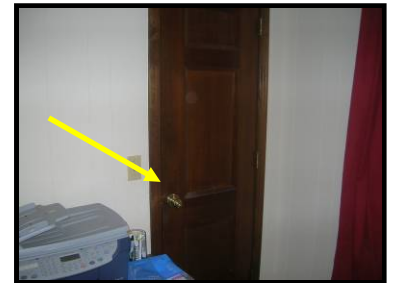
- **Safety Issue: Improve:** The back bedroom closet window did not open because it may be painted shut or do not fit properly in their frames. All windows should be brought to proper working order. In cases of emergency windows are often called upon to serve as a means of egress and should function as required.
- **Safety Issue: Improve:** The end window in the end family room and the kitchen windows did not stay open when raised. Some will drop swiftly toward the window sill. This can create a hazard for children and can impede the use of such windows as a means of egress in case of a fire. It is recommended that the tensioning springs be adjusted or replaced to bring the windows into proper working order.
- **Information:** It should be noted that the closet in the end family room is locked and should be opened and the condition of the closet inspected before closing.
