# Building Inspection Report

██████████ en Ave., Nashville TN 37212

Inspection Date: January 18, 2008

Report Number: TW011808PT

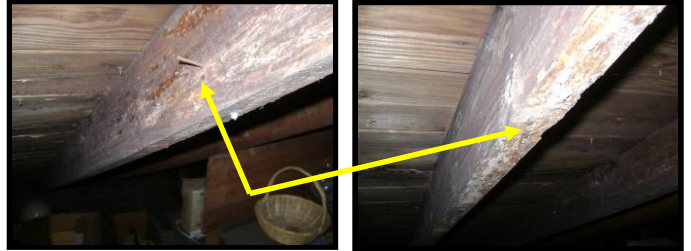
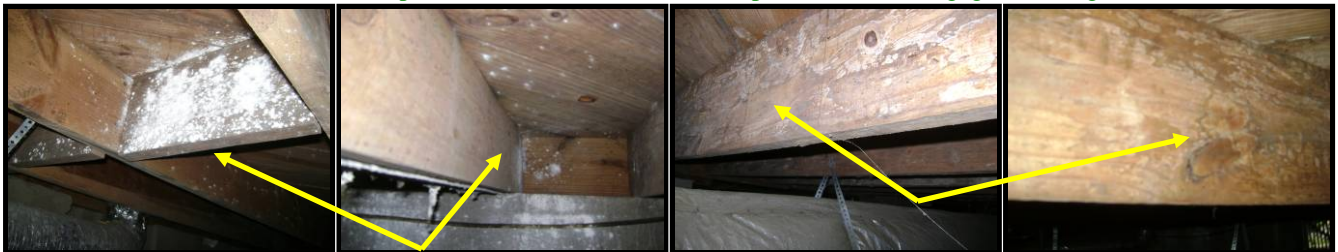
- Information: Safety Issue: Improve:** Mold type growth is visible on most of the floor joists and on the insulation and subflooring in the crawl space and on some of the rafters in the attic. The level of mold growth is moderate to high. *The presence of certain mold and mold spores in housing can result in mild to severe health effects in humans and pets and can deteriorate the structure of the dwelling resulting in structural damage. Health effects include, but are not limited to: sinus congestion, blurry vision, sore throat, dry cough, aches and pains, skin irritation, bleeding of the lungs, headaches, memory loss and fever. As humans vary greatly in their chemical make-up, so does the individual's reaction to mold exposure. For some people, a small number of mold spores can cause ill effects. In others it may take more.* Because mold can adversely affect you health and the amount of mold present is significant, it is BJK's Company policy to recommend that a sample be taken and sent to the laboratory to determine the type(s) of mold that are present to help determine the proper course of action to be taken. Because of the amount of mold present it is recommended that a professional be engaged to mitigate the mold.

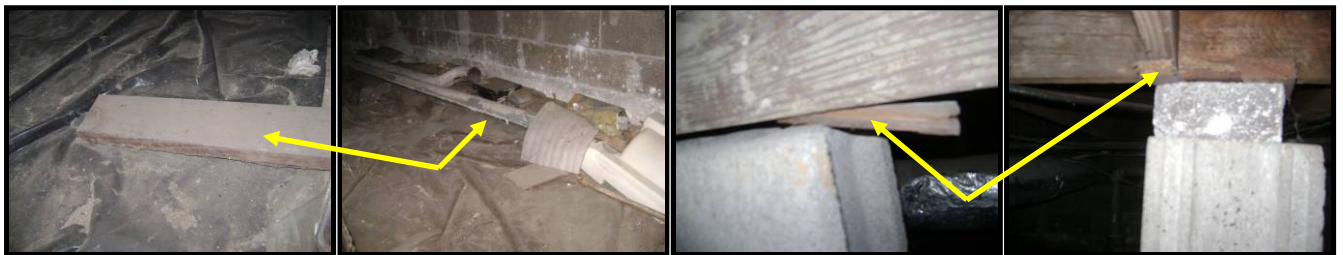
- Information: Improve:** Wood shims on the piers are more subject to compression and shrinkage then are steel shims. Generally speaking when wood shims are utilized they should be driven in from opposing sides and should be not less than 4 inches by 8 inches. Some of the wood shims are improper. While the overall structure may not be affected improper shims tend to allow or are responsible for greater than typical settling and movement. Changing out the shims now would only help to prevent ore reduce future movement.

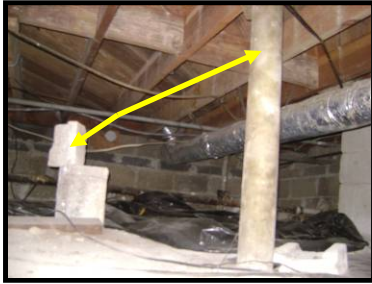
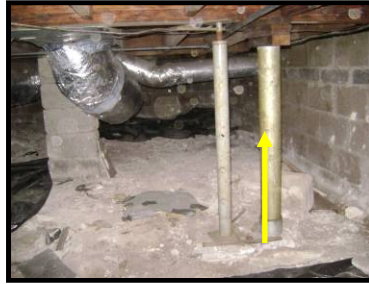
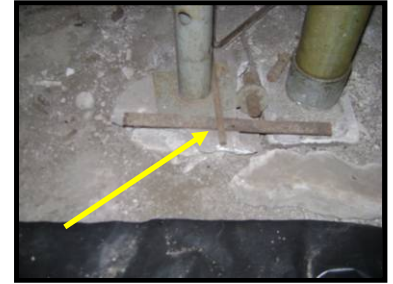
- **Information: Improve:** Some additional supports have been added in the crawlspace area of the house. The supports do not appear to have been installed in a workman like manor and may not be functioning as intended. It is recommended that the added supports be removed and re-installed in a professional manor.

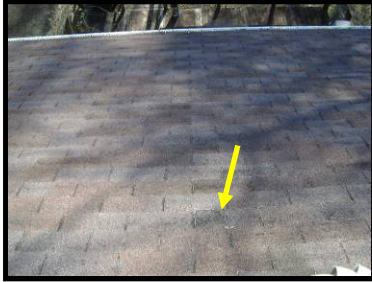
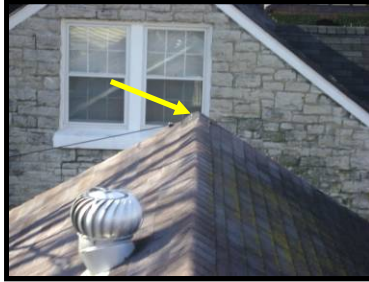
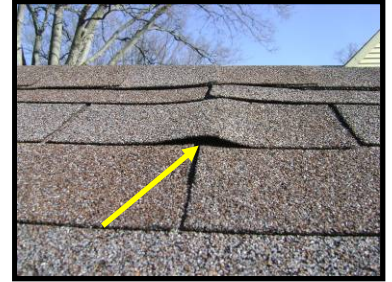
- **Repair:** There are several “nail pops” in various locations on the roof which need to be fixed. Nails will often lift as the materials expand and contract with the weather. Sometimes the roofing nails were not sufficiently driven into the wood beneath the shingle. Such nails will eventually break through the surface of the overlying shingle tab which can lead to leaks. All “nail pops” should be properly repaired to prevent leaks which could damage the home.

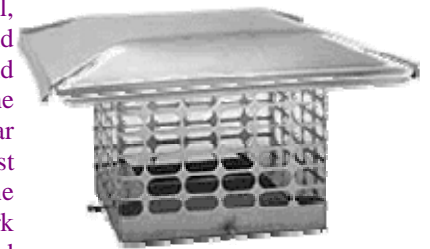
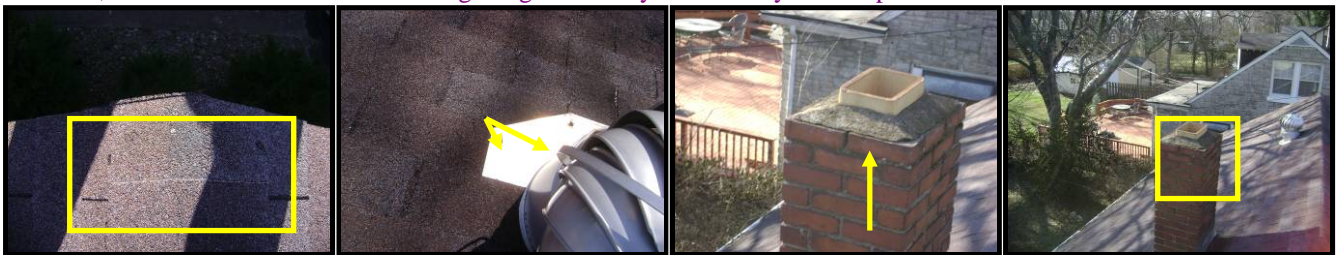
- **Repair:** The masonry chimney cap has some cracks in the concrete which need to be sealed with roofing cement or other appropriate sealant to prevent moisture penetration. Moisture penetration will eventually cause damage to the brickwork and structure if not kept sealed.

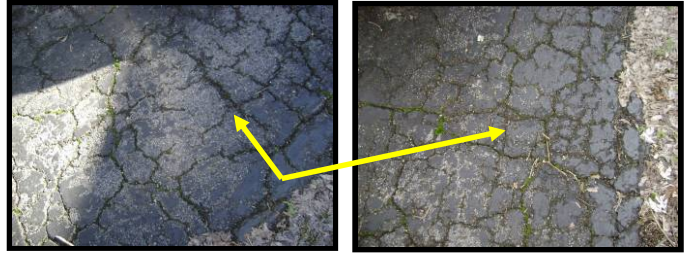
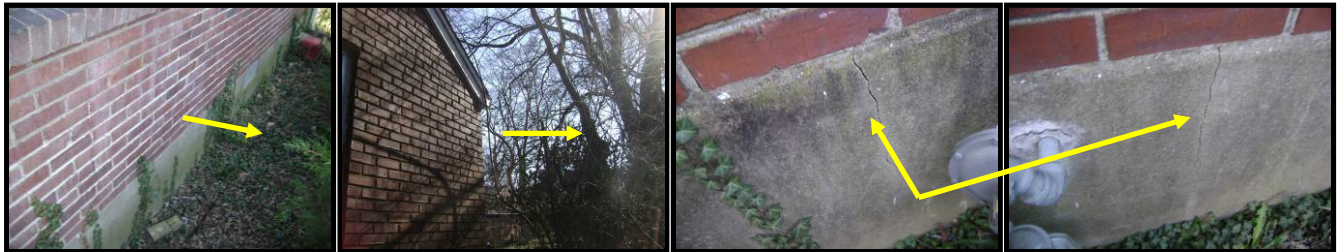
- **Repair:** There were a few minor cracks in the cement parging material that covers the foundation block. This is fairly common and not considered to be structurally significant. These cracks should be sealed with caulk or mortar to keep out moisture and monitored for changes in character such as widening or displacement.

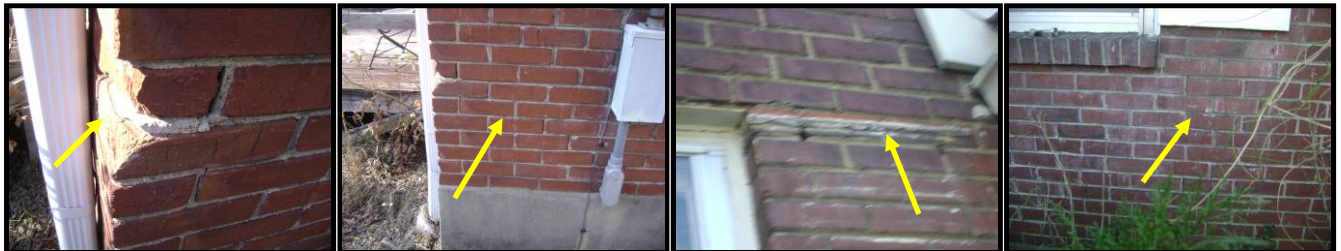
- **Repair:** There is some damaged brickwork at the back left corner of the house. Damaged or missing bricks should be properly installed to preserve the integrity of the wall and to keep out moisture, insects and other "critters."
- **Repair:** There were a few minor cracks or deteriorated mortar joints in the brick veneer of the home. This is fairly common and not considered to be structurally significant. Obviously, these cracks should be sealed with caulk or mortar to keep out moisture and monitored for changes in character such as widening or displacement.

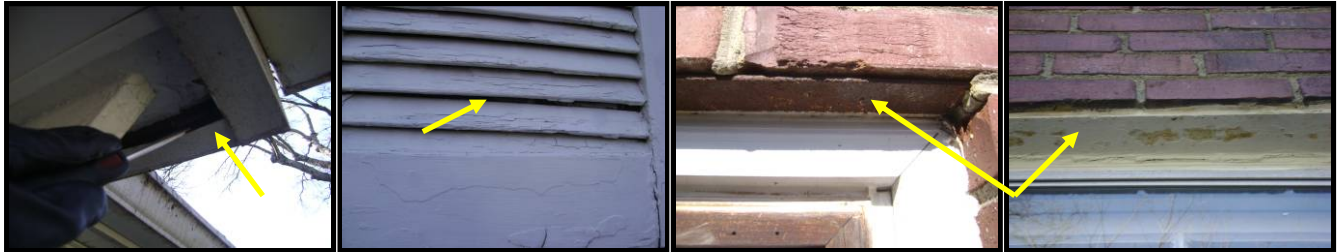
- **Improve:** There is rust starting to form on the lintels (the metal angel iron above doors and windows in brickwork) at several locations. Sand, prime and paint with a good quality rust inhibiting paint. Rusted lintels are known to damage brickwork.

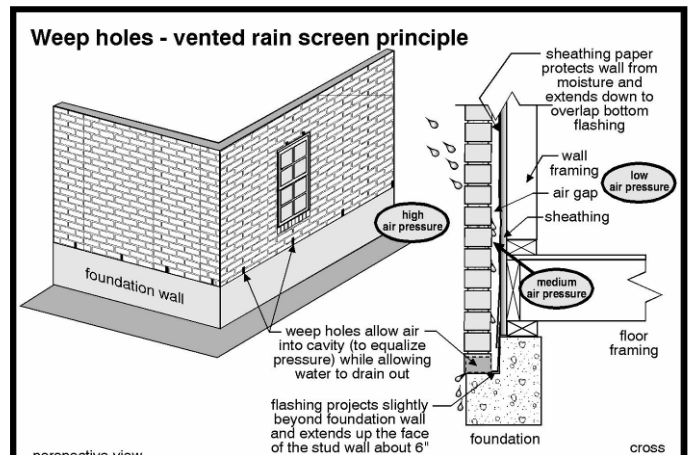
- Improve:** Weep holes were not installed as required on the building. Weep holes are intended to allow water to exfiltrate and air to infiltrate the wall cavity. **Weep holes should be provided in masonry veneer and in the outside wythe of masonry walls at a maximum spacing of 4 ft (1219 mm) on center by omitting mortar in the head joints** Weep holes shall be located in the first course above the foundation wall or slab, and other points of support, including structural floors, shelf angles, and lintels. Shown at right are diagrams showing the proper placement for weep holes. **There is no evidence of any ill-effects from the lack of the required weep holes. Drilling weep holes in the mortar joints around the building to allow air infiltration to enter and dry the cavity is a simple and inexpensive.**

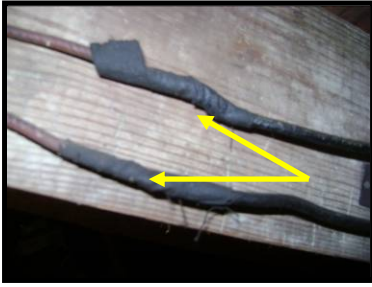
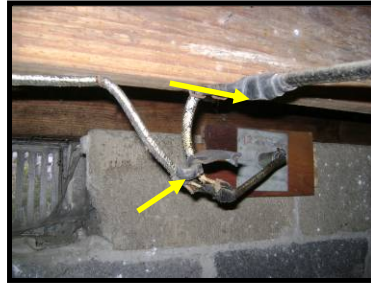
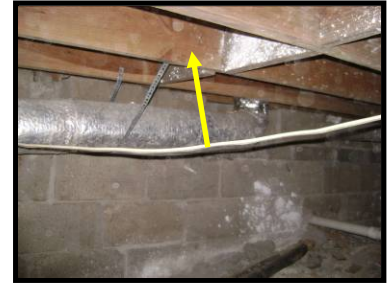
- **Improve:** Wires are required to be properly supported and secured at intervals not exceeding 4 ½ feet along their runs and must be secured within 12 inches of a box, cabinet or fitting. Some of the wires in the crawl space need to be properly secured.

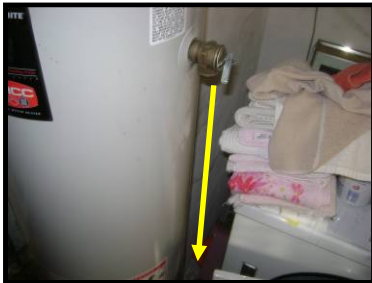
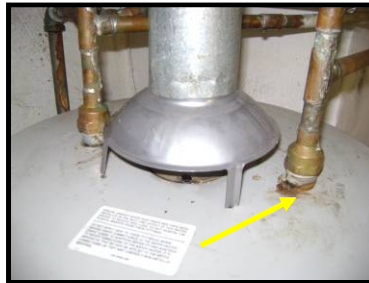
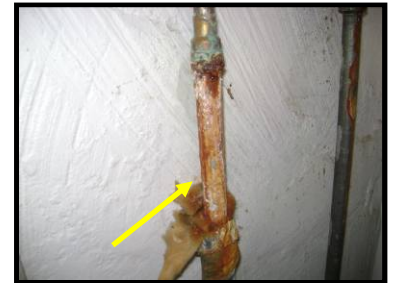
- **Improve: Repair:** Corrosion caused by electrolytic action (electrolysis) occurs when pipes of dissimilar metals (such as galvanized steel and copper pipe) are joined. This often occurs at the top of water heaters. There is rust forming at the top and around the water heater in the laundry room and it would be wise to have dielectric unions installed at the pipe connections.

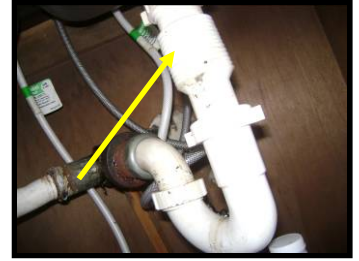
- **Repair:** A water shutoff valve is required to be installed by a commode. There was no water shutoff valve by the commode in the bathroom as required, and one should be installed.

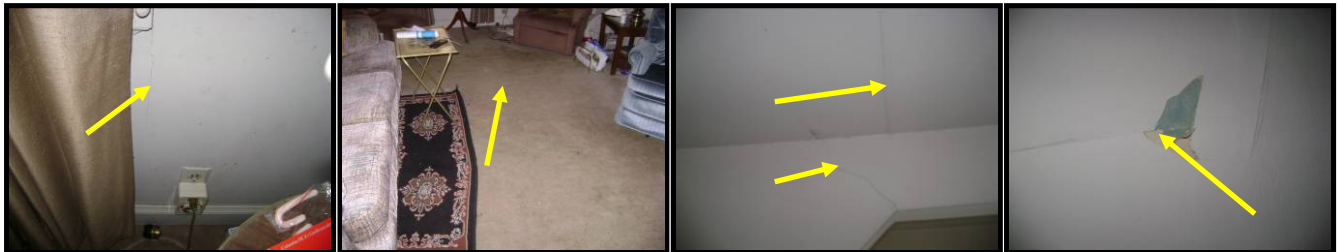
- **Major Concern: Repair:** Most of the interior finishes are in mild disrepair. There is a significant amount of cracking in the plaster around the home. This indicates that the house has experienced some minor settlement. The settlement did not appear to have caused major damage, but rather cosmetic flaws. It would be wise that rather than tape and spackle the cracks in the plaster, the old cracked and aged plaster be completely torn out and replaced with drywall. During the removal and instillation of the drywall, it is recommended that the isolation throughout the house be improved. The carpet throughout the house is worn and should be removed. The instillation of the bathroom appeared to have been done in less than a professional manor, and it may be desired to remove and replace all fixtures and finishing material. A significant amount of expense should be anticipated to refresh all of the interior finishes to a more desired living condition.

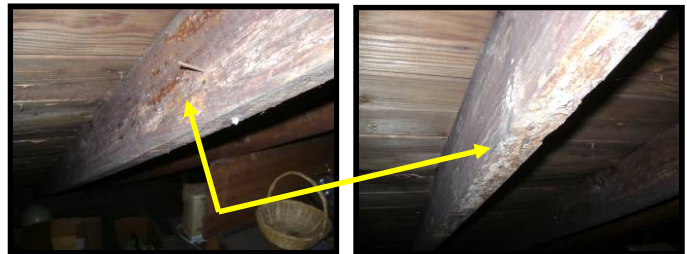
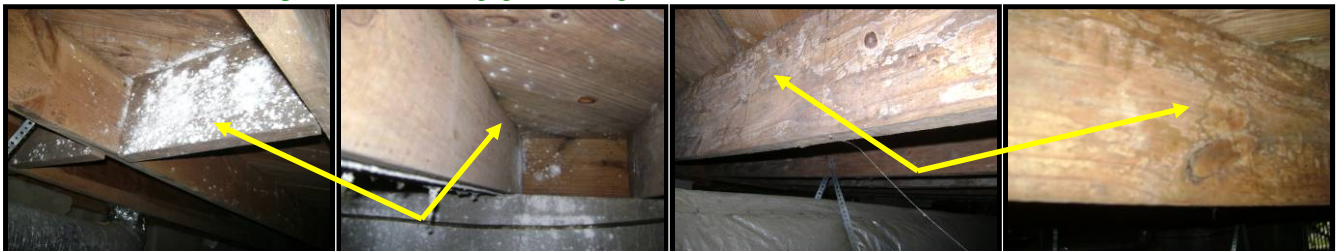
- **Information:** **Safety Issue:** **Improve:** **Mold type growth is visible on most of the floor joists and on the insulation and subflooring in the crawl space and on some of the rafters in the attic. The level of mold growth is moderate to high.** *The presence of certain mold and mold spores in housing can result in mild to severe health effects in humans and pets and can deteriorate the structure of the dwelling resulting in structural damage. Health effects include, but are not limited to: sinus congestion, blurry vision, sore throat, dry cough, aches and pains, skin irritation, bleeding of the lungs, headaches, memory loss and fever. As humans vary greatly in their chemical make-up, so does the individual's reaction to mold exposure. For some people, a small number of mold spores can cause ill effects. In others it may take more.* Because mold can adversely affect you health and the amount of mold present is significant, it is BJK's Company policy to recommend that a sample be taken and sent to the laboratory to determine the type(s) of mold that are present to help determine the proper course of action to be taken. Because of the amount of mold present it is recommended that a professional be engaged to mitigate the mold.

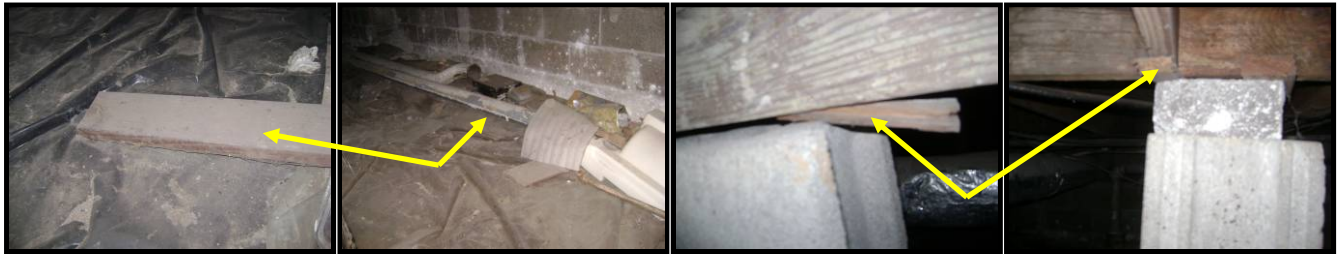
- **Information: Improve:** Wood shims on the piers are more subject to compression and shrinkage than are steel shims. Generally speaking when wood shims are utilized they should be driven in from opposing sides and should be not less than 4 inches by 8 inches. Some of the wood shims are improper. While the overall structure may not be affected improper shims tend to allow or are responsible for greater than typical settling and movement. Changing out the shims now would only help to prevent or reduce future movement.

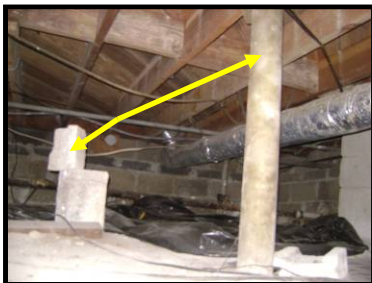
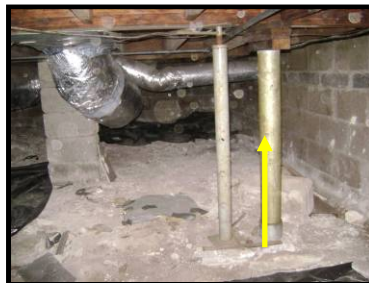
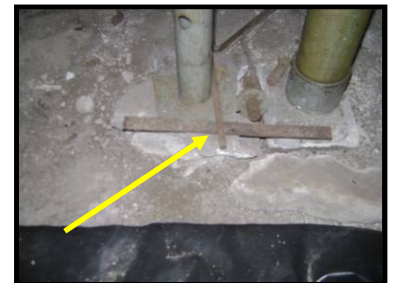
- **Improve:** Termite shields are required to be installed at the top of the foundation block under the framing members and at the tops of all columns. Termite shields are installed to help prevent termites from reaching the framing members of the house. There were no termite shields installed in the crawlspace of the home. It is recommended that termite shields be properly installed.
- **Information: Improve:** Some additional supports have been added in the crawlspace area of the house. The supports do not appear to have been installed in a workman like manner and may not be functioning as intended. It is recommended that the added supports be removed and re-installed in a professional manner.

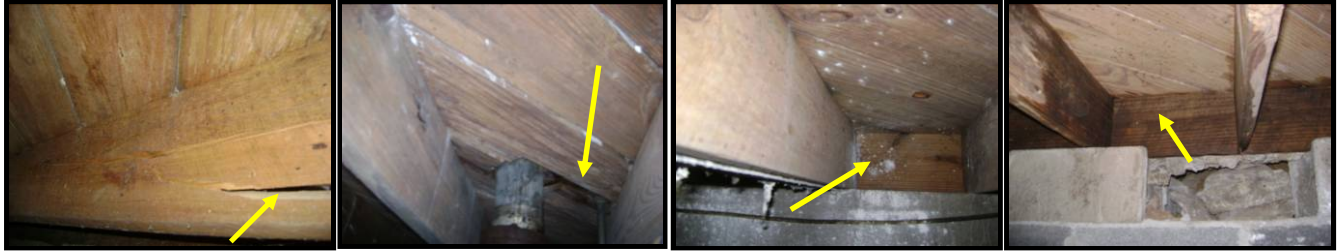
- **Repair:** The inspector observed a considerable amount of moisture in the crawlspace. Moist crawlspaces can lead to mold growth, insect damage and rot. It is recommended that the conditions leading to the moist conditions be properly remedied.

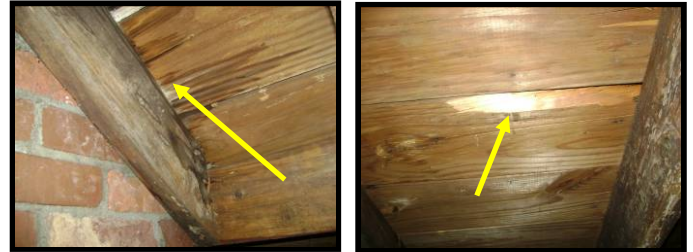
- **Monitor:** Evidence of previous leaks was observed from within the attic. The stains were tested for moisture and found to be dry at the time of the inspection.
- **Monitor: Improve:** There were several broken decking members observed from within the attic. The damaged decking material can be repaired at the time of re-roofing.

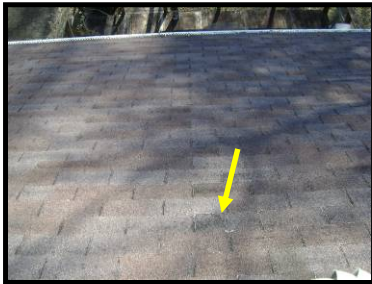
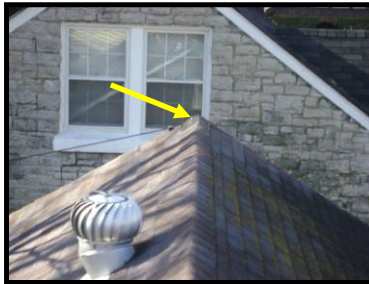
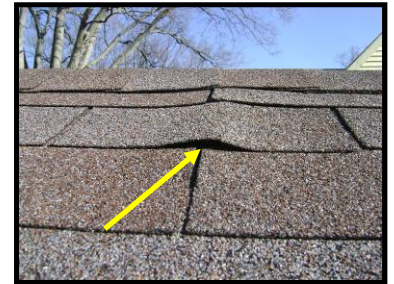
- **Repair:** There are several “nail pops” in various locations on the roof which need to be fixed. Nails will often lift as the materials expand and contract with the weather. Sometimes the roofing nails were not sufficiently driven into the wood beneath the shingle. Such nails will eventually break through the surface of the overlying shingle tab which can lead to leaks. All “nail pops” should be properly repaired to prevent leaks which could damage the home.

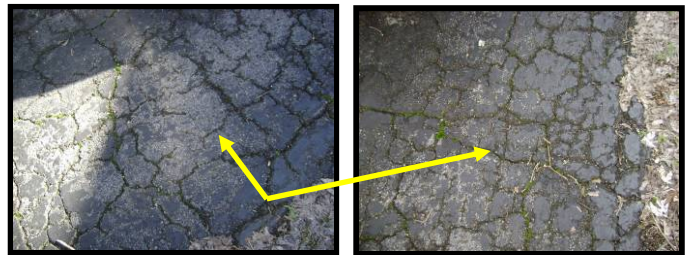
- **Major Concern: Improve:** The surface of the driveway is significantly deteriorated. Resurfacing will be necessary to correct the condition.
- **Repair:** There are some settlement cracks in the walkway. It is recommended that they be filled to prevent moisture from entering and eroding the surface beneath the cement which will lead to additional cracking. Sonneborn and Trimco make some excellent long lasting products to help seal such cracks. Exterior Materials, 665 Wedgewood Ave. Nashville, TN, (near the State Fair Grounds) carries Sonneborn and Trimco products.

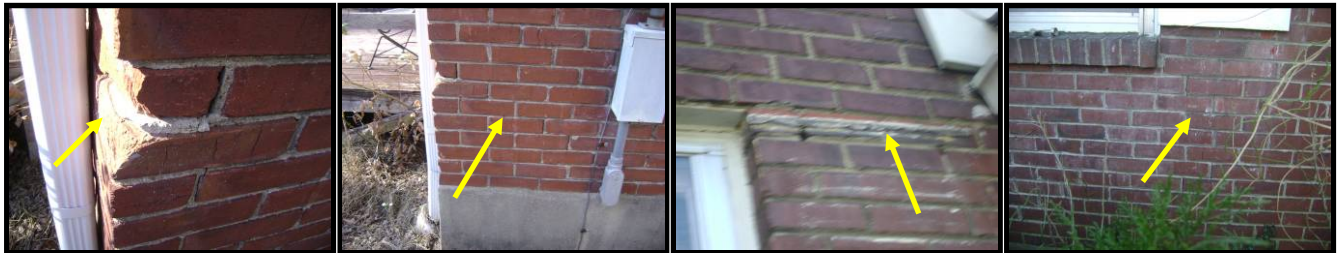
- **Repair:** There is some damaged brickwork at the back left corner of the house. Damaged or missing bricks should be properly installed to preserve the integrity of the wall and to keep out moisture, insects and other "critters."
- **Repair:** There were a few minor cracks or deteriorated mortar joints in the brick veneer of the home. This is fairly common and not considered to be structurally significant. Obviously, these cracks should be sealed with caulk or mortar to keep out moisture and monitored for changes in character such as widening or displacement.

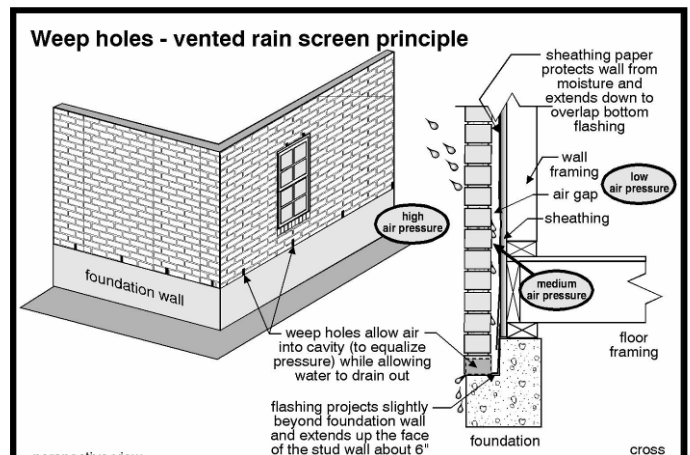
- **Improve:** Weep holes were not installed as required on the building. Weep holes are intended to allow water to exfiltrate and air to infiltrate the wall cavity. **Weep holes should be provided in masonry veneer and in the outside wythe of masonry walls at a maximum spacing of 4 ft (1219 mm) on center by omitting mortar in the head joints** Weep holes shall be located in the first course above the foundation wall or slab, and other points of support, including structural floors, shelf angles, and lintels. Shown at right and below are diagrams showing the proper placement for weep holes. **There is no evidence of any ill-effects from the lack of the required weep holes. Drilling weep holes in the mortar joints around the building to allow air infiltration to enter and dry the cavity is a simple and inexpensive.**

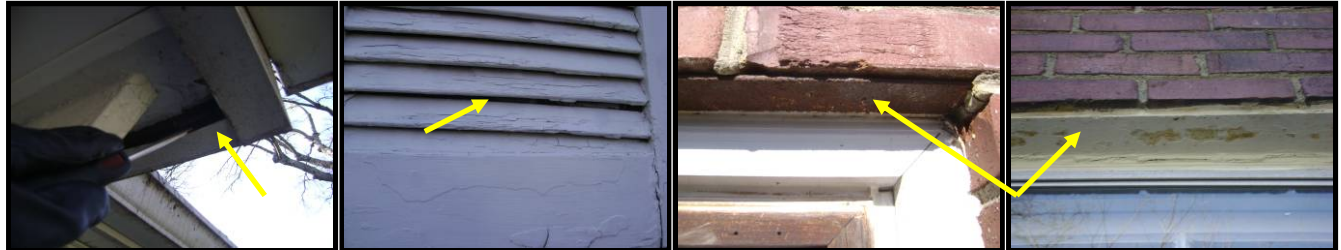
- **Repair:** The metal fascia trim above the front door is loose and needs to be properly secured to prevent the wind from getting behind the siding and causing damage and loss of siding.
- **Repair:** The wood trim around the entire home has reached the point where painting maintenance is required. Exterior wood trim on windows, dormers, chimneys, porch railings and columns, etc., must be kept well painted to prevent decay. Proper preparation including scraping, sanding and painting with a good quality paint will protect the wood and your investment.
- **Improve:** There is rust starting to form on the lintels (the metal angel iron above doors and windows in brickwork) at several locations. Sand, prime and paint with a good quality rust inhibiting paint. Rusted lintels are known to damage brickwork.
