Building Inspection Report

[REDACTED] Court, Nashville TN 37215

Inspection Date: January 18, 2008

Report Number: DD012508A

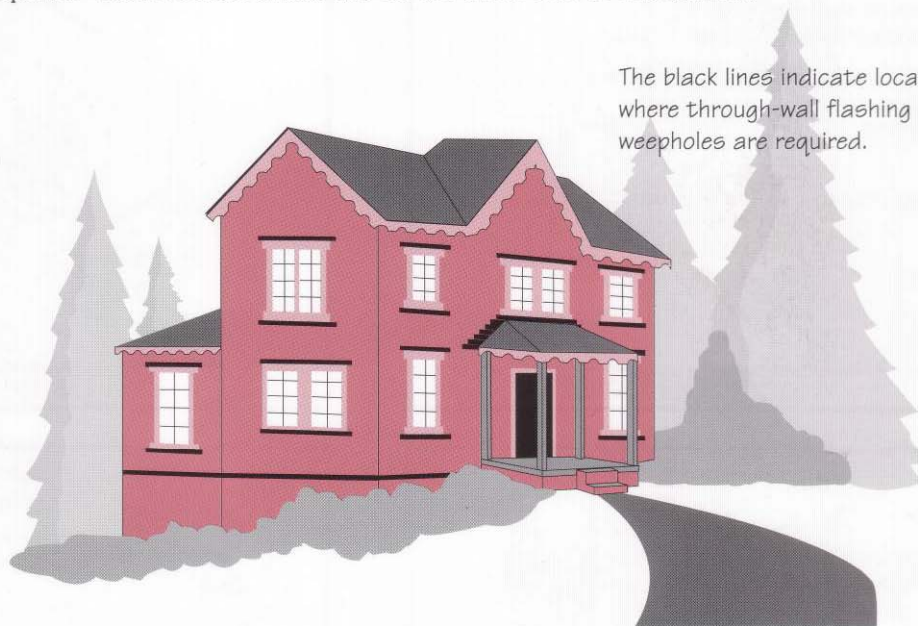
The 1995 CABO **1 and 2 Family Dwelling Code** and the 1994 Edition of the **Standard Building Code*** call for flashing and weepholes in masonry veneer.

The black lines indicate locations where through-wall flashing and weepholes are required.

- **Improve:** Weep holes were not installed as required on the building. Weep holes are intended to allow water to exfiltrate and air to infiltrate the wall cavity. **Weep holes should be provided in masonry veneer and in the outside wythe of masonry walls at a maximum spacing of 4 ft (1219 mm) on center by omitting mortar in the head joints** Weep holes shall be located in the first course above the foundation wall or slab, and other points of support, including structural floors, shelf angles, and lintels. Shown at right and below are diagrams showing the proper placement for weep holes. **There is no evidence of any ill-effects from the lack of the required weep holes. Drilling weep holes in the mortar joints around the building to allow air infiltration to enter and dry the cavity is a simple and inexpensive.**

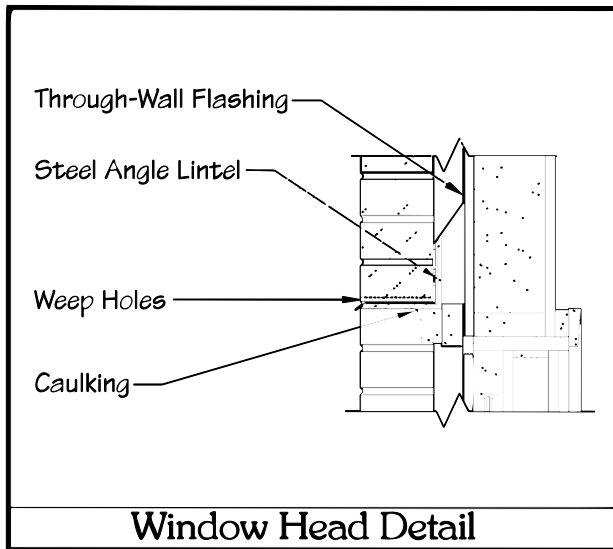
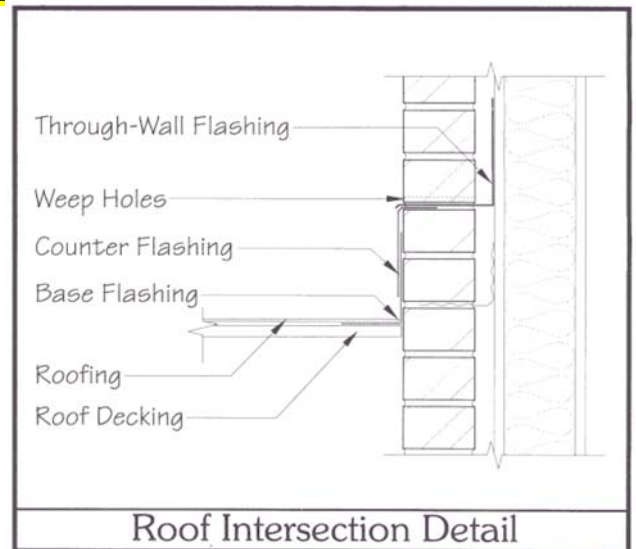
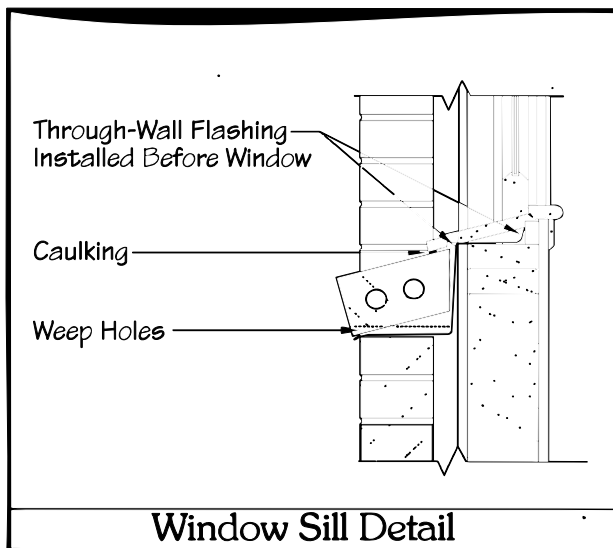
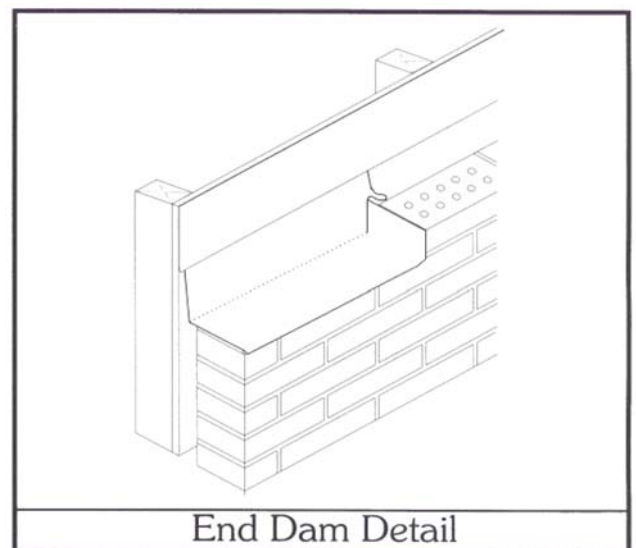
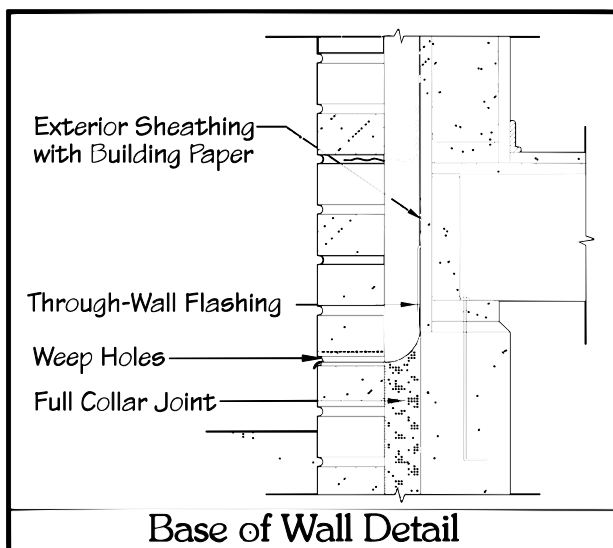
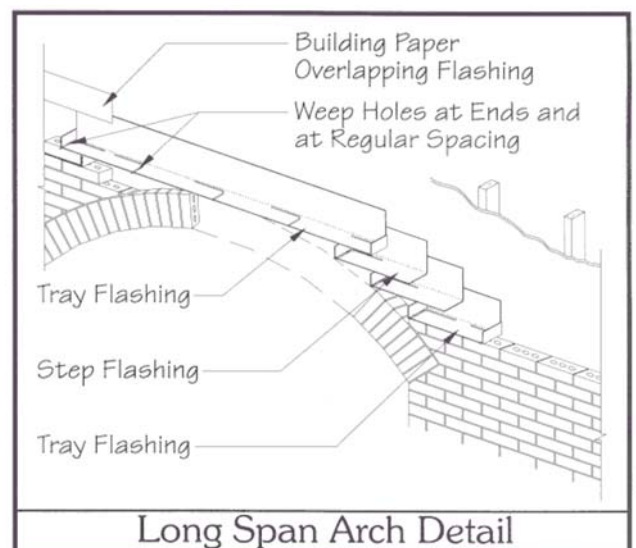
- **Improve:** There is rust starting to form on the lintels (the metal angel iron above doors and windows in brickwork) above the garage doors, the pedestrian door of the garage and several of the windows. Sand, prime and paint with a good quality rust inhibiting paint. Rusted lintels are known to damage brickwork. Also caulk between the lintel and the wood frame.

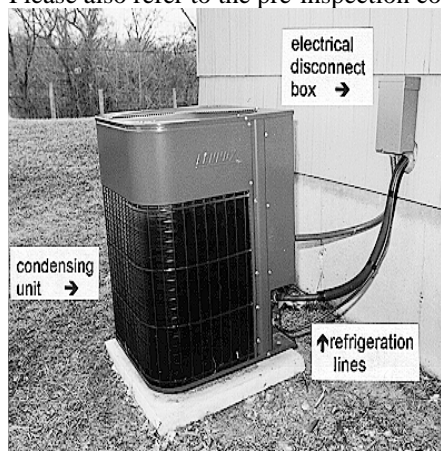
ILLUSTRATION ONLY

Condenser grills/fins should be kept clean and free of debris for proper operation of the units. Also all plants and shrubs should be kept trimmed at least 2 feet away from the units to allow adequate air flow and access to the units.
