Building Inspection Report

4th Avenue N. Nashville TN 37219

Inspection Date: July 12, 2007

Report Number: JA071207AC

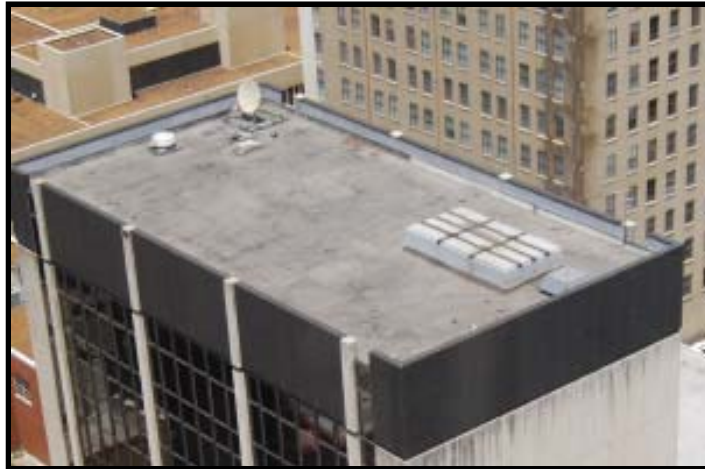
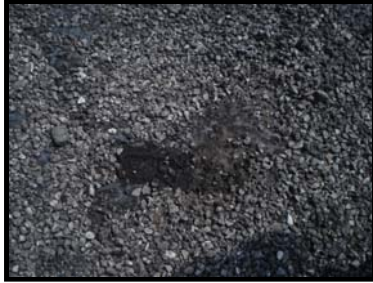
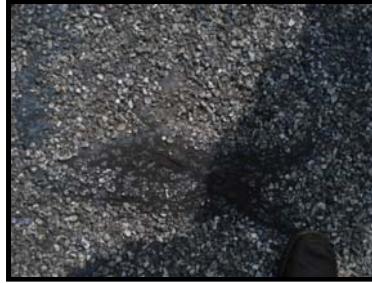
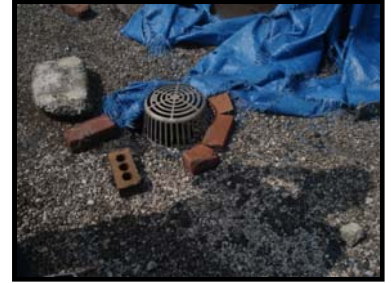
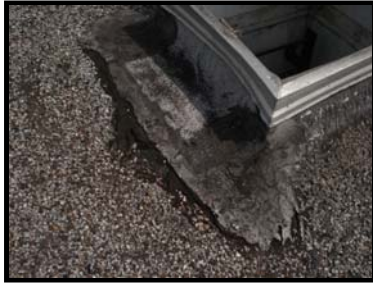
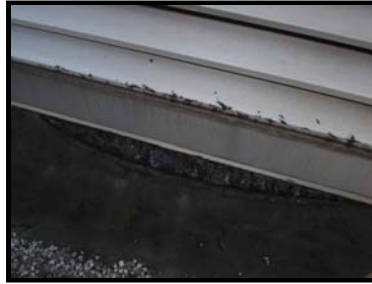
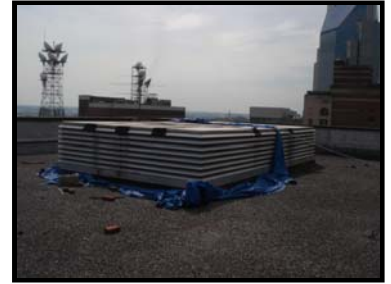
THE ROOF ABOVE THE MECHANICAL FLOOR

The flashing on the parapet walls have failed and are allowing water to enter.

There is damage to flashings around penetrations give rise to moisture collecting under roof topping.

There is bubbling and air pockets in the roofing material indicating delamination and that moisture is under some of the areas.

There is noted deterioration of the surface beneath the stone casting commensurate with aged worn out material in need of replacement.

- The asphalt in the gravel roof system has desaturated.
- The body of the roof is splitting in places.
- There are air pockets because of trapped moisture.
- Numerous scars on the roof from repairs.
- Wall flashings separating because of desaturation.

- Remove all loose gravel.
- Install moisture vents to eliminate air pockets and trapped moisture.
- Fill all voids and splits with fiber.
- Tie all wall and mechanical flashing with fiber.
- Cover entire roof with binder.
- Apply two layers of R400 Rubber
- Apply two layers of R500 Rubber.
- There will be a total of five layers equal to 60 Mil on upper roof.

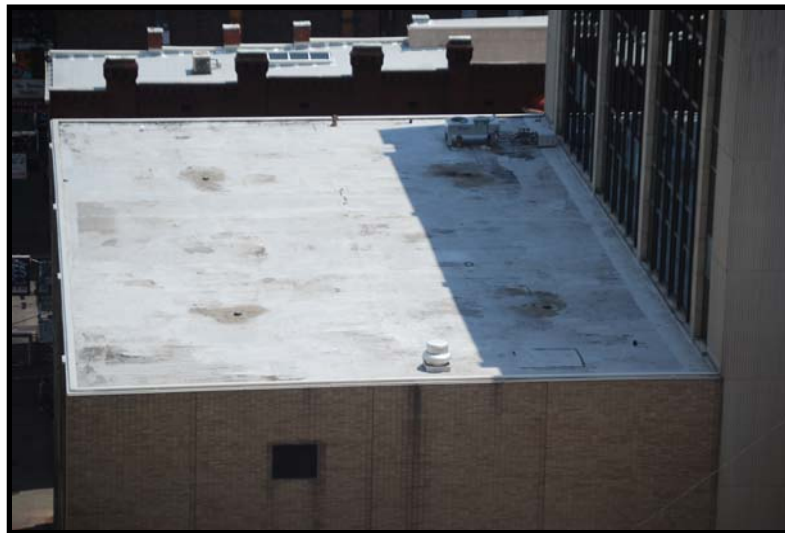
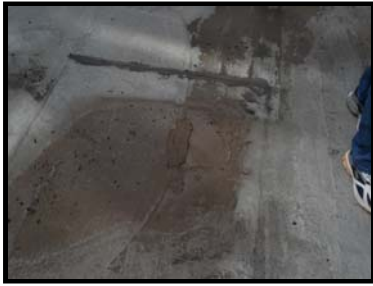
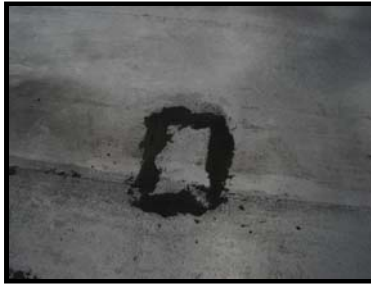
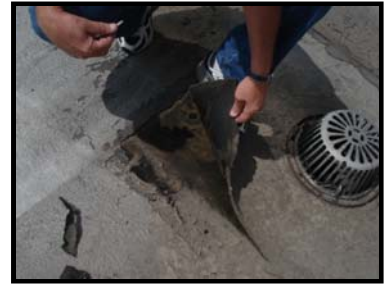
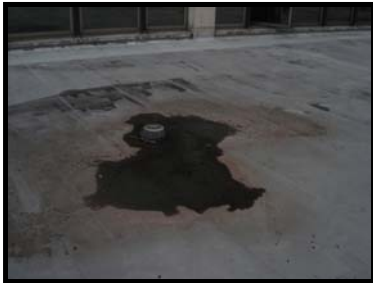
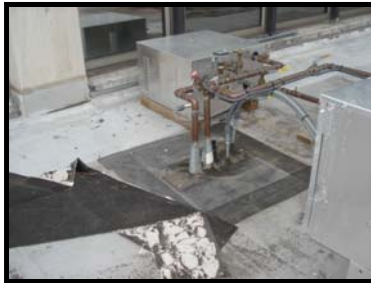
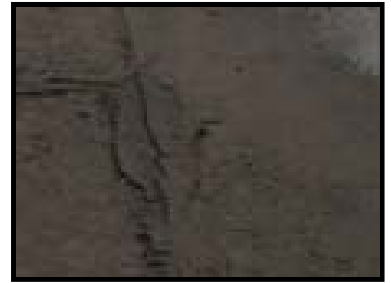
THE ROOF ABOVE THE FOURTH FLOOR

Numerous patches which are failing are indicative of past roof failures.

There are seams that are separating and there are pockets under indicating that there is trapped moisture.

- The lower roof is modified bitumen.
- The seams in the main body are separating.
- There are air pockets because of trapped moisture.
- Wall flashing separating in seams.

- Cover all seams with fiber
- Install moisture vents to eliminate air pockets and trapped moisture.
- Tie all wall and mechanical with fiber.
- Cover entire roof with binder.
- Apply two layers of R500 Rubber.
- There will be a total of three layers equal to 30 Mil on lower roof.

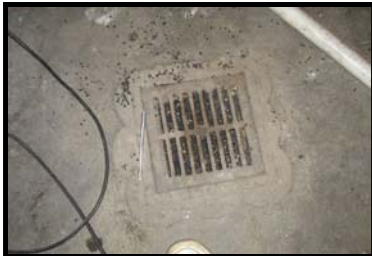
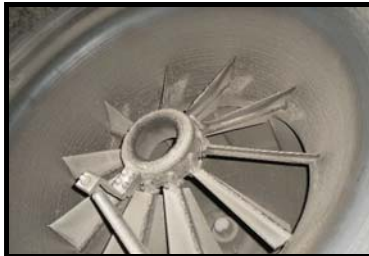
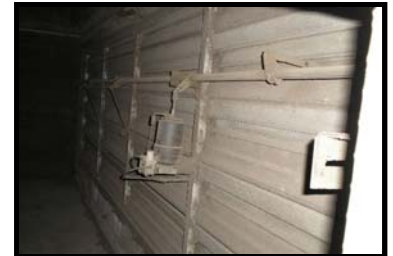
The floor drains in the penthouse are clogged up.

The booster fan intake blades and outside air louvers are covered in dirt

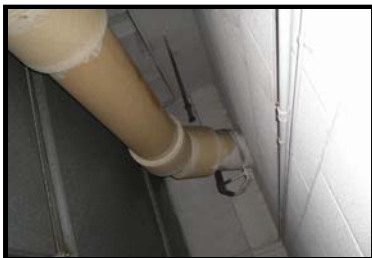
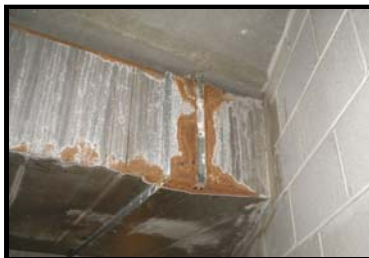
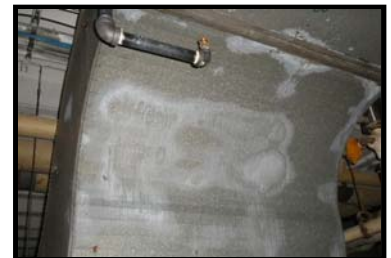
Many hangers and insulation shields are unhooked and missing

The humidifiers have damaged the duct work with moisture

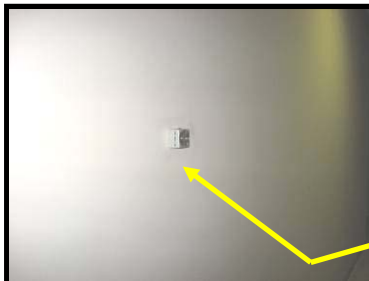
FORTH LEVEL

- **Repair:** One of the ducts in the ceiling cavity over room number 4-I has been unhooked and should be repaired during renovations.
- **Repair:** The thermostat in back hall did not operate as intended and the thermostat in room number 4-DD is damaged and should be repaired.

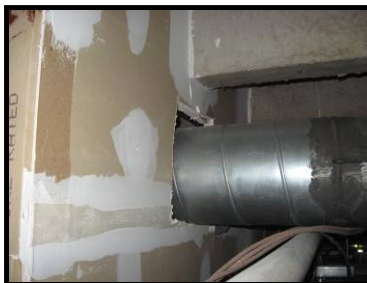
FOURTH LEVEL

- **Repair: Safety Issue:** There are several pipe chases in the walls and ceiling cavity of the 4th floor that need to be sealed to prevent penetration in case of a fire.

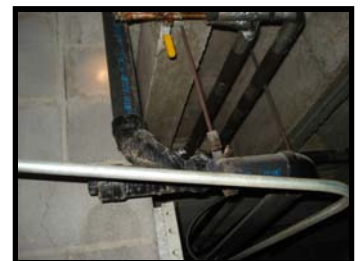
THIRD LEVEL

- **Safety Issue: Investigate:** From the opening in the ceiling of room S it was observed that there were what appeared to be black polybutylene DWV pipes. Because the space between the ceiling tile and the bottom of the floor above is used as a return air plenum the presence of polybutylene DWV and other plastic piping is generally not recommended as in case of a fire the pipes can burn and give off hazardous fumes. Local codes may require that if such pipes are allowed they be wrapped to prevent such off gassing.

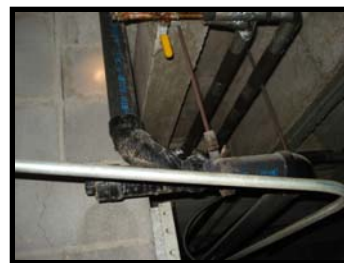
- **Improve: Investigate:** From the opening in the ceiling of room S it was observed that there were what appeared to be black polybutylene DWV pipes. Polybutylene piping is a low-cost piping formed of plastic resin. It is commonly gray, white, or sometimes black in color. Poly piping is employed as a substitute for copper piping in both underground water mains and interior plumbing. Due to the ease of installing poly piping, it was used in the construction of millions of buildings throughout the U.S. between 1978 and 1995; however, it has been discovered that as poly pipe ages and reacts with water-soluble oxidants, it begins to degrade and can leak, causing severe damage to the surrounding building structure. If the piping is no longer in service it would be wise to remove it and if it is still in service it would be wise to replace it with metal piping. (Also see Ventilation section)

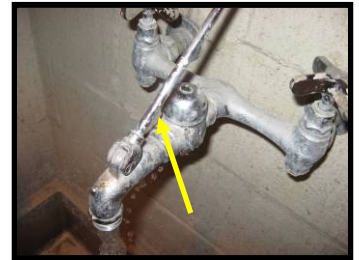
- **Repair:** The faucet in the mop room in the 1st floor is leaky and should be repaired or replaced.

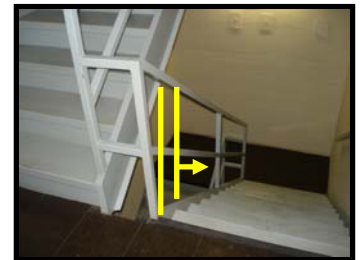
- **Safety Issue: Improve:** All stairways are required to have grippable handrails installed. When they are partially open on one or both sides, they are required to have vertical balusters spaced no more that 4" apart to prevent a child from falling off the stairs to the ground. The landings also should have protective railings with such balusters.
- **Safety Issue: Improve:** The fire extinguishers on most levels were out of date and should be brought current.
- **Safety Issue: Improve:** Many of the "EXIT" lights were out and did not function. Additionally not all corridors were properly equipped with sufficient battery lights for emergency evacuations.

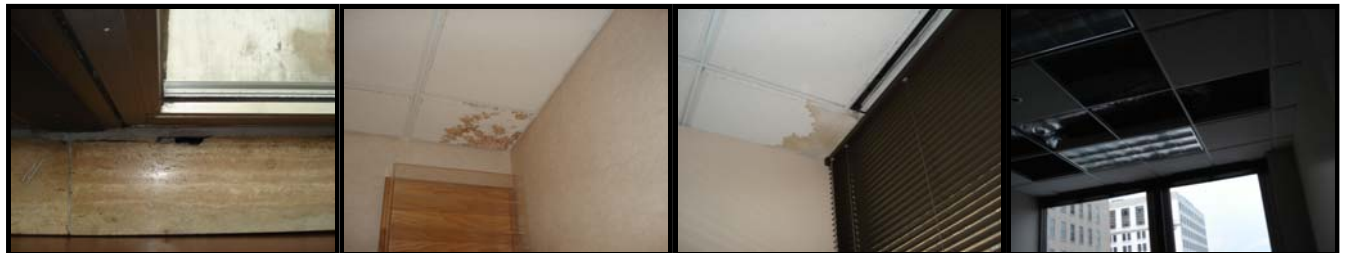
- **Repair:** Ceiling stains were observed in the ceilings of rooms B, C, D, K, SR, KIT and FRONT LOBY. The damaged ceiling tiles should be replaced and the areas above the stains checked.
- **Improve:** There is a chip out of the sill in room D. The opening should be filled with an appropriate caulking.

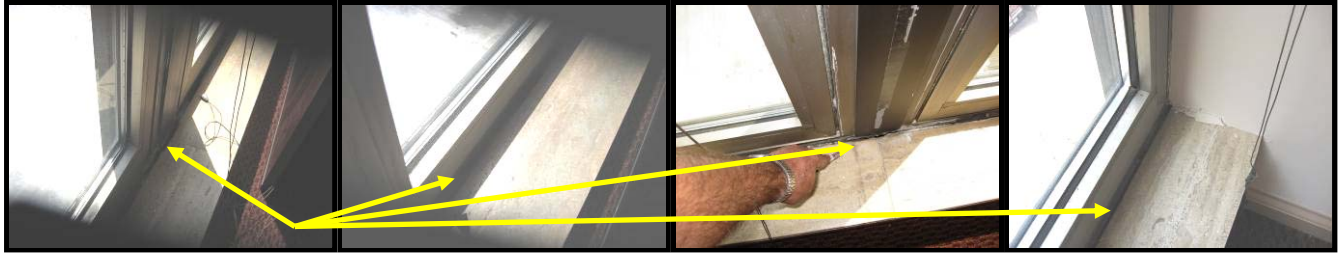
- **Monitor: Repair:** Greater than normal separation was observed between the windows and the marble sills in room numbers 7-D, 7-E, 7-F and 7-G. It is recommended that this condition be further investigated as it may indicate movement of the window frames in these areas.

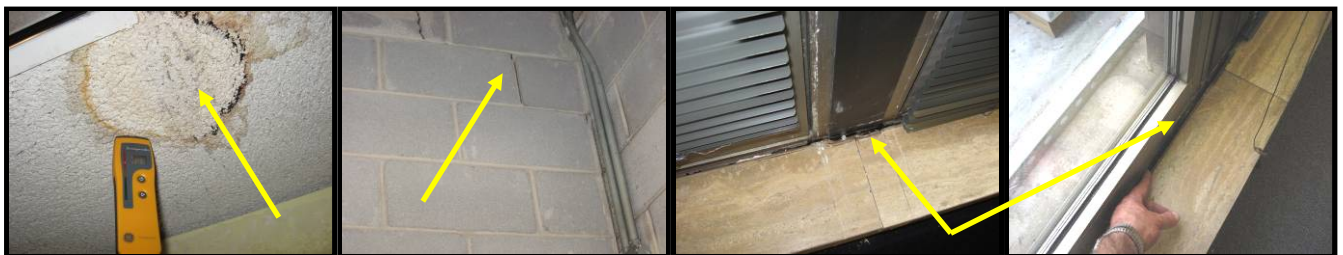
- **Repair:** Moisture staining was observed in the ceiling tiles of the ceiling in room number 5-A. Moisture was present in the stains from a leak in a condensate line. It is recommended that the stained ceiling tiles be replaced.
- **Monitor:** Block cracks were observed in the block walls of the mechanical room of the 5th floor. It is recommended that the cracks be monitored for additional movement.
- **Monitor: Repair:** Greater than normal separation was observed between the windows and the marble sills in room numbers 5-B and 5-K. It is recommended that this condition be further investigated as it may indicate movement of the window frames in these areas.

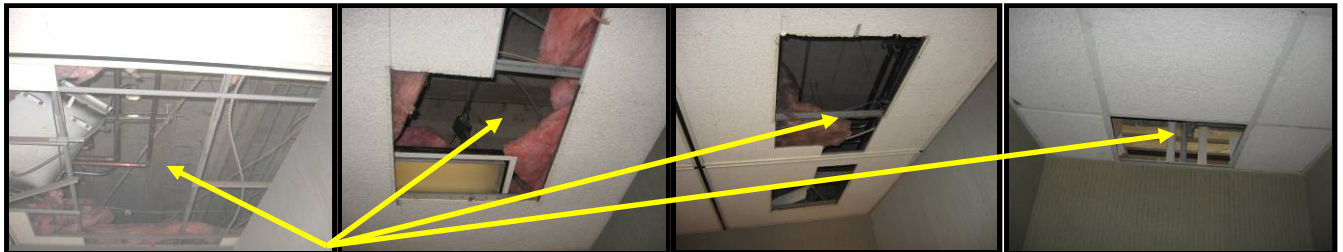
- **Information:** The interior of the fourth floor is in distressed condition and will take extensive interior renovations to bring the floor into proper condition.
- **Repair:** Extensive ceiling cavity work is in progress in several rooms of the 4th floor. Extensive ceiling work will be necessary to bring the ceilings into proper condition after the work is complete.

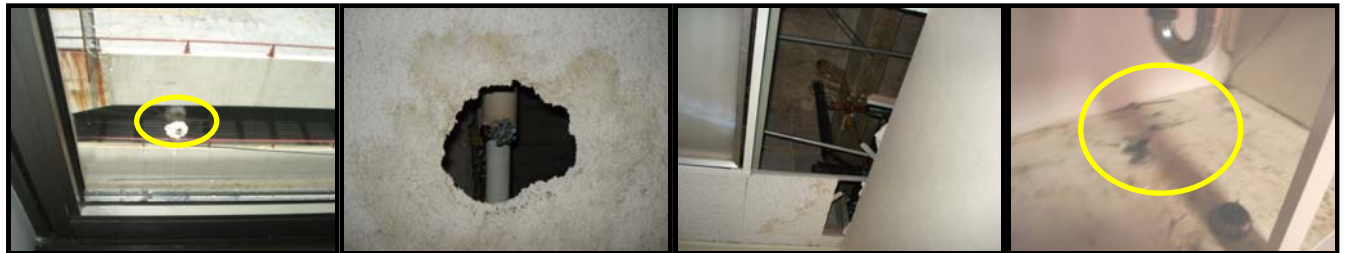
- **Safety Issue: Repair: Information:** There is what appears to be mold under the sink in room S. The presence of certain mold and mold spores in buildings can result in mild to severe health effects in humans. Health effects include, but are not limited to: sinus congestion, blurry vision, sore throat, dry cough, aches and pains, skin irritation, bleeding of the lungs, headaches, memory loss and fever. As humans vary greatly in their chemical make-up, so does the individual's reaction to mold exposure. For some people, a small number of mold spores can cause ill effects; in others, it may take more. It is important that any mold be appropriately cleaned and the source of moisture contributing to the mold growth eliminated.

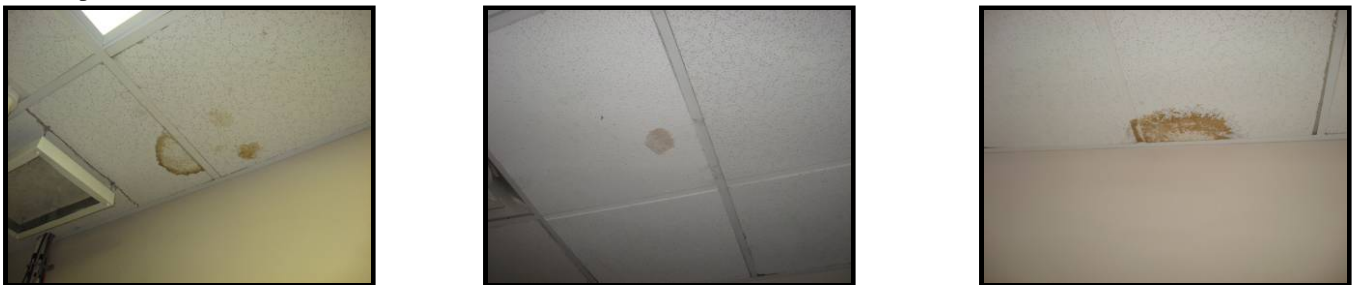
- **Repair:** Moisture staining was observed in room numbers 2-A, 2-E and 2-Z. It is recommended that the stains be properly repaired.

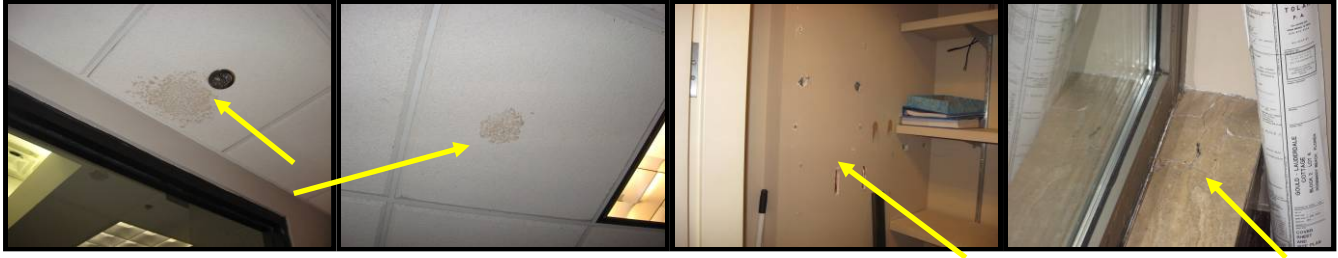
- **Repair:** Moisture staining was observed in room numbers 1-F and 1-GG. No moisture was detected at the time of the inspection. All moisture stains should be properly repaired.
- **Repair:** Drywall damage was observed in room number 1-I (closet). All damaged drywall should be repaired.
- **Repair:** One of the marble window sills is cracked in room number 1-NN.
