Building Inspection Report

[REDACTED] k Lane, Nashville TN 37214
Inspection Date: January 10, 2008

Report Number: ML011008AD

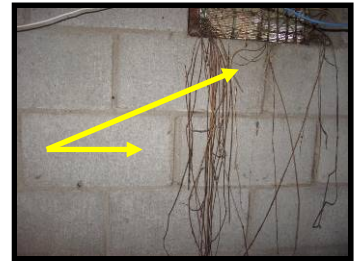
- Monitor:** Common minor settlement cracks were observed in the foundation walls at the left of the front wall of the crawl space. This implies that some structural movement of the building has occurred. Cracks of this type should be watched for any sign of additional movement. In the absence of any sign of ongoing movement, repair should not be necessary. If these cracks should worsen or a more in-depth evaluation is desired, a structural engineer who is familiar with foundation repair or qualified foundation repair contractor should be consulted.

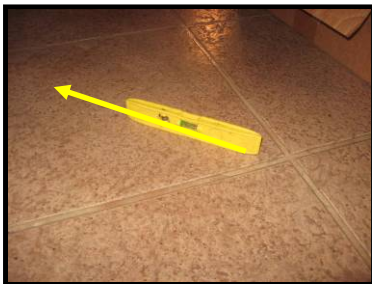
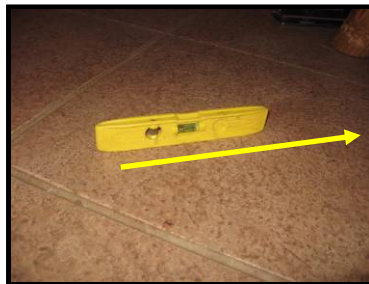
- Repair:** Soft places were observed in the sub floor of the unfinished master bathroom. This condition should be addressed when preparations are made to complete the bathroom.

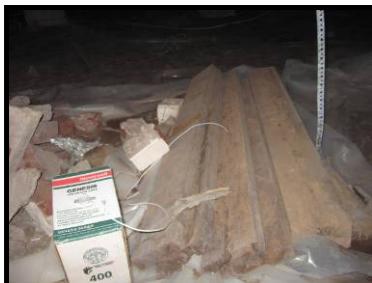
- **Improve:** All wood debris and/or trash should be removed from the crawl space. Such debris tends to attract termites and organic debris around a property increases risk of insect or rot damage to your home.

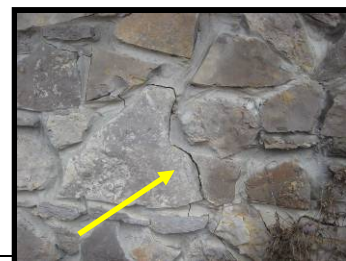
- **Improve:** Cracked mortar joints were observed in the stone walls of the pool pump house that should be sealed to prevent moisture intrusion and additional cracking.

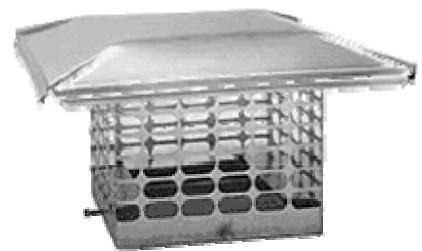
- **Information:** Standard caps are made from a number of materials including steel, stainless steel, copper or aluminum. The most popular styles are stainless steel and black painted steel. Most models feature side screening which keeps most birds and small animals out of the chimney and also keeps larger sparks from exiting the chimney. These caps are mounted onto the chimney in various ways, the most popular being screws which are spaced around the base angle of the cap and tightened against the flue tile. If the chimney is unlined or the flue does not protrude far enough out the top, inside mounting models can be used. If neither of these methods work manufacturers also provide mounting angles or other fasteners which can be lag bolted or cemented down to the top of the chimney structure. Stainless Steel is a preferable material since it can better handle constant exposure to rain, wind, smoke and the other nasty conditions on top of your chimney. It also is less susceptible to rust, which will reduce the chance of getting stains on your chimney from cap runoff.

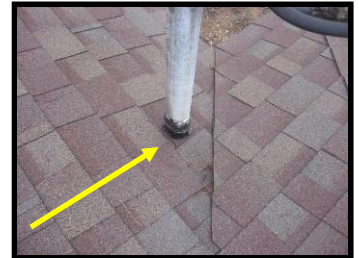
- **Major Concern: Repair:** The roof of the pool pump house is in very poor condition and should be replaced.
- **Repair:** There is no rubber boot on the service entrance mast at the front of the house. It is recommended that the proper rubber boot be replaced to prevent moisture intrusion.

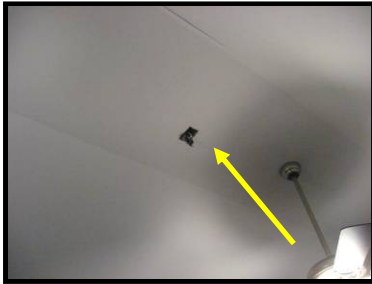
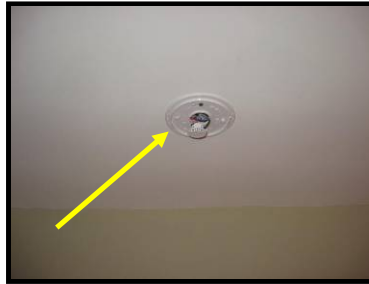
- **Repair:** The outlet in the ceiling of the back bonus room is loose and uncovered and should be repaired.
- **Improve:** The ceiling fan in the left front bedroom did not operate when tested and should be repaired.
- **Safety Issue: Repair:** The smoke alarm in the front middle bedroom is missing and should be replaced.
- **Safety Issue: Improve:** Since 1971 it has been a standard building practice for bathroom and exterior outlets to be GFCI protected. The exterior outlets are not protected as required.

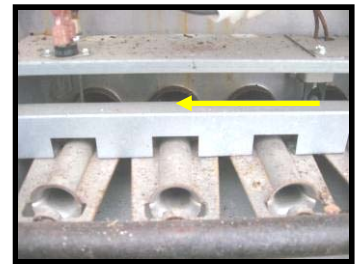
- **Improve: Safety Issue:** The HVAC package unit was observed to be rusty in the burner chamber of the unit. While this may not affect the functionality of the system, it is recommended that the heat exchanger and all other components be checked by a qualified service contractor to insure safe and efficient operation.
- **Information:** When operated in the heating mode of operation the Gibson gas package unit produced a temperature of 113 degrees and brought the ambient temperature to 62 degrees. This temperature differential indicated adequate performance.

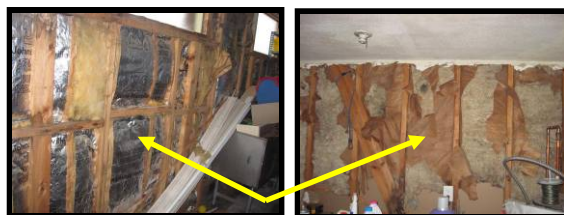
- **Improve:** It is recommended that additional soffit vents be added to the front of the house to improve attic ventilation.
- **Improve:** The insulation in the garage room is in poor condition and should be replaced during renovations.

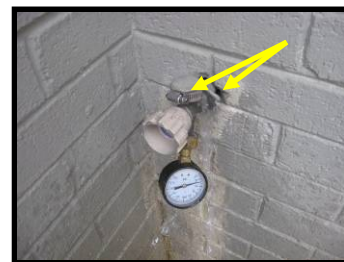
- **Repair:** The hose bibs (exterior faucets) are not properly secured to the building. The collar should be securely fastened into the brick or substrate by a mechanical means.
- **Repair:** The hose bib at the front of the house is leaky and should be repaired or replaced
- **Information: Improve:** The plumbing in the unfinished master bathroom is incomplete. This includes the drain and waste lines and the water supply lines. A considerable amount of work will be required to rough the plumbing in so the renovation process can be completed.
- **Repair:** The sink in the hall bathroom has been moved with the intention of moving the plumbing. (The sink does not work at this time) It is recommended that a licensed plumber be engaged to give estimates on the appropriate course of action to be taken to repair the hall bathroom sink and rough in the master bathroom.

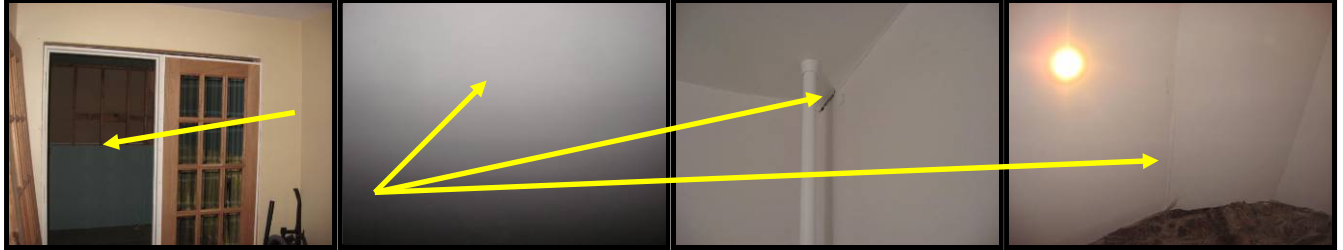
- **Improve:** The master bathroom is completely unfinished and a considerable investment will be required to complete the project.
- **Improve:** There are several small ceiling cracks and other blemishes commonly associated with the “settling” common in most homes. There is some shrinkage which occurs in the framing of the home which gives rise to these types of imperfections. Some of these cracks could be attributed to poor drywall finishing practices. Almost all of these problems are not structurally significant and can be repaired easily with drywall joint tape and compound

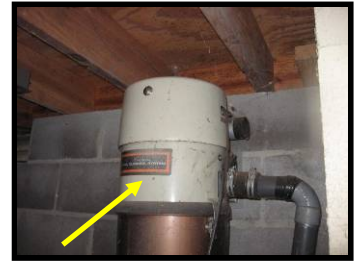
- **Information:** There is a whole house Vacuum system in the back crawl space that is not in use and was not tested. It appears that the system is completely unhooked.

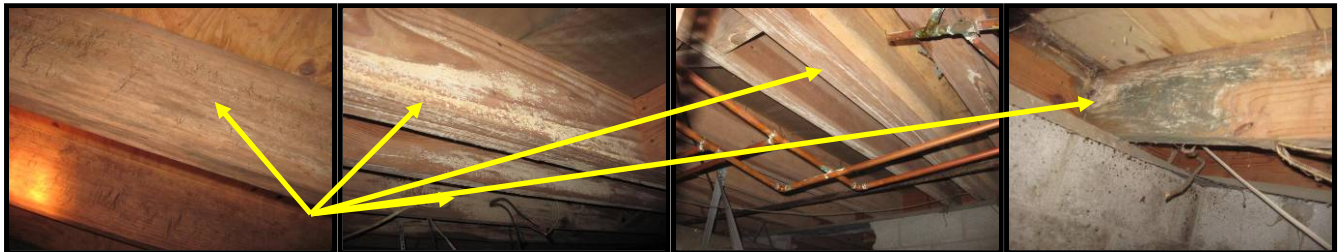
- **Information: Safety Issue: Improve:** A mold type growth is visible on most of the floor joists in the crawl space. The level of mold growth is moderate to high. *The presence of certain mold and mold spores in housing can result in mild to severe health effects in humans and pets and can deteriorate the structure of the dwelling resulting in structural damage. Health effects include, but are not limited to: sinus congestion, blurry vision, sore throat, dry cough, aches and pains, skin irritation, bleeding of the lungs, headaches, memory loss and fever. As humans vary greatly in their chemical make-up, so does the individual's reaction to mold exposure. For some people, a small number of mold spores can cause ill effects. In others it may take more.* Because mold can adversely affect your health and the amount of mold type growth present is significant, it is BJK's Company policy to recommend that a sample be taken and sent to the laboratory to determine the type(s) of mold that are present to help determine the proper course of action to be taken. Because of the amount of mold type growth present it is recommended that a professional be engaged to mitigate the mold.

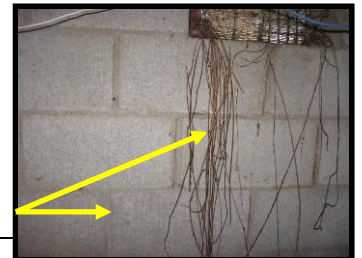
- **Monitor:** Common minor settlement cracks were observed in the foundation walls at the left of the front wall of the crawl space. This implies that some structural movement of the building has occurred. Cracks of this type should be watched for any sign of additional movement. In the absence of any sign of ongoing movement, repair should not be necessary. If these cracks should worsen or a more in-depth evaluation is desired, a

structural engineer who is familiar with foundation repair or qualified foundation repair contractor should be consulted.

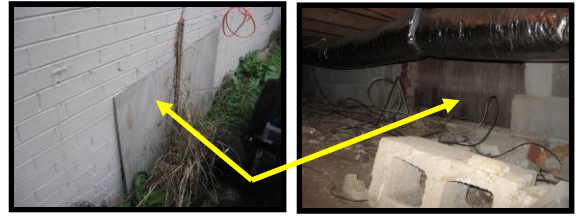
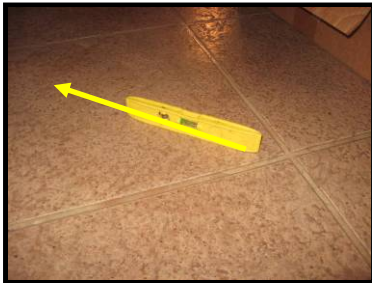
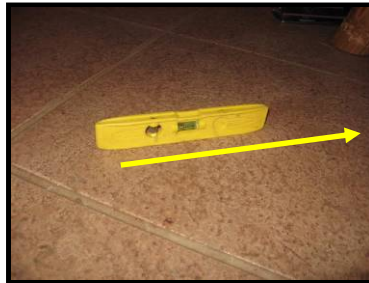
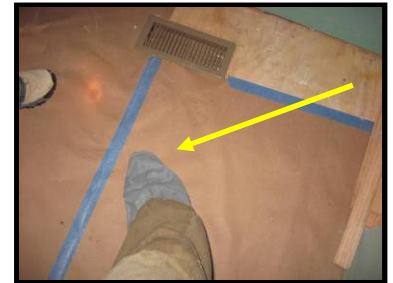
- **Repair:** A portion of the foundation and exterior brick wall has been removed to accommodate the ducts of a Package HVAC unit at the left side of the back addition. Since an HVAC unit is no longer in use in that location the foundation and brick wall should be restored.
- **Monitor:** The floor structure shows common sagging and movement particularly in the dining room area. This is usually the result of the age and framing design of the building. There was not evidence of need for immediate repair. If additional movement should take place or a more in-depth evaluation is desired, a structural engineer should be consulted.
- **Repair:** Soft places were observed in the sub floor of the unfinished master bathroom. This condition should be addressed when preparations are made to complete the bathroom.

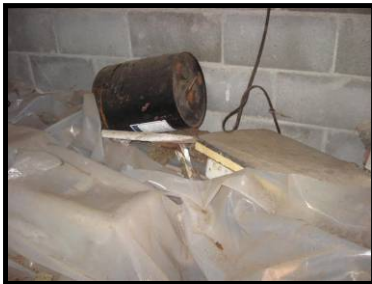
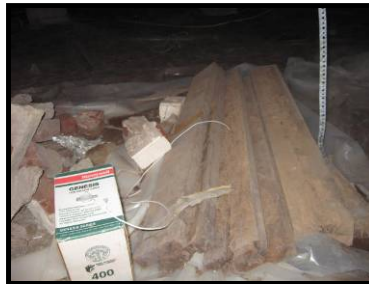
- **Improve:** All wood debris and/or trash should be removed from the crawl space. Such debris tends to attract termites and organic debris around a property increases risk of insect or rot damage to your home.

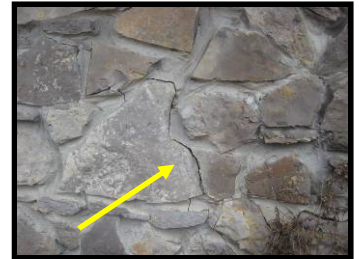
- **Improve:** Cracked mortar joints were observed in the stone walls of the pool pump house that should be sealed to prevent moisture intrusion and additional cracking.

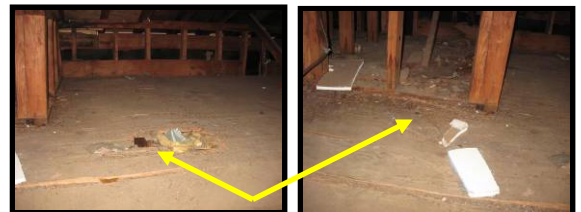
- **Improve:** Some of the plywood floor decking over the garage room is moisture damaged and should be replaced. The source of moisture appears to have been repaired.

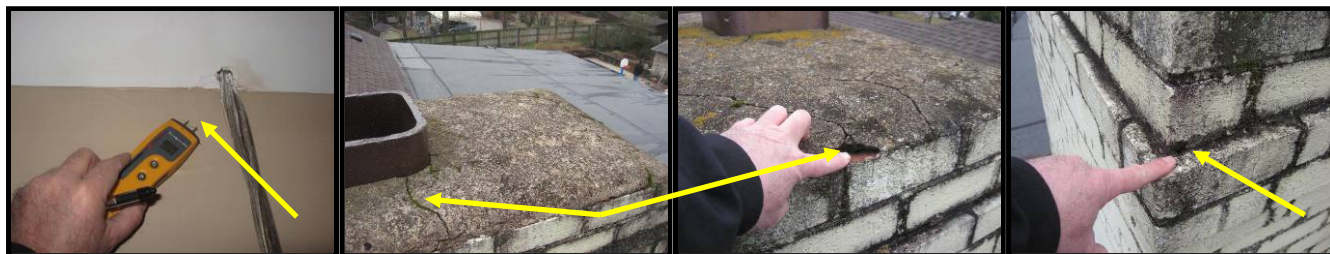
- **Monitor: Repair:** Moisture and moisture damage was observed at the right ceiling and wall by the fireplace (from facing the fireplace). It is recommended that the chimney and flashing be examined to attempt to determine the source of the moisture. It is recommended that repairs be made by a licensed roofing contractor.
- **Repair:** The masonry chimney cap has some cracks in the concrete which need to be sealed with roofing cement or other appropriate sealant to prevent moisture penetration. Moisture penetration will eventually cause damage to the brickwork and structure if not kept sealed.
- **Repair:** The masonry chimney needs re-pointing in places (replacing the mortar between the bricks) to avoid water damage.

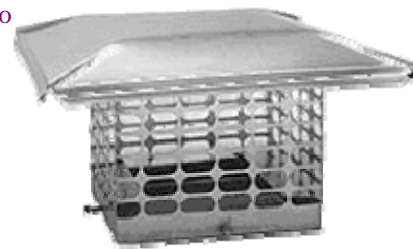
- Information:** Standard caps are made from a number of materials including steel, stainless steel, copper or aluminum. The most popular styles are stainless steel and black painted steel. Most models feature side screening which keeps most birds and small animals out of the chimney and also keeps larger sparks from exiting the chimney. These caps are mounted onto the chimney in various ways, the most popular being screws which are spaced around the base angle of the cap and tightened against the flue tile. If the chimney is unlined or the flue does not protrude far enough out the top, inside mounting models can be used. If neither of these methods work manufacturers also provide mounting angles or other fasteners which can be lag bolted or cemented down to the top of the chimney structure. Stainless Steel is a preferable material since it can better handle constant exposure to rain, wind, smoke and the other nasty conditions on top of your chimney. It also is less susceptible to rust, which will reduce the chance of getting stains on your chimney from cap runoff.

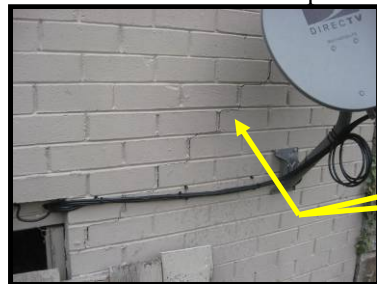
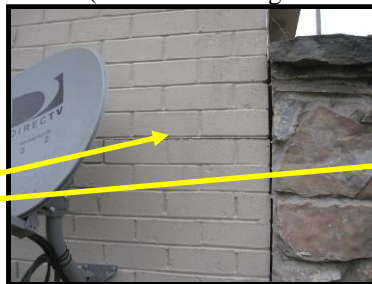
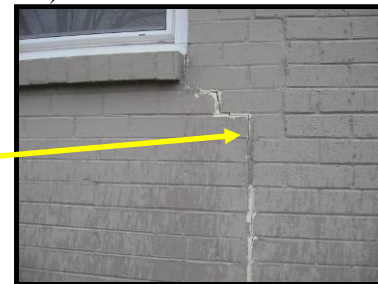
- **Repair:** There were a few minor cracks or deteriorated mortar joints in the brick veneer of the home at the back left corner addition wall and where the garage doors have been bricked in. This is fairly common and not considered to be structurally significant. Obviously, these cracks should be sealed with caulk or mortar to keep out moisture and monitored for changes in character such as widening or displacement. Minor settlement in areas of the foundation walls where too much rain water flows from downspouts is often the cause. (Also see Roofing Section re: downspouts)

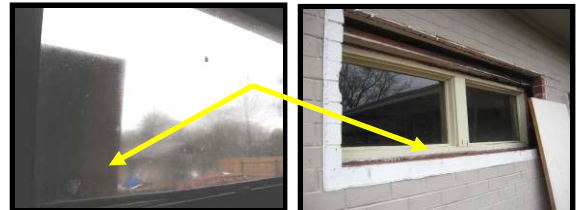
- **Repair:** The back windows of the garage room are single pane, in poor condition and all of the exterior trim has been removed. It is recommended that the windows be repaired or replaced.
- **Repair:** The wood trim around exterior of the home has reached the point where painting maintenance is required. Exterior wood trim on windows, dormers, chimneys, porch railings and columns, etc., must be kept well painted to prevent decay. Proper preparation including scraping, sanding and painting with a good quality paint will protect the wood and your investment.
- **Improve:** The final grading at the front of the house should be improved to proper run water away from the foundation.

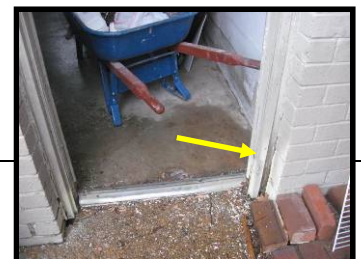
- **Repair:** Localized wood rot was observed in the wood jam of the garage pedestrian door at the back of the house. Additionally the door itself is damaged. It is recommended that the entire door assembly be replaced.

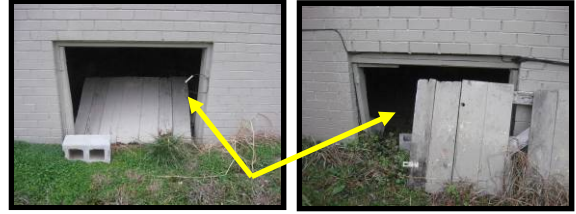
- **Repair:** Both of the crawl space doors at the exterior of the house are damaged and should be replaced.

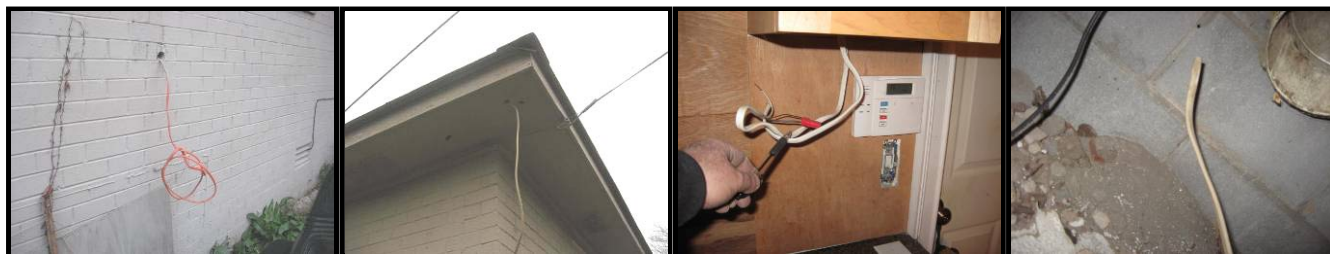
- **Repair: Safety Issue:** There are improperly terminated wires in the in the kitchen, attic and crawl space and at the exterior of the house. All wires are required to be terminated within an approved box fitted with a cover or and approved fixture.
- **Safety Issue: Improve:** All wire splices are required to be contained within appropriate boxes and fitted with covers. There are several inline splice in the attic, crawl space and under the kitchen sink which should be corrected.
- **Repair:** All junction boxes should be fitted with cover plates, in order to protect the wire connections.
- **Repair:** Damaged wiring should be replaced or appropriately repaired.

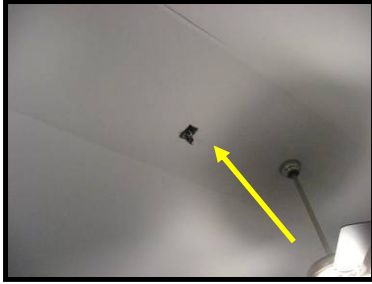
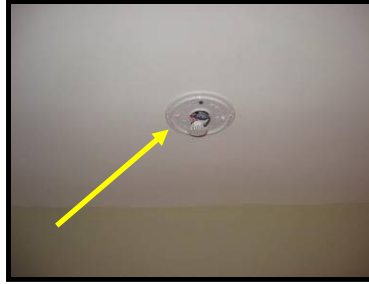
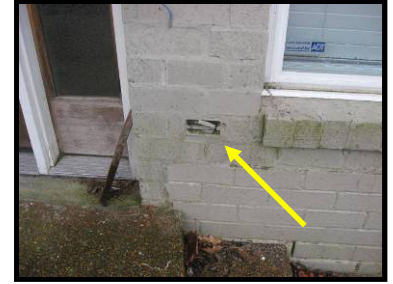
- **Repair:** The outlet in the ceiling of the back bonus room is loose and uncovered and should be repaired.
- **Improve:** The ceiling fan in the left front bedroom did not operate when tested and should be repaired.
- **Safety Issue: Repair:** The smoke alarm in the front middle bedroom is missing and should be replaced.
- **Safety Issue: Improve:** Since 1971 it has been a standard building practice for bathroom and exterior outlets to be GFCI protected. The exterior outlets are not protected as required.

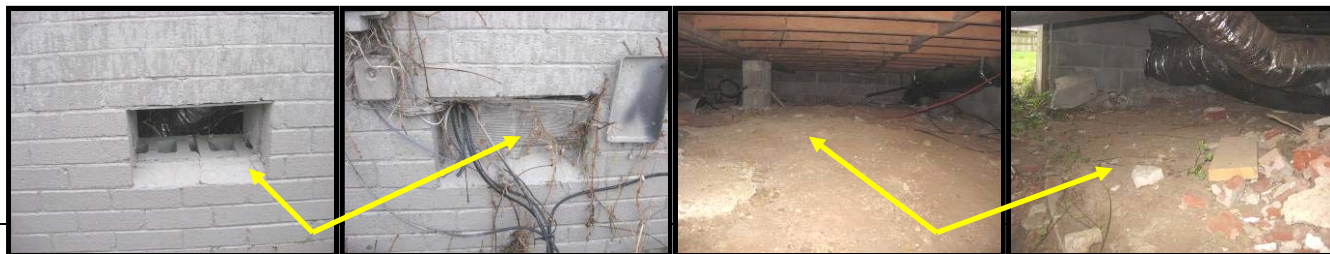
- **Repair:** Some of the crawl space vents are missing and others are in poor condition. It is recommended that all of the crawl space vents be replaced.
- **Improve:** A moisture (vapor) barrier should be installed on the crawl space floors in the additions of the house. Such barriers help to keep down the levels of moisture in the crawl space areas.

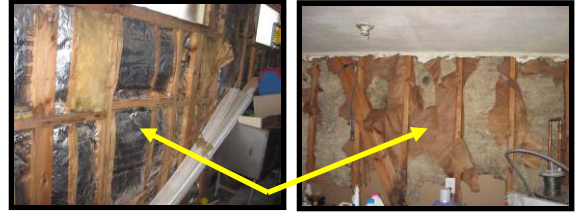
- **Improve:** It is recommended that additional soffit vents be added to the front of the house to improve attic ventilation.
- **Improve:** The insulation in the garage room is in poor condition and should be replaced during renovations.

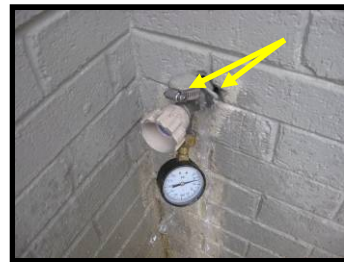
- **Repair:** The hose bibs (exterior faucets) are not properly secured to the building. The collar should be securely fastened into the brick or substrate by a mechanical means.
- **Repair:** The hose bib at the front of the house is leaky and should be repaired or replaced
- **Information: Improve:** The plumbing in the unfinished master bathroom is incomplete. This includes the drain and waste lines and the water supply lines. A considerable amount of work will be required to rough the plumbing in so the renovation process can be completed.
- **Repair:** The sink in the hall bathroom has been moved with the intention of moving the plumbing. (The sink does not work at this time) It is recommended that a licensed plumber be engaged to give estimates on the appropriate course of action to be taken to repair the hall bathroom sink and rough in the master bathroom.

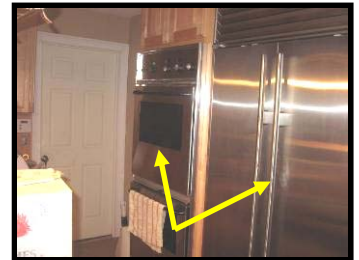
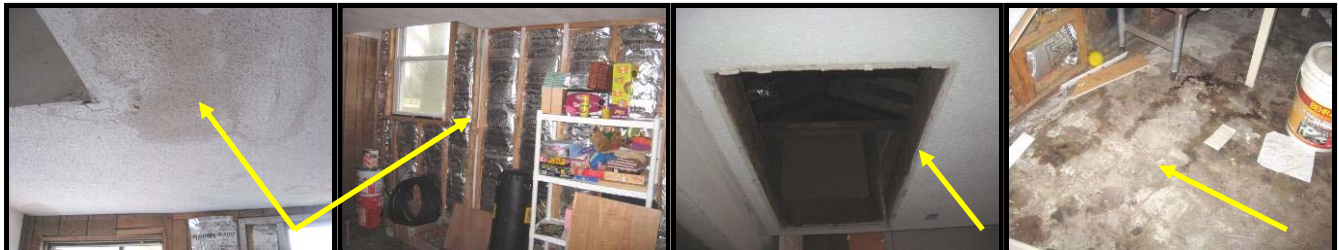
- **Repair:** A proper attic access should be installed.
- **Information:** There are stains in the ceiling of the garage room. The stains were tested for moisture and found to be dry at the time of the inspection. To prevent the stain from coming through your next paint job it is recommended that the stain be first painted with "Kills," "Bentz," or lacquer. The drywall in this area may have to be replaced.

- **Monitor:** Moisture stains were observed on the concrete floor of the garage room. This may indicate that water is entering the room from outside. This condition should be monitored and taken into consideration when renovating.

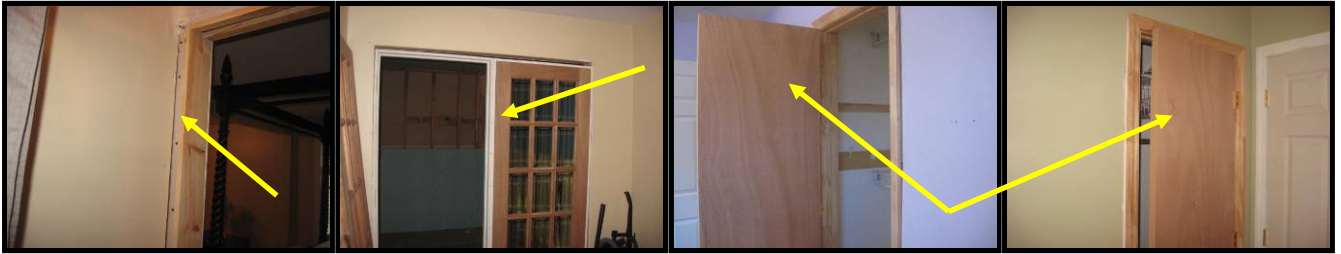
- **Improve:** Several of the closet and bathroom doors of the house are unfinished. All doors should be properly installed and finished.

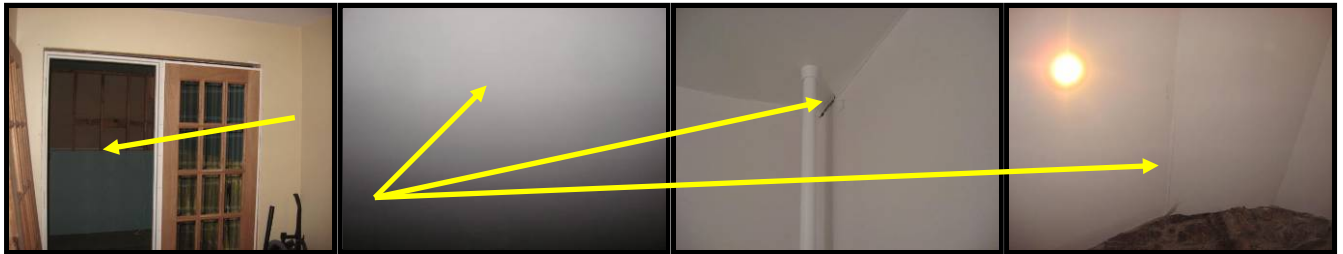
- **Improve:** The master bathroom is completely unfinished and a considerable investment will be required to complete the project.
- **Improve:** There are several small ceiling cracks and other blemishes commonly associated with the “settling” common in most homes. There is some shrinkage which occurs in the framing of the home which gives rise to these types of imperfections. Some of these cracks could be attributed to poor drywall finishing practices. Almost all of these problems are not structurally significant and can be repaired easily with drywall joint tape and compound

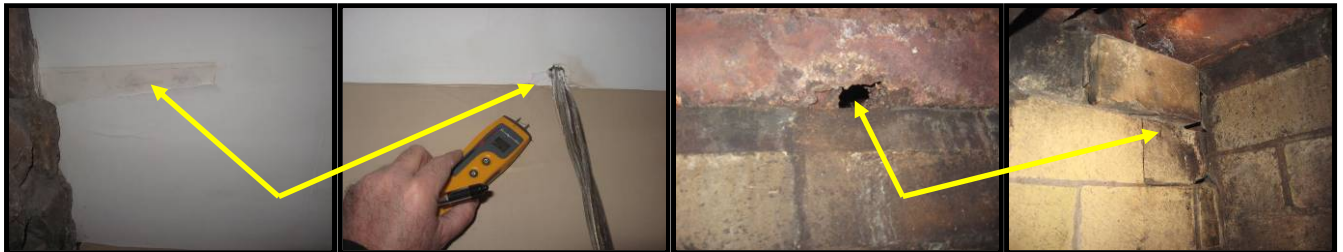
- **Repair:** Moisture damage was observed at the ceiling over the chimney and the wall at the right side of the chimney. Moisture was detected when tested. When the source of moisture is repaired the damage should be able to be repaired with drywall tape and compound.
- **Repair:** The metal damper in the fireplace in the family room is rusted and damaged and should be repaired.
- **Repair:** There are loose firebricks and cracks in the firebox of the fireplace in the family room. It is recommended that the fireplace and chimney be cleaned and examined by a certified chimney sweep and repaired to ensure safe operation.

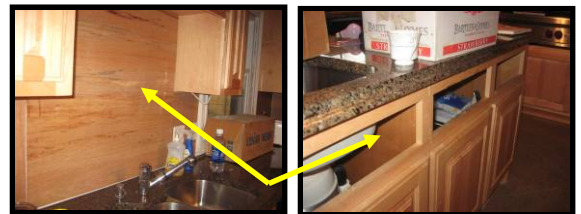
- **Repair: Safety Issue:** There is a gap between the stone front of the fireplace and the hearth. It is recommended that the gap be filled.
- **Improve:** The kitchen is unfinished particularly the wall behind the counter and some of the cabinet fronts of the island. It is recommended that the kitchen be properly completed.

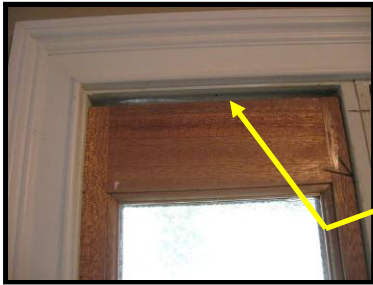
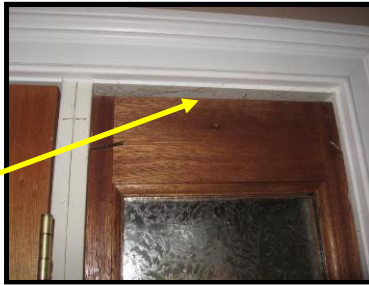
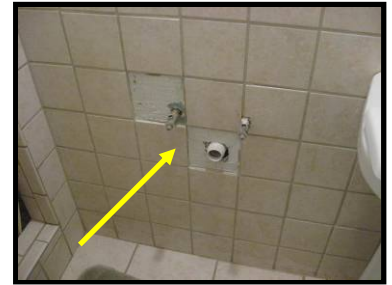
- **Repair:** The side glass panels of the front door are loose in the frame and there is a considerable gap at the top of the door jam. It is recommended that the front door be properly repaired.
- **Repair:** The tiles on the wall behind the sink in the hall bathroom will have to be replaced when the plumbing is moved.

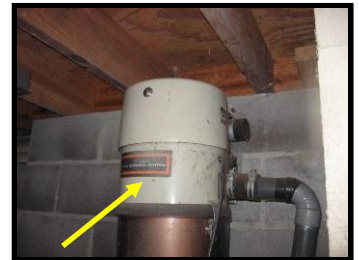
- **Information:** There is a whole house Vacuum system in the back crawl space that is not in use and was not tested. It appears that the system is completely unhooked.
