# Building Inspection Report

[REDACTED] Rd., Brentwood TN 37027

Inspection Date: February 19, 2007

Report Number: RN021907PD

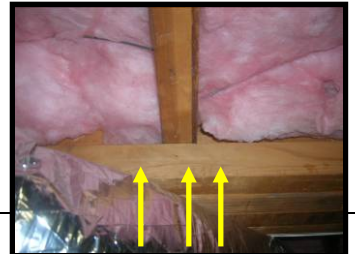
- Information: Repair:** Floors are generally framed with solid-sawn lumber, floor trusses, or wood I-joists. Joist end-bearing should not be less than 1-1/2" on wood or metal, or 3" on masonry. Joists should be attached to the girders or beams by means of joist hangers, or toe-nailed into girders with a ledger. Face nailing alone is not sufficient to carry the load of the floor joist and it is required that 3- 16D penny nails be installed under each floor joist through the ledger. The ledger boards

installed under the floor joists in the crawl space were not properly nailed with 3 - 16D penny nails under each joist as required. This condition should be corrected.

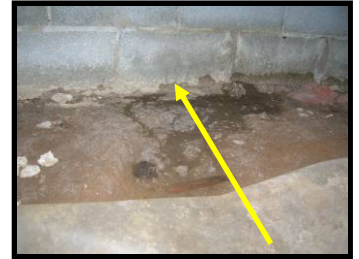
- **Improve:** Moisture was observed on the crawl space floor. It is recommended that lot and gutter drainage issues be addressed to help maintain a dry crawl space. (See roofing section)

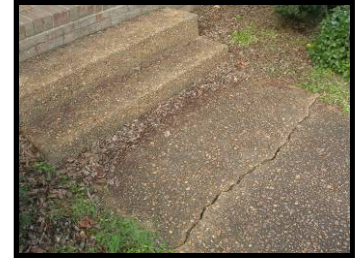
- **Safety Issue: Improve:** The steps leading to the front porch have settled into the ground significantly resulting in a rather large rise 11 inch between the top step and the porch surface. Generally, the maximum height distance between steps should be no greater than 7 3/4." This is likely caused by poor site preparation and inadequate footing support under this section of concrete. It may be possible to raise this back to near original position by a process called concrete leveling, where stone "slag" is pumped under the step section which lifts the concrete up where needed. A-1 Concrete Leveling can be reached at 931-840-9451 or at [www.a1concrete.com](http://www.a1concrete.com) for more information.

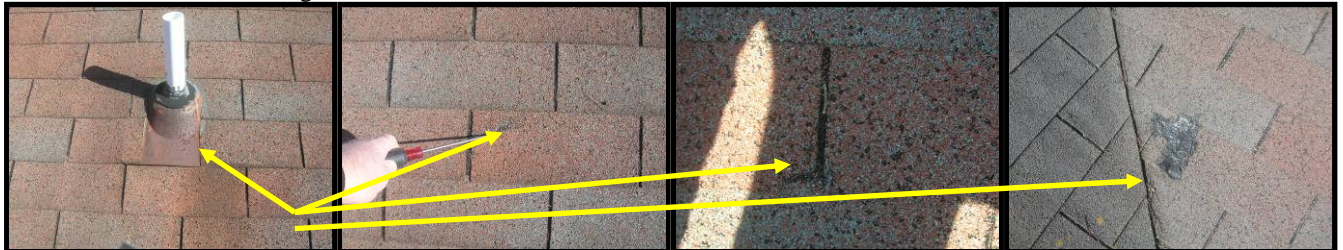
- **Repair:** The roof shingles are 15 years old and have reached the end of their useful life. There are a number of damaged or broken shingle tabs and the plumbing vent boots appear to be deteriorating. It is recommended that it be replaced. It is also recommended that the roof be stripped before installing a new roof surface which will help locate any damaged or deteriorated roof decking.

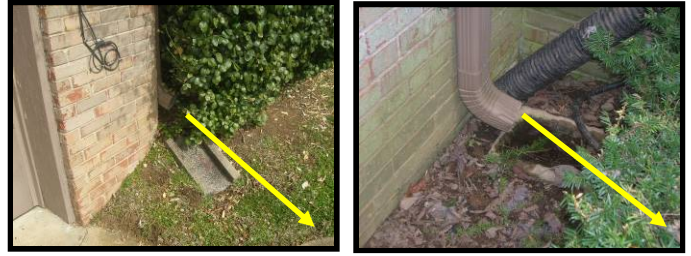
**Improve:** It is important to divert water away from the foundation of the home with a gutter and downspout system that is kept clean and in good repair. It is recommended that all downspouts be extended with plastic diverter tubes to channel water at least 4 to 5 feet away from the building. This is important for helping to maintain a dry crawl space. Downspouts which discharge onto cement should have splash blocks beneath them.

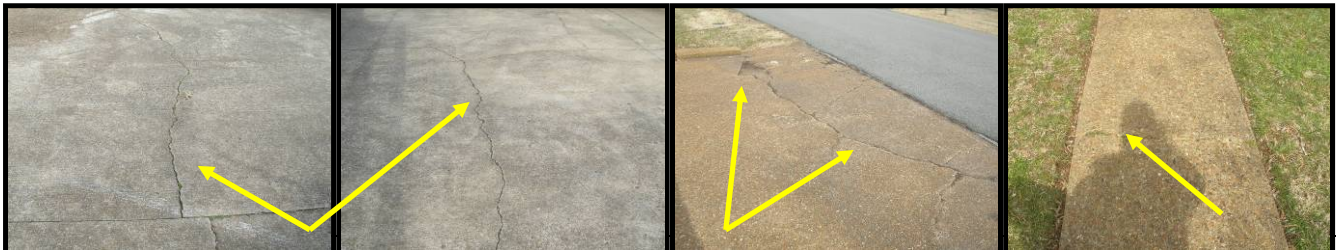
- **Repair:** There are several settlement cracks in the cement driveway and sidewalks. It is recommended that they be filled to prevent moisture from entering and eroding the surface beneath the cement which will lead to additional cracking. Sonneborn and Trimco make some excellent long lasting products to help seal such cracks. Exterior Materials, 665 Wedgewood Ave. Nashville, TN (near the State Fair Grounds) carries Sonneborn and Trimco products. The drive entrance is severely deteriorated and cracked and may have to be replaced.

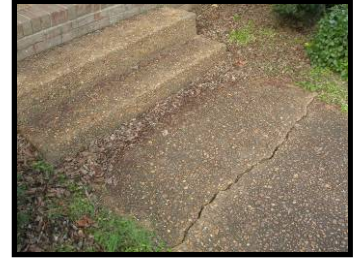
- **Safety Issue: Improve:** The steps leading to the front porch have settled into the ground significantly resulting in a rather large rise 11 inch between the top step and the porch surface. Generally, the maximum height distance between steps should be no greater than 7 ¾." This is likely caused by poor site preparation and inadequate footing support under this section of concrete. It may be possible to raise this back to near original position by a process called concrete leveling, where stone "slag" is pumped under the step section which lifts the concrete up where needed. A-1 Concrete Leveling can be reached at 931-840-9451 or at [www.a1concrete.com](http://www.a1concrete.com) for more information.

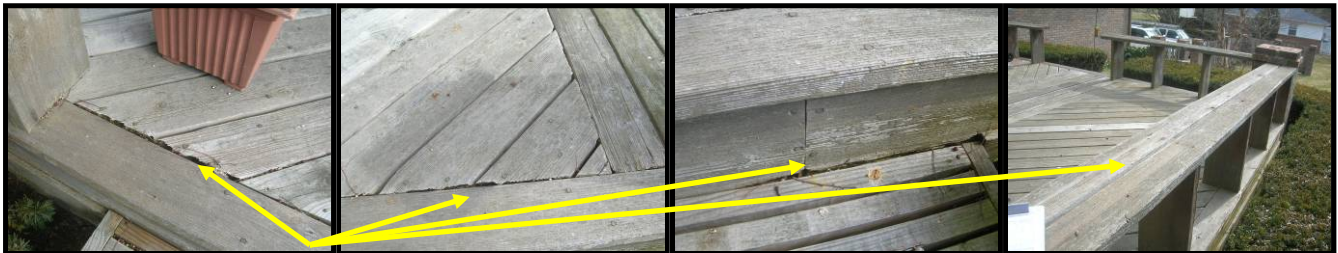
- **Repair:** The decking boards of the back deck are deteriorated in several places. It is recommended that all deteriorated decking boards be properly replaced.
- **Repair:** The ledger board at the back of the deck is deteriorated (by the back steps) and should be properly repaired.
- **Improve:** The back deck is at the point of needing to be stained to prevent moisture intrusion and further deterioration.
- **Information:** It should be noted that the bottom structural components of the back deck were inaccessible due to the brick foundation wall at its exterior. There may be additional damage that was not observable at the time of this inspection.

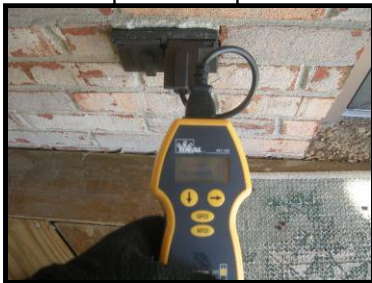
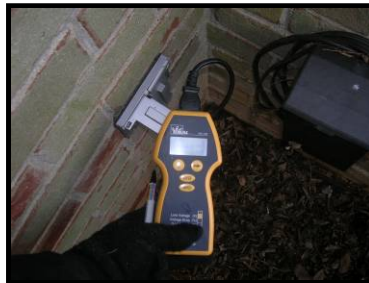
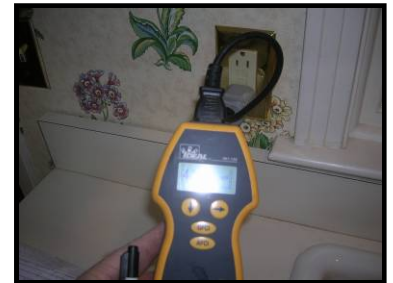
- **Safety Issue: Improve:** Since 1971 it has been a standard building practice for bathroom and exterior outlets to be GFCI protected. The exterior outlets are not protected as required.
- **Safety Issue: Improve:** Since 1975 it has been a standard building practice to have garage outlets be GFCI protected. The garage outlets are not so protected as required.
- **Repair: Safety Issue:** The ground fault circuit interrupter (GFCI) outlet in the kitchen did not trip when the test button was depressed or when a fault was placed on the line. The outlet is either defective or improperly wired. The outlet should be repaired or replaced as necessary.

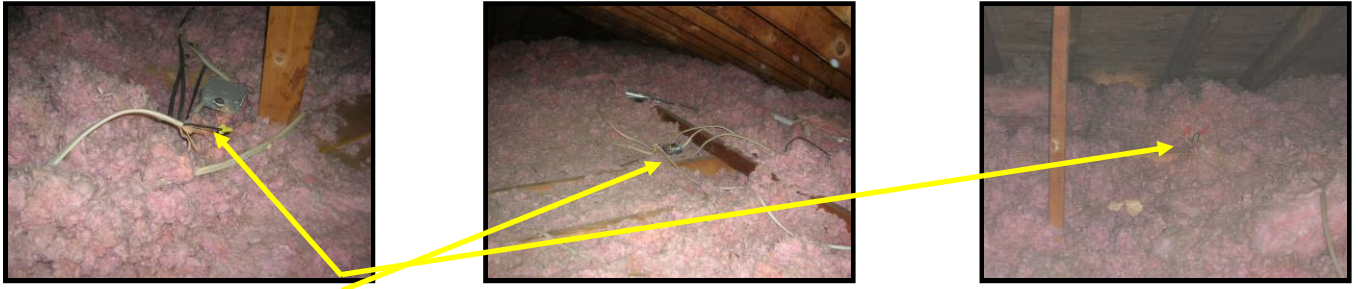
- **Repair: Safety Issue:** There are improperly terminated wires in the attic that should be repaired. All wires are required to be terminated within an approved box fitted with a cover and approved fixture.
- **Repair:** There are open junction boxes in the crawl space. All junction boxes should be fitted with cover plates, in order to protect the wire connections.

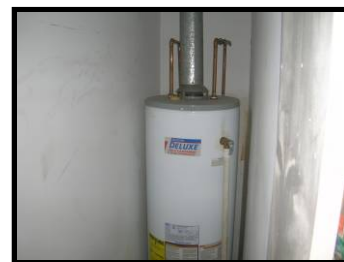
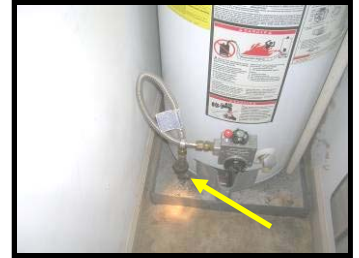
- **Repair, Safety Issue: Information:** In houses which are built extremely tight (for energy conservation), ALL flame-heating systems should use outside combustion air. This includes the conventional house furnaces and water heaters. What this means is that the fire will use air that came from outdoors rather than air which came from inside the house, which used to be the common procedure. In super-tight new houses, using house air doesn't work, because in order to use up some house air (and make it go up the chimney), OTHER, OUTSIDE air would have to get into the house to replace it. And the tight construction doesn't allow enough air leakage in to do this. The net effect could be that smoke wouldn't go UP the chimney, and if somebody turns on a bathroom ventilator or a kitchen exhaust fan, smoke may actually come back DOWN the chimney to replace THAT air that was leaving the house! There is no outside source of combustion air for the gas water heater located the back of the first floor closet. **This is unsafe and needs immediate action** An adequate supply of combustion air is necessary for all fuel-burning appliances. Most appliances vent by gravity (their flue gasses are lighter than the air in the environment where combustion takes place) so they naturally rise up a flue. Open draft hoods allow the intake of additional air to dilute the flue gasses. Air is also needed to vent and cool the appliances themselves. Three functions are then included in the topic of combustion air. They are air for combustion, dilution and ventilation. About 10 cubic feet of air is needed for combustion of one cubic foot of natural gas, in addition to the air needed for dilution and ventilation. The products of natural gas (methane) combustion are carbon dioxide and water vapor. An inadequate supply of combustion air can be very hazardous. If there is insufficient oxygen to fully burn the fuel at the correct temperature, deadly carbon monoxide will also be a

product of combustion. If the air pressure in the appliance space is lower than that in the flue pipe, products of combustion might “spill” out of a draft hood and enter the interior environment. As houses are built tighter and to higher energy-efficient standards, the building interiors do not have enough infiltration of fresh air to supply our combustion air, and an external source of supply becomes necessary. It is recommended that two openings, one within the upper 12 inches and one within the lower 12” of the room, to a source of exterior air be installed. Additional combustion air can usually be provided without difficulty or expense.

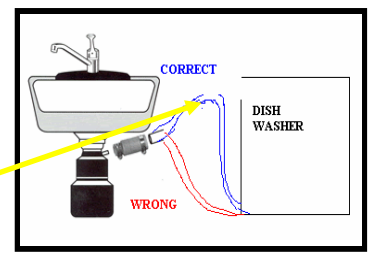
- **Improve:** The drain, from the dishwasher which connects to the drain under the kitchen sink, needs to be modified. Presently the drain rises up from the dishwasher to the drain. It needs to be re-routed to first run up above the drain and then downward to the drain. This rise is necessary to prevent water draining from the sink from backing up into the dishwasher.

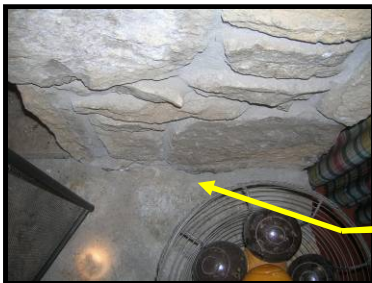
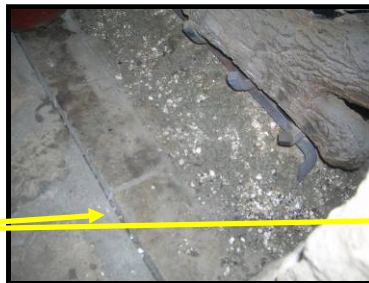
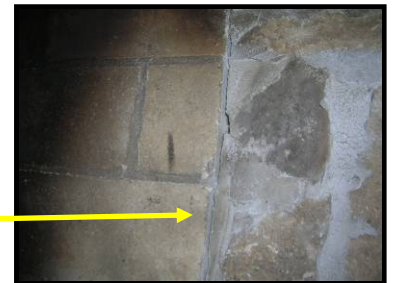
- **Repair: Safety Issue:** The fireplace in the back family room has cracks between the firebox and the stone face. There is also a crack between the hearth and the stone face and firebox. It is recommended that the chimney and fireplace be cleaned and inspected by a certified chimney sweep. It is additionally recommended that the fireplace be properly repaired to ensure safe operation. It is recommended that the fireplace not be used until the proper repairs are made.

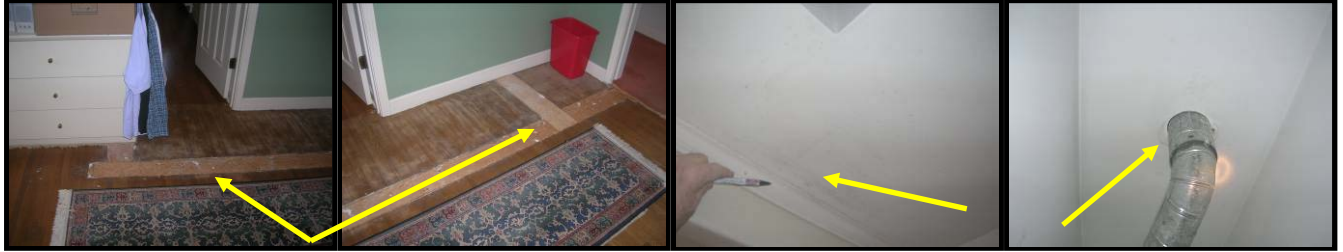
- **Repair:** Moisture stains were observed on the ceiling by the water heater vent. It is recommended that the roof flashing be checked and repaired and the ceiling properly repaired.
