# Building Inspection Report

██████████ en Ave., Nashville TN 37212

Inspection Date: January 18, 2008

Report Number: TW011808PT

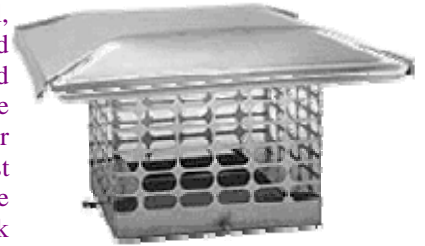
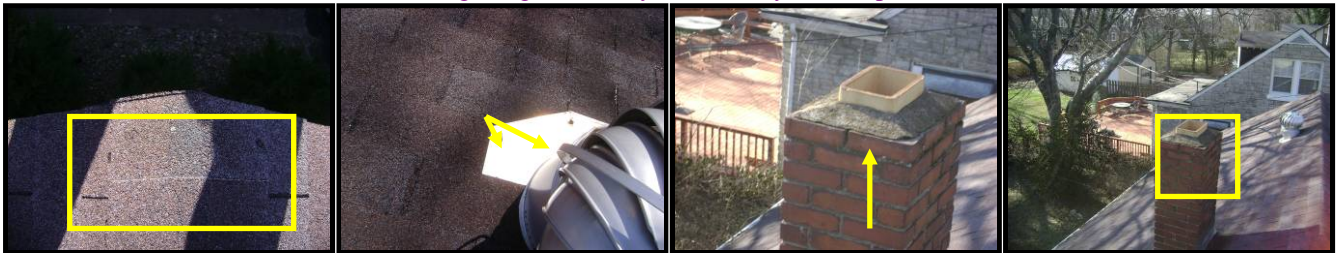
- **Repair:** The masonry chimney cap has some cracks in the concrete which need to be sealed with roofing cement or other appropriate sealant to prevent moisture penetration. Moisture penetration will eventually cause damage to the brickwork and structure if not kept sealed.

- **Improve:** It is important to divert water away from the foundation of the home with a gutter and downspout system that is kept clean and in good repair. It is recommended that all downspouts be extended with plastic diverter tubes to channel water at least 4 to 5 feet away from the building. This is important for helping to maintain a dry crawl space. Downspouts which discharge onto cement should have splash blocks beneath them.

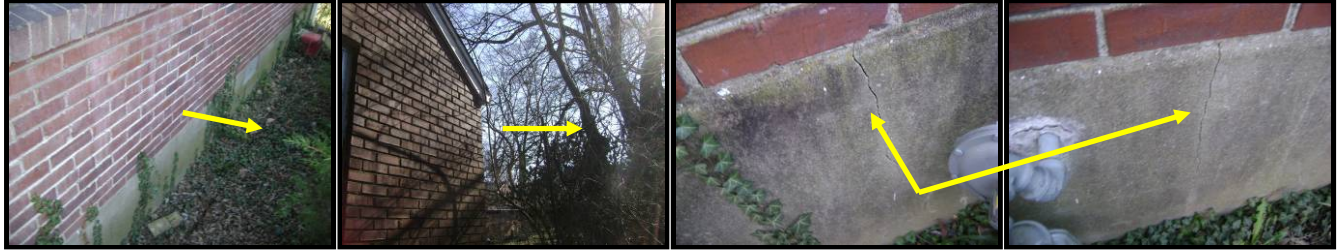
- **Repair:** There is some damaged brickwork at the back left corner of the house. Damaged or missing bricks should be properly installed to preserve the integrity of the wall and to keep out moisture, insects and other "critters."
- **Repair:** There were a few minor cracks or deteriorated mortar joints in the brick veneer of the home. This is fairly common and not considered to be structurally significant. Obviously, these cracks should be sealed with caulk or mortar to keep out moisture and monitored for changes in character such as widening or displacement.

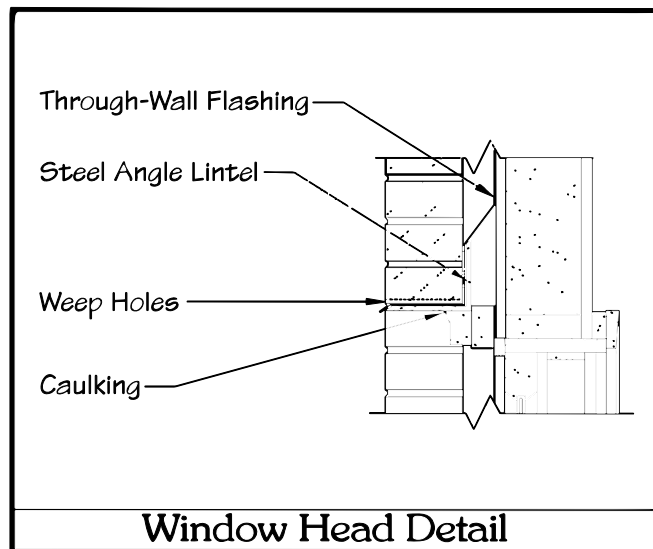
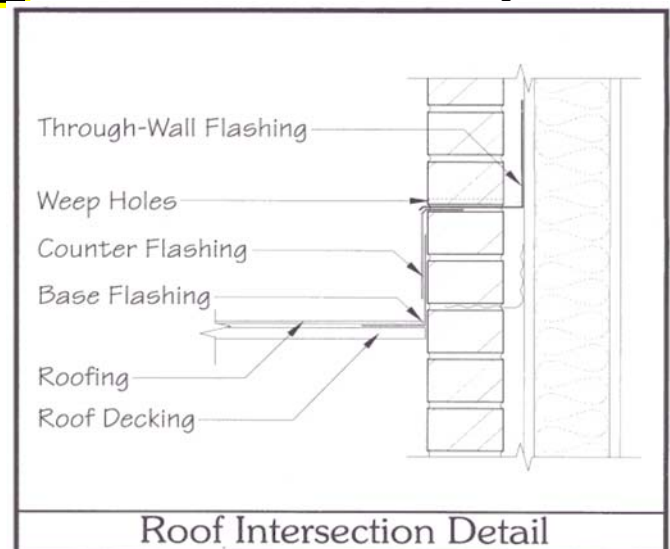
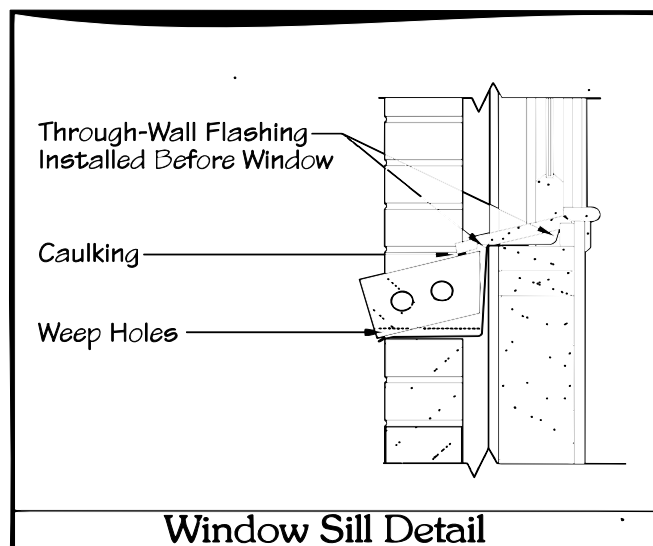
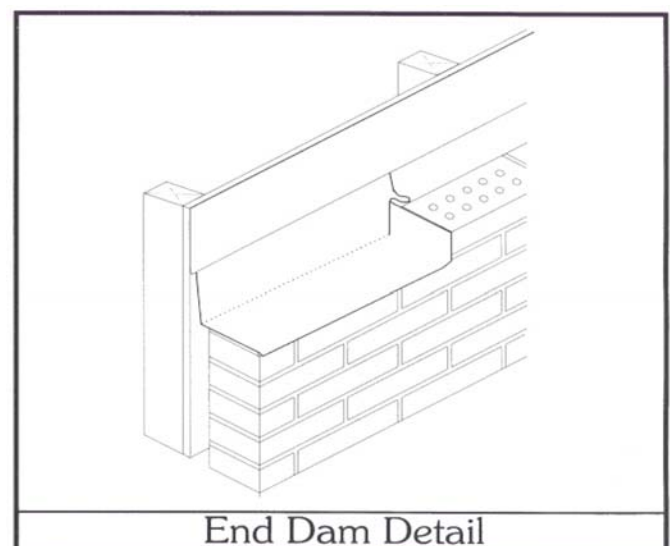
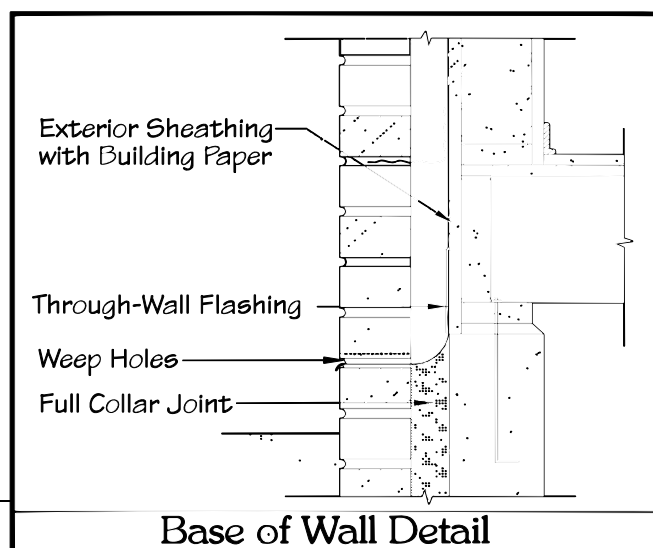
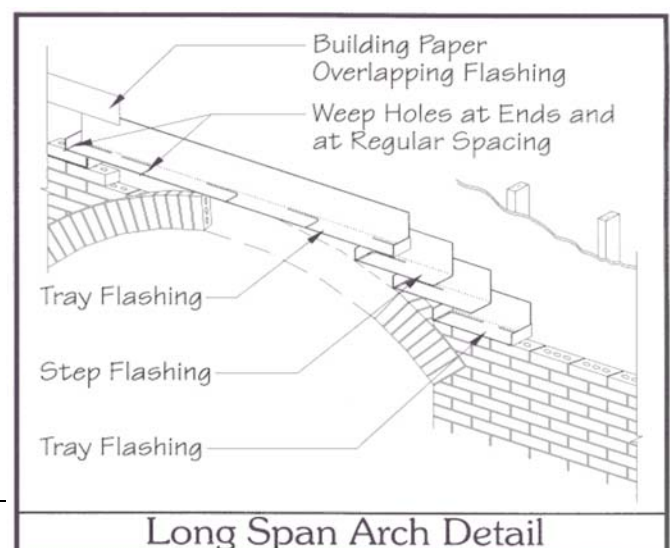
- **Repair:** The metal fascia trim above the front door is loose and needs to be properly secured to prevent the wind from getting behind the siding and causing damage and loss of siding.
- **Repair:** The wood trim around the entire home has reached the point where painting maintenance is required. Exterior wood trim on windows, dormers, chimneys, porch railings and columns, etc., must be kept well painted to prevent decay. Proper preparation including scraping, sanding and painting with a good quality paint will protect the wood and your investment.
- **Improve:** There is rust starting to form on the lintels (the metal angel iron above doors and windows in brickwork) at several locations. Sand, prime and paint with a good quality rust inhibiting paint. Rusted lintels are known to damage brickwork.

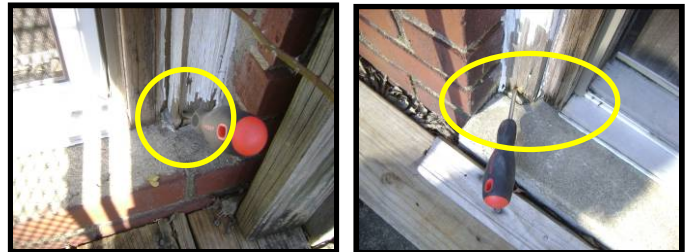
- **Repair:** Ledger boards, which attach a deck frame to a building, should be bolted to the frame of the structure. Standard building practices require use of 1/2” through bolts spaced 4 feet apart as the proper method of securing a deck to the building.
- **Repair:** The construction of the deck is low quality. The deck shows evidence of rot. Replacement may eventually be desired. Repairing damaged and rotted boards may help extend the life of the deck.

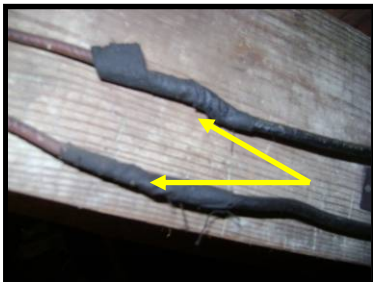
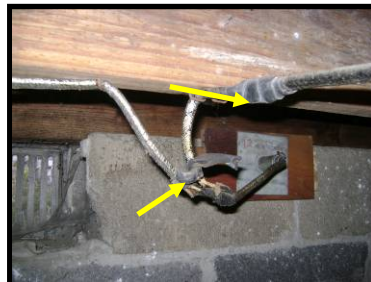
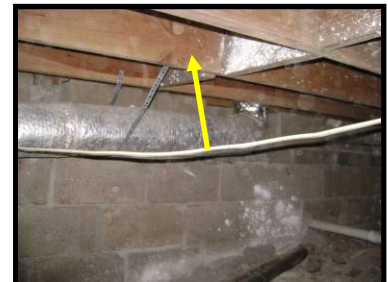
- **Repair:** The electrical conduit going to the HVAC unit on the back of the house is damaged and needs to be repaired.
- **Safety Issue: Improve:** All wire splices are required to be contained within appropriate boxes and fitted with covers. There are inline splices in the crawlspace, attic and in the front right bedroom closet which should be corrected.

- **Improve:** Wires are required to be properly supported and secured at intervals not exceeding 4 ½ feet along their runs and must be secured within 12 inches of a box, cabinet or fitting. Some of the wires in the crawl space need to be properly secured.

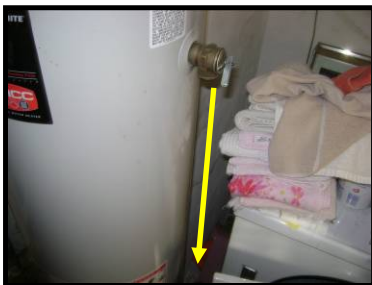
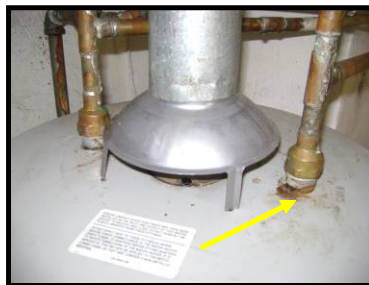
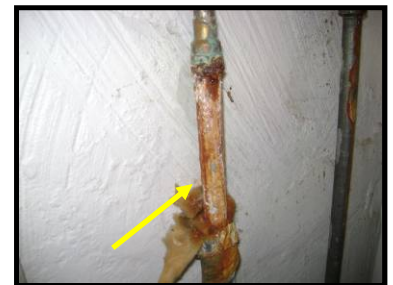
- **Repair, Safety Issue:** It is required that a pipe be plumbed from the pressure relief valve of the water heater and that such pipe terminate in a downward direction within 6 inches of the ground. (It is preferable to have the pipe terminate about 1 ½ to 2 inches from the floor.) The pipe must be a ¾ inch pipe and may be metal or plastic. This is a safety requirement to prevent scalding should the pressure relief valve open. There is no such pipe on the water heater located in the laundry room.

- **Improve: Repair:** Corrosion caused by electrolytic action (electrolysis) occurs when pipes of dissimilar metals (such as galvanized steel and copper pipe) are joined. This often occurs at the top of water heaters. There is rust forming at the top and around the water heater in the laundry room and it would be wise to have dielectric unions installed at the pipe connections.

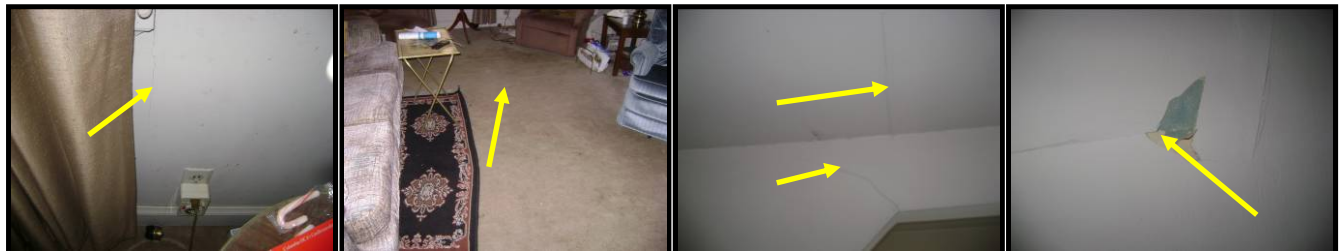
- Major Concern: Repair:** Most of the interior finishes are in mild disrepair. There is a significant amount of cracking in the plaster around the home. This indicates that the house has experienced some minor settlement. The settlement did not appear to have caused major damage, but rather cosmetic flaws. It would be wise that rather than tape and spackle the cracks in the plaster, the old cracked and aged plaster be completely torn out and replaced with drywall. During the removal and instillation of the drywall, it is recommended that the isolation throughout the house be improved. The carpet throughout the house is worn and should be removed. The instillation of the bathroom appeared to have been done in less than a professional manor, and it may be desired to remove and replace all fixtures and finishing material. A significant amount of expense should be anticipated to refresh all of the interior finishes to a more desired living condition.
